**CONTRACT C1053.06: FLOOD DAMAGE REPAIRS TO STRUCTURES
ON MR309 IN SEWEWEEKSPOORT PASS**

INCEPTION REPORT

11 May 2016

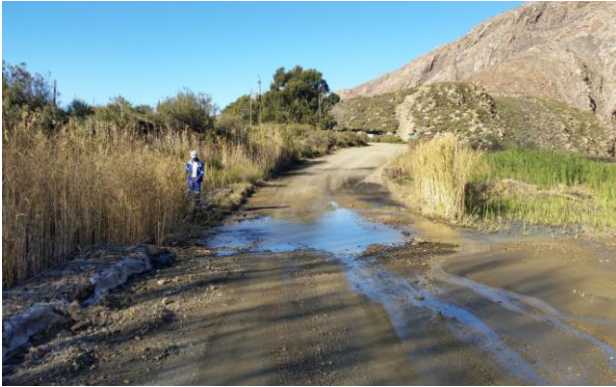
MR309_40.9KM

Km Dist.	GPS Coordinates	Existing Structure	Proposed Structure	Priority
40.90	33°21'41.30"S 21°24'35.42"E	3x600mm pipes with gabions upstream, ponding occurs at inlet and outlet	6m wide causeway	M

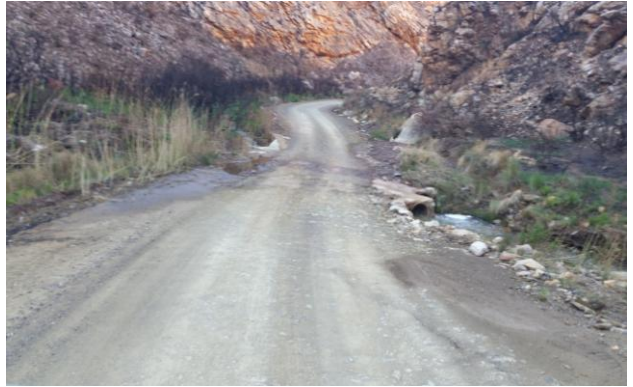
MR309_44.1KM

44.10	33°22'51.38"S 21°24'31.32"E	2x600mm encased pipes, large skew angle	4m wide causeway	L
44.30	33°22'55.45"S 21°24'26.95"E	2x600mm encased pipes, with wing walls, apron slabs, gabions downstream damaged	6m wide causeway	M

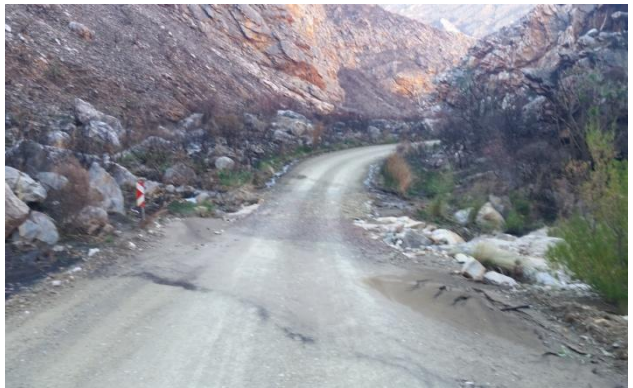
MR309_44.5KM

44.50	33°23'1.12"S 21°24'21.51"E	2x600mm encased pipes, grouted stone head walls, base scoured and water running under structure	4m wide causeway	M
44.70	33°23'8.56"S 21°24'22.03"E	2x600mm encased pipes, heavy siltation, low level	6m wide causeway	H

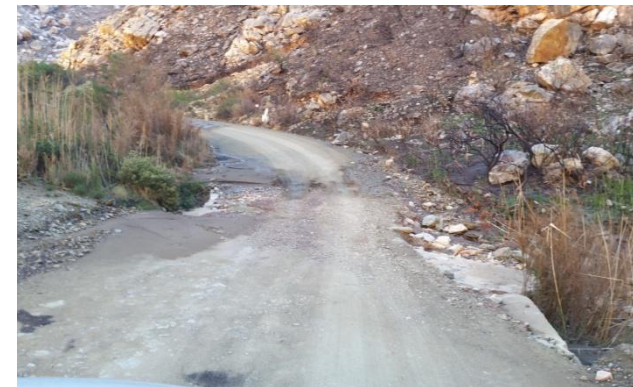
MR309_45.05KM

45.05	33°23'11.26"S 21°24'31.42"E	2x600mm encased pipes, grouted stone head walls, mostly damaged, slight siltation	4m wide causeway	H
45.10	33°23'13.16"S 21°24'34.38"E	2x600mm encased pipes, with stone and concrete head walls upstream	4m wide causeway	H

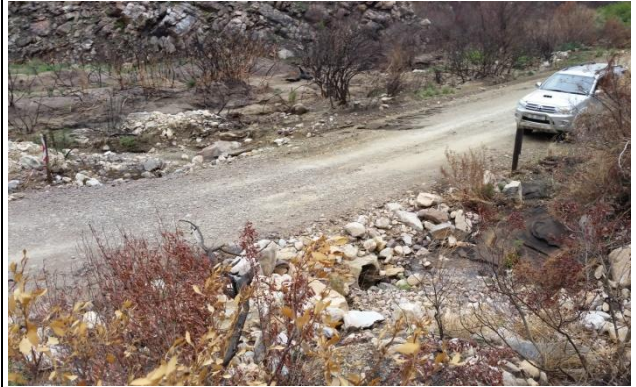
MR309_45.5KM

45.50	33°23'24.84"S 21°24'37.91"E	1x600mm pipe only for side stream	3m wide causeway	H
45.97	33°23'27.84"S 21°24'22.06"E	2x600mm encased pipes with concrete and stone head walls at inlet and outlet, heavy siltation, structure completely buried	4m wide causeway	M

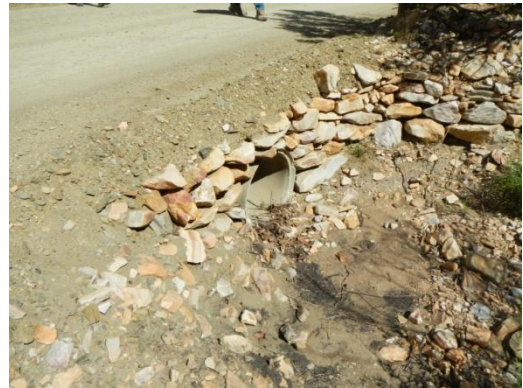
MR309_46.35KM

46.35	33°23'23.57"S 21°24'7.61"E	1x600mm pipe with stone head wall	2m wide causeway	M
46.50	33°23'26.04"S 21°24'5.27"E	2x600mm pipes with concrete and stone head walls at inlet and outlet, stone pitching aprons, siltation, structure completely buried	6m wide causeway	H

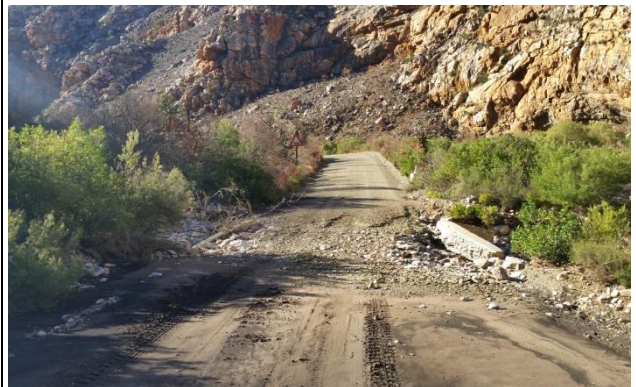
MR309_48KM

48.00	33°24'3.53"S 21°23'55.81"E	1x900mm pipe, stone head and wing walls, damaged apron slabs both sides, river channel is deep	6m wide causeway	H
50.10	33°24'42.25"S 21°24'31.50"E	3x600mm pipes with stone head walls up and down stream, stone pitching aprons severely damaged	8m wide causeway	H

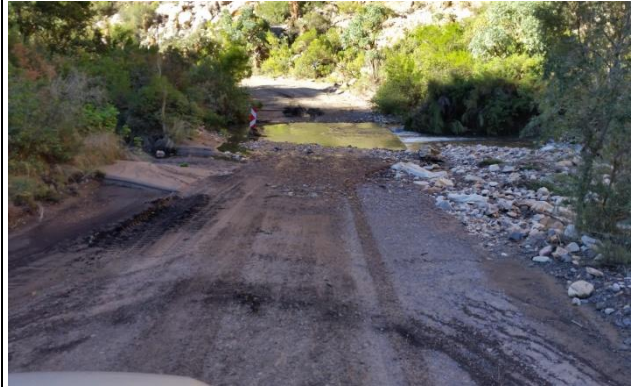
MR309_50.3KM

50.30	33°24'46.14"S 21°24'29.91"E	2x900mm pipes with stone head and return wall downstream, severely damaged and siltation issue	5m wide causeway	H
50.80	33°24'56.08"S 21°24'14.54"E	3x600mm pipes with stone head and return walls up and down stream, severely damaged and siltation prevalent	6m wide causeway	H

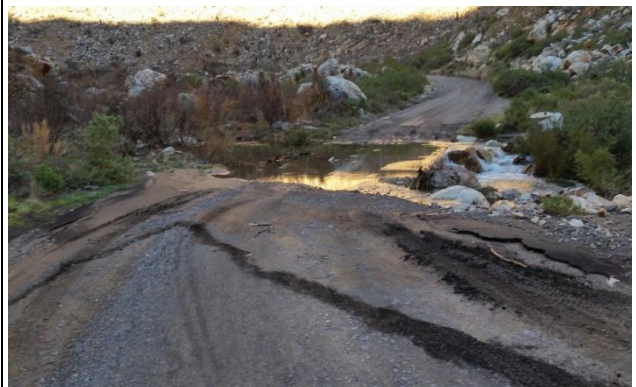
MR309_51.1KM

51.10	33°24'59.11"S 21°24'7.50"E	2x900mm pipes with stone head wall up and down stream, severely damaged, large boulders abundant in river bed	6m wide causeway	H

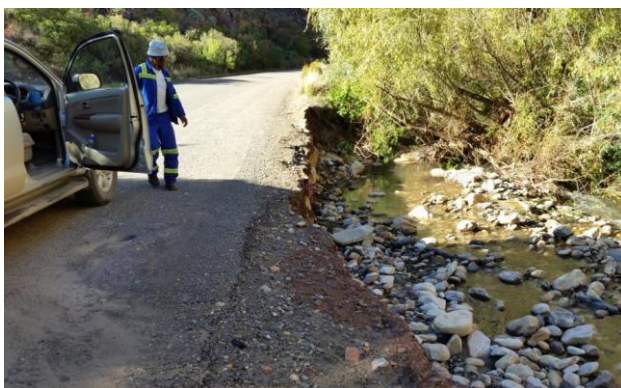
MR309_51.6KM

51.60	33°25'1.52"S 21°23'51.22"E	River blocked by fallen tree and erodes bank and under scours road when flood comes through	30m concrete or gabion wall	H

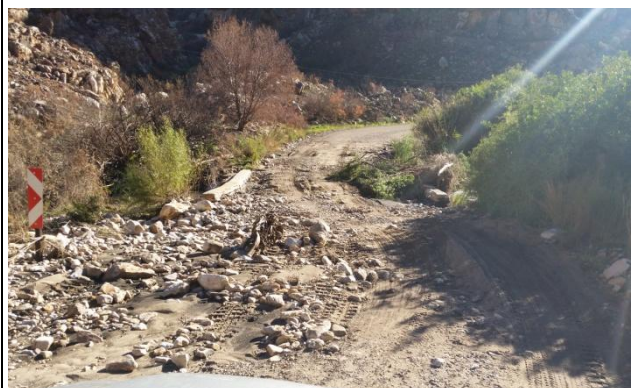
MR309_52KM

52.00	33°25'16.31"S 21°23'50.59"E	2x900mm pipes with stone head wall up and down stream, severely damaged, boulders abundant in river bed	6m wide causeway	H

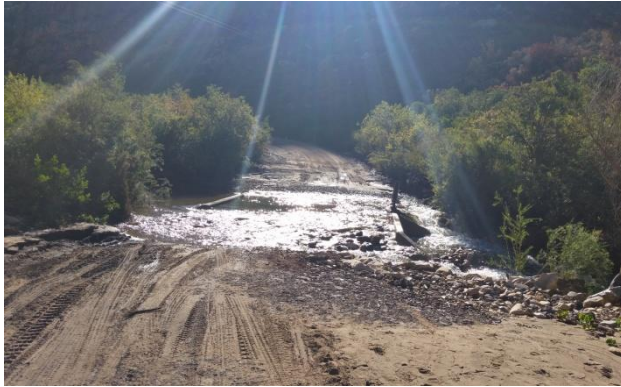
MR309_53.2KM

53.20	33°25'35.88"S 21°24'16.53"E	2x900mm pipes with concrete protection works up and down stream, scouring severe	6m wide causeway	H
53.40	33°25'39.94"S 21°24'20.83"E	2x600mm pipes with stone head walls at and outlet, mostly buried, nearly completely destroyed	6m wide causeway	H

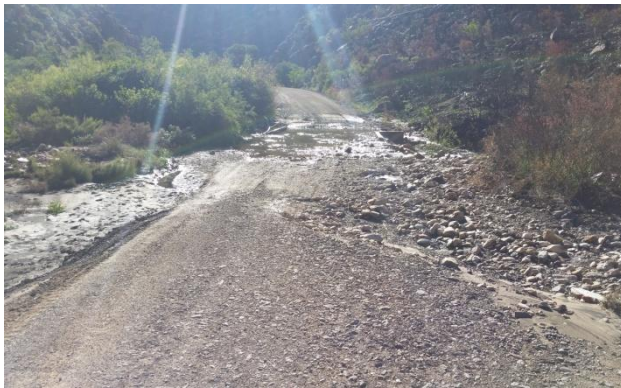
MR309_53.5KM

53.50	33°25'43.76"S 21°24'23.71"E	2x900mm pipes with concrete protection works up and down stream, scouring severe	6m wide causeway	H
53.80	33°25'52.34"S 21°24'31.94"E	Road way gets flooded by river and washes material away completely during floods	100m long concrete retaining wall	H

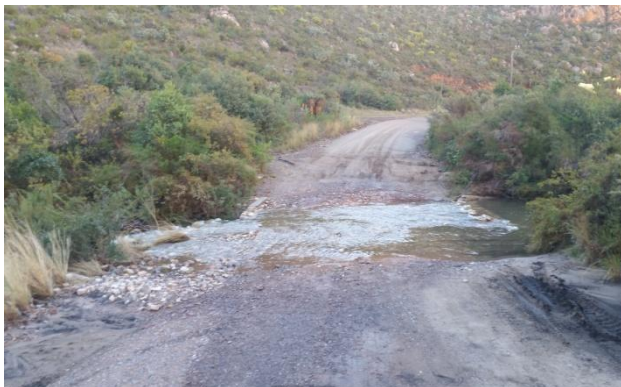
MR309_54.1KM

54.10	33°25'56.48"S 21°24'26.57"E	2x900mm pipes with stone head wall up and down stream, mostly damaged, large boulders abundant in river	6m wide causeway	H

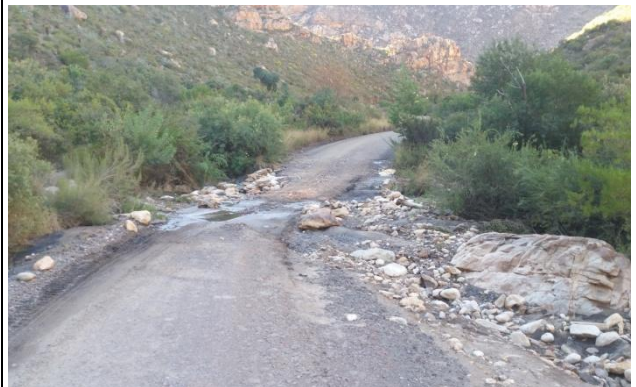
MR309_54.3KM

54.30	33°26'0.20"S 21°24'24.55"E	2x900mm pipes with stone head wall up and down stream, mostly damaged, large boulders abundant in river bed, siltation high	6m wide causeway	H

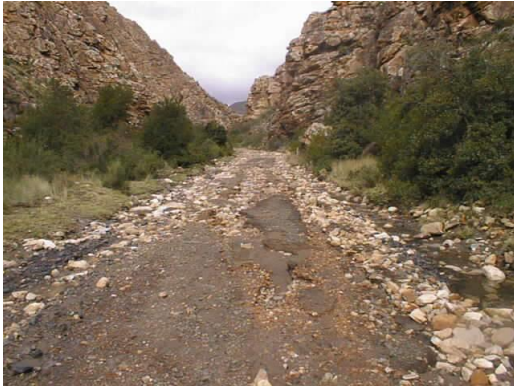
MR309_54.4KM

54.40	33°26'3.00"S 21°24'24.34"E	Road way gets flooded by river and washes material away completely during floods	350m long concrete retaining wall	H
57.10	33°27'14.40"S 21°25'15.08"E	57m long causeway with 6x2.4m openings, 500mm thk slab, aprons and wing walls, 4 openings completely blocked with rocks only 2 openings clear	Drop inlet and river realignment	H

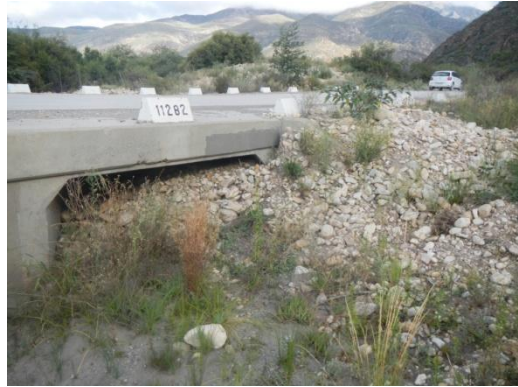
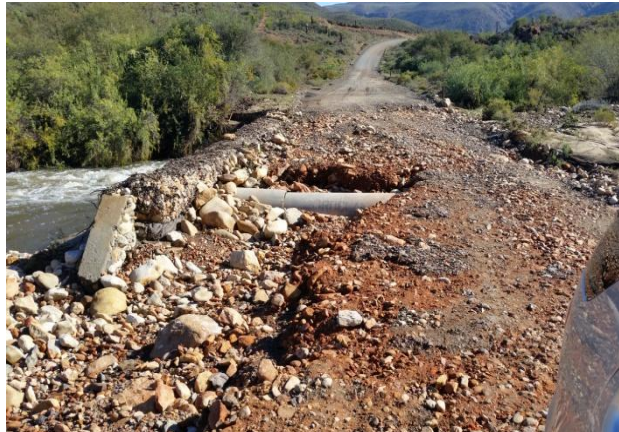
MR309_57.1KM

57.10	33°27'14.40"S	57m long causeway with 6x2.4m openings, 500mm thk slab, aprons and wing walls, 4 openings completely blocked with rocks only 2 openings clear, major rock siltation issue	H	Original List
	21°25'15.08"E
