**Botanical Assessment
for the proposed upgrading of the DR1797
Road (Redford Road), Kurland,
Western Cape Province**

Prepared for HATCH

April 2019

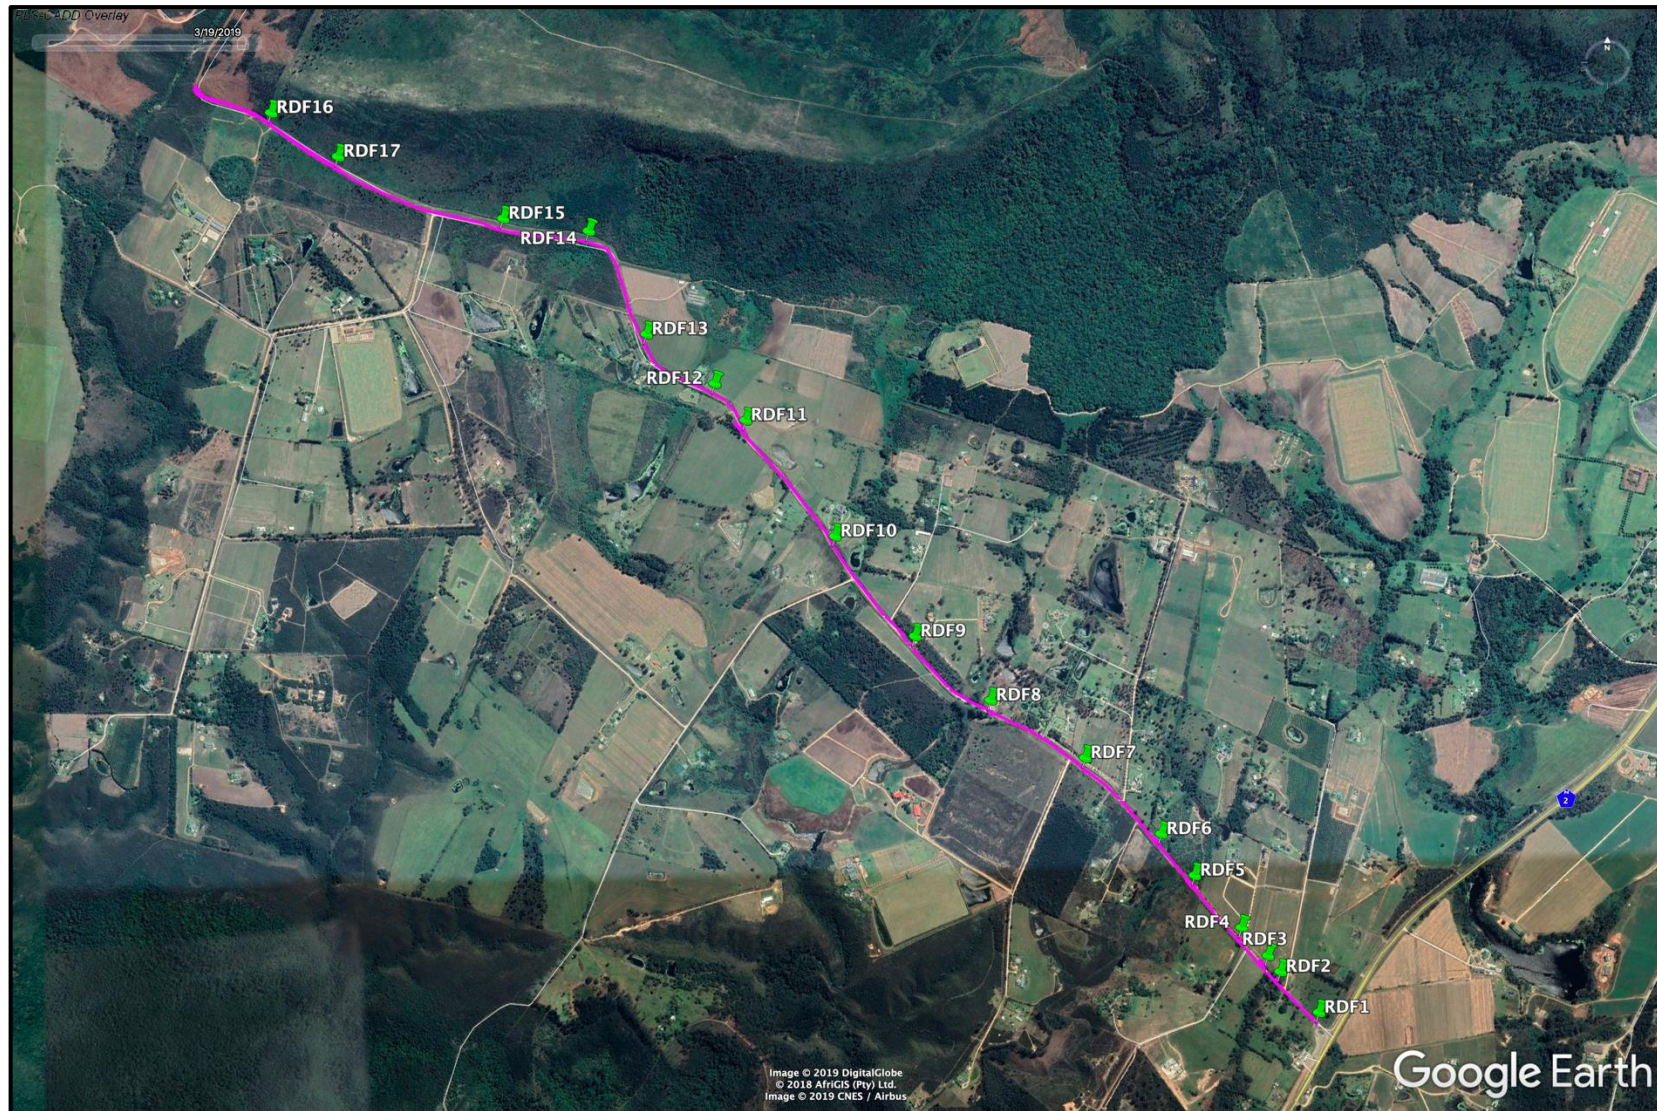
Figure 3. Aerial image (Google Earth Pro™) showing the DR1797 (pink line) which was the survey route with sample waypoints indicated by green pins and labels RDF#.

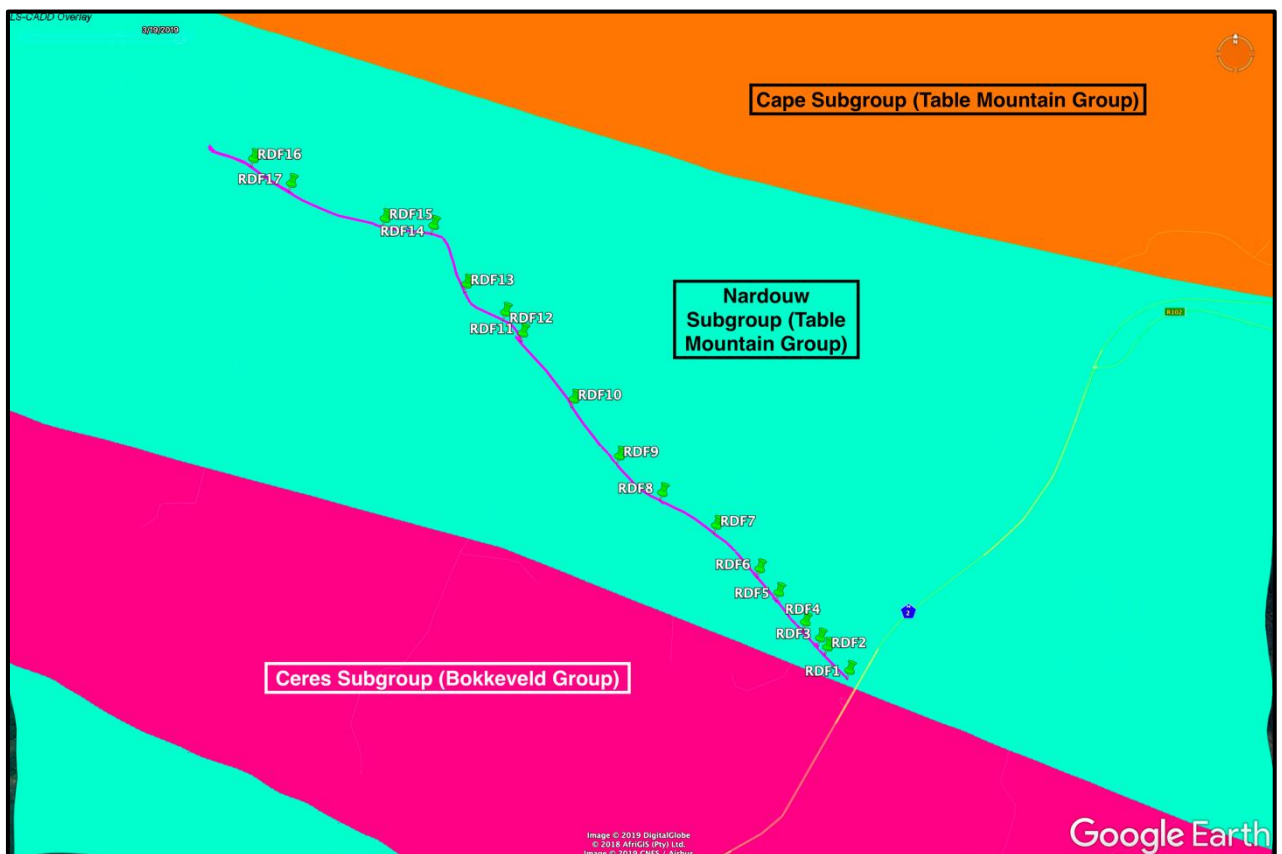
The entire route of the road as surveyed lies within a zone underlain by sandstone sediments of the Nardouw Subgroup (Table Mountain Group) (Figure 4). No shale sediments of the Ceres Subgroup are found in the area surveyed.

Figure 4. Geological Map (Council for Geoscience 1: 1 000 000) indicating the location of the Redford Road entirely within a zone underlain by Nardouw Subgroup sandstone.

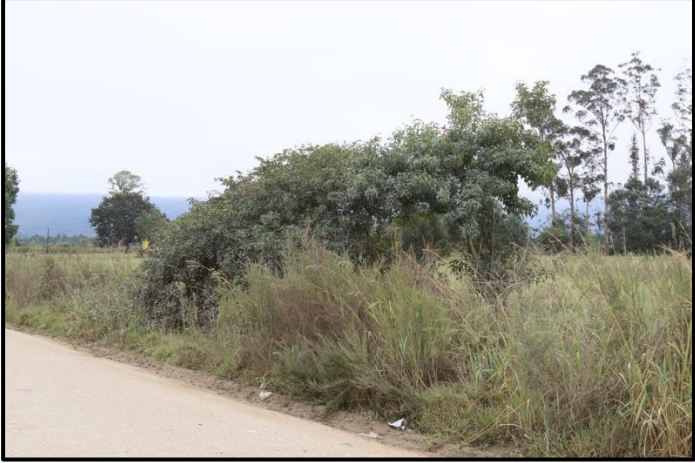
RDF1: S 33° 57' 16.0" E 23° 28' 27.9"	<p>Southwest side: On the southwest side, the vegetation is disturbed and similar to that on the northeast side but with a few addition species. Species recorded here include, <i>Acacia mearnsii</i> (seedlings), <i>Arctotheca calendula</i>, <i>Cheilanthes</i> sp., <i>Conyza scabrida</i>, <i>Cynodon dactylon</i>, <i>Digitaria eriantha</i>, <i>Erica canaliculata</i>, <i>Helichrysum cymosum</i>, <i>Metalasia</i> sp., <i>Phyllica</i> sp., <i>Searsia chirindensis</i>, <i>Stenotaphrum secundatum</i>, <i>Taraxacum</i> sp.</p>

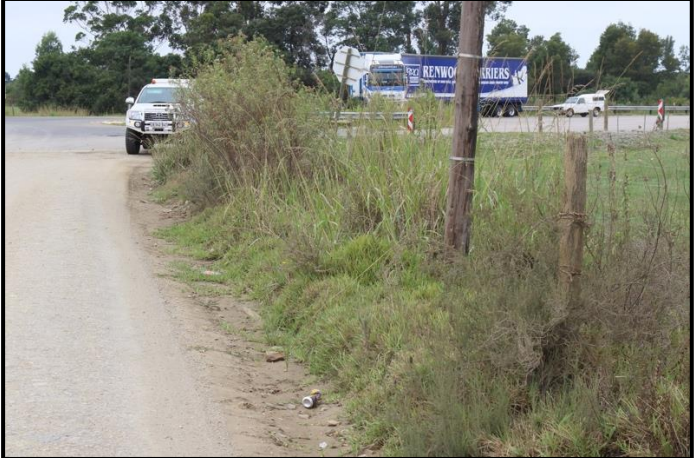
<p>RDF2: S 33° 57' 11.6" E 23° 28' 22.8"</p>	<p>Northeast side: Highly disturbed with tall <i>Eucalyptus</i> sp. trees. The vegetation below the trees is weedy and not sensitive. Species recorded include, <i>Euryops virgineus</i>, <i>Digitaria eriantha</i>, <i>Stenotaphrum secundatum</i>, <i>Acacia mearnsii</i> (seedlings), <i>Diospyros dichrophylla</i>.</p>

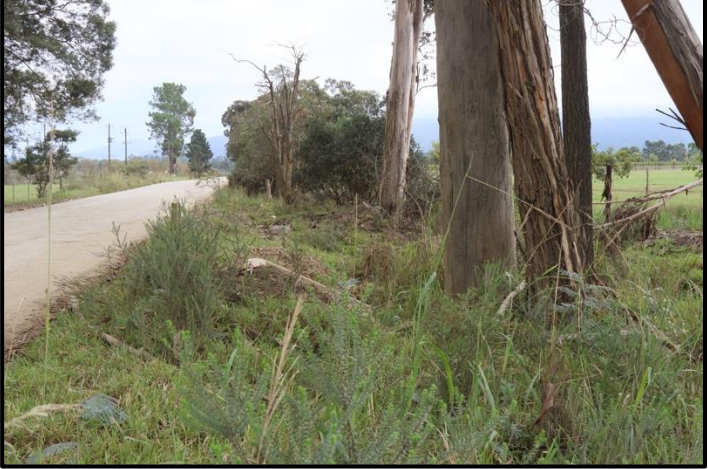
<p>RDF2: S 33° 57' 11.6" E 23° 28' 22.8"</p>	<p>Southwest side: A stand of invasive black wattle (<i>Acacia mearnsii</i>) lies adjacent to the road reserve that is highly disturbed and does not support much vegetation. It has very low sensitivity.</p>

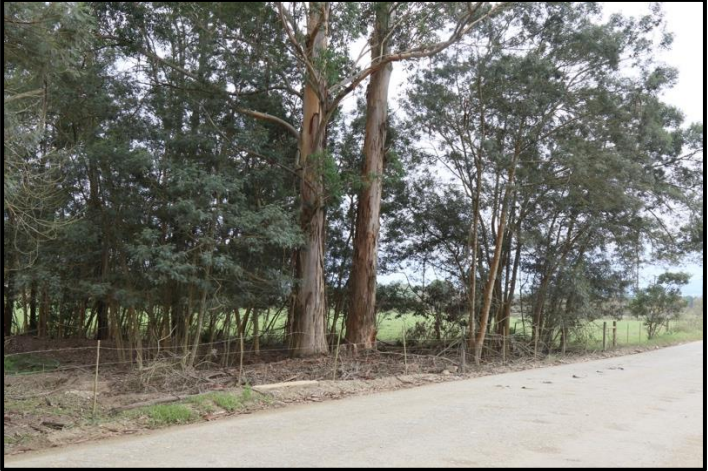
<p>RDF3: S 33° 57' 09.9" E 23° 28' 21.2"</p>	<p>Northeast side: The vegetation consists of some exotic trees (<i>Eucalyptus ficifolia</i>) and a few indigenous shrubs but the road reserve here is generally highly disturbed. The species recorded apart from the trees are, <i>Calopsis</i> sp., <i>Cynodon dactylon</i>, <i>Diospyros dichrophylla</i>, <i>Hypoxis hemerocallidea</i>, <i>Osteospermum moniliferum</i>, <i>Selago dolosa</i>, <i>Stenotaphrum secundatum</i>.</p>

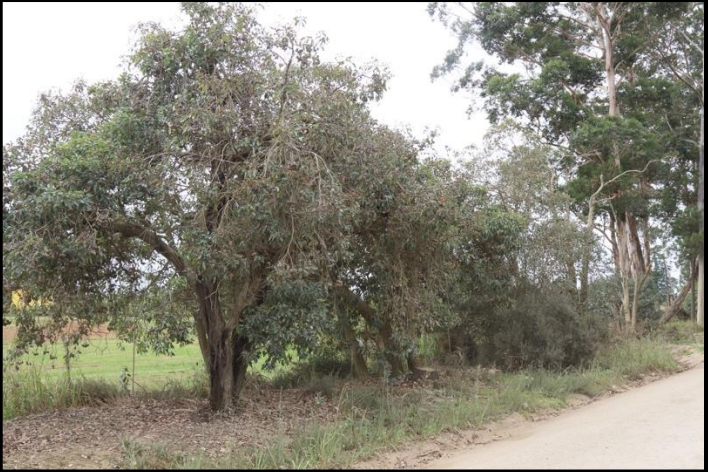
<p>RDF3: S 33° 57' 09.9" E 23° 28' 21.2"</p>	<p>Southwest side: The road reserve is generally disturbed with low botanical sensitivity. Plant species recorded include <i>Acacia mearnsii</i>, <i>Agapanthus praecox</i>, <i>Anthospermum aethiopicum</i>, <i>Cynodon dactylon</i>, <i>Digitaria eriantha</i>, <i>Helichrysum petiolare</i>, <i>Searsia chirindensis</i>, <i>Selago dolosa</i>, <i>Stenotaphrum secundatum</i>.</p>

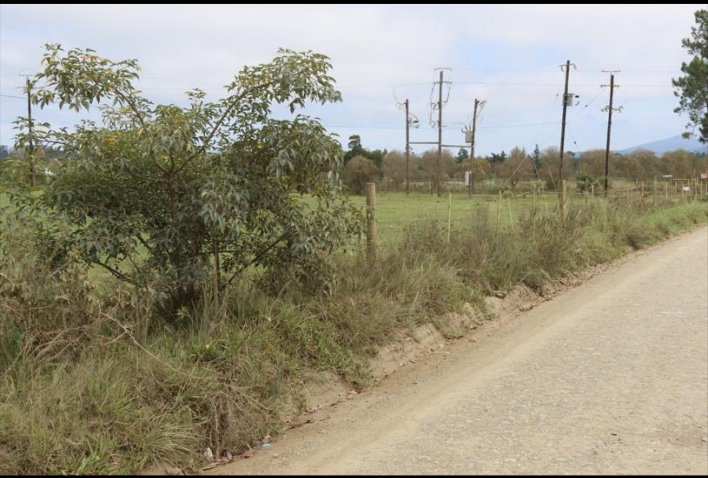
<p>RDF4: S 33° 57' 6.9" E 23° 28' 17.8"</p>	<p>Northeast side: Generally disturbed with water furrow. Trees and shrubs have been planted and cultivated. The road reserve is manicured. Plants species present, <i>Digitaria eriantha</i>, <i>Ficus cf. natalensis</i>, <i>Halleria lucida</i>, <i>Stenotaphrum secundatum</i>, <i>Syzigium sp.</i>, <i>Tarchonanthus camphoratus</i>, <i>Osteospermum moniliferum</i>.</p>

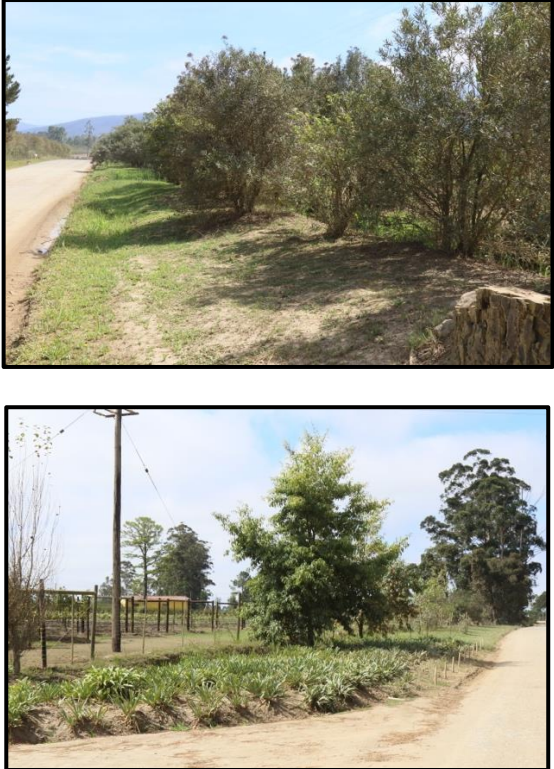
<p>RDF4: S 33° 57' 6.9" E 23° 28' 17.8"</p>	<p>Southwest side: Mowed <i>Stenotaphrum secundatum</i> with mowed sedges and <i>Hypoxis hemerocallidea</i>. A few trees of exotic <i>Pinus radiata</i> along the fence.</p>

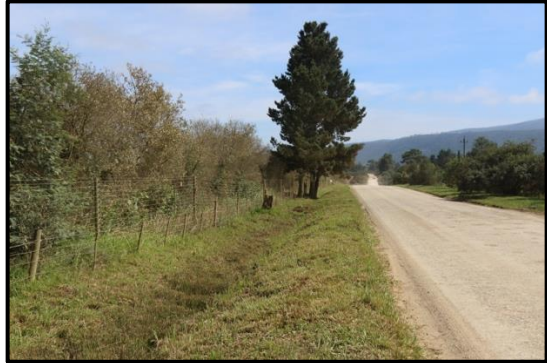
<p>RDF5: S 33° 57' 01.3" E 23° 28' 11.7"</p>	<p>Northeast side: The road dips here towards a stream and a remnant patch of Tsitsikamma sandstone Fynbos is present. The vegetation is shrubby and dense and extends from this waypoint 'through' the stream to the NE side. Plant species recorded include <i>Aspalathus sp.</i>, <i>Digitaria eriantha</i>, <i>Erica discolor</i>, <i>Pittosporum viridiflorum</i>, <i>Pteridium aquilinum</i>, <i>Searsia chirindensis</i>, <i>Searsia lucida</i>.</p> <p><i>Pittosporum viridiflorum</i> is a protected tree and must be avoided.</p> <p>The vegetation has moderate sensitivity.</p>

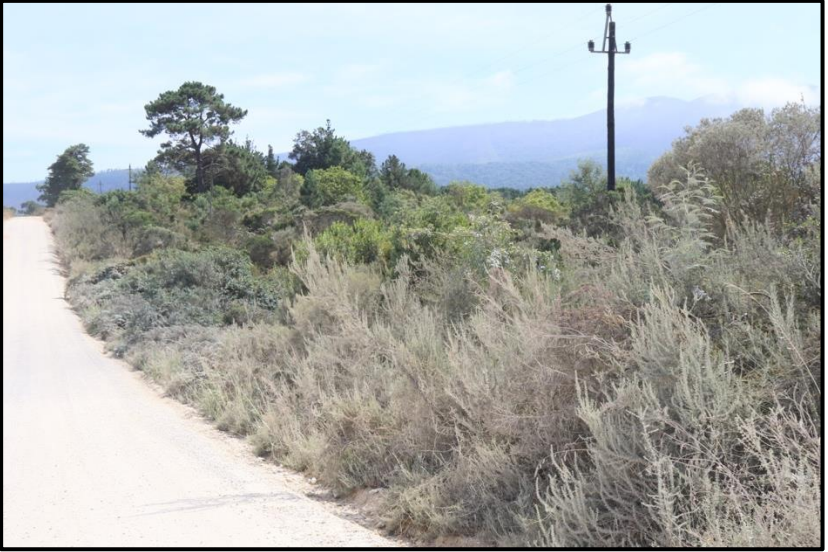
<p>RDF5: S 33° 57' 01.3" E 23° 28' 11.7"</p>	<p>Southwest side: The shrub vegetation has mostly been removed on the southwest side that has introduced a high level of disturbance. However, the field stratum still supports numerous indigenous species. Some trees have been planted. Species recorded include, <i>Acacia mearnsii</i> (invasive- seedling), <i>Athanasia trifurcata</i>, <i>Digitaria eriantha</i>, <i>Ekebergia capensis</i> (planted), <i>Eragrostis capensis</i>, <i>Eragrostis curvula</i>, <i>Lobelia coronopifolia</i>, <i>Pteridium aquilinum</i>, <i>Searsia chirindensis</i>, <i>Syzigium sp.</i> (planted), <i>Watsonia sp.</i></p>

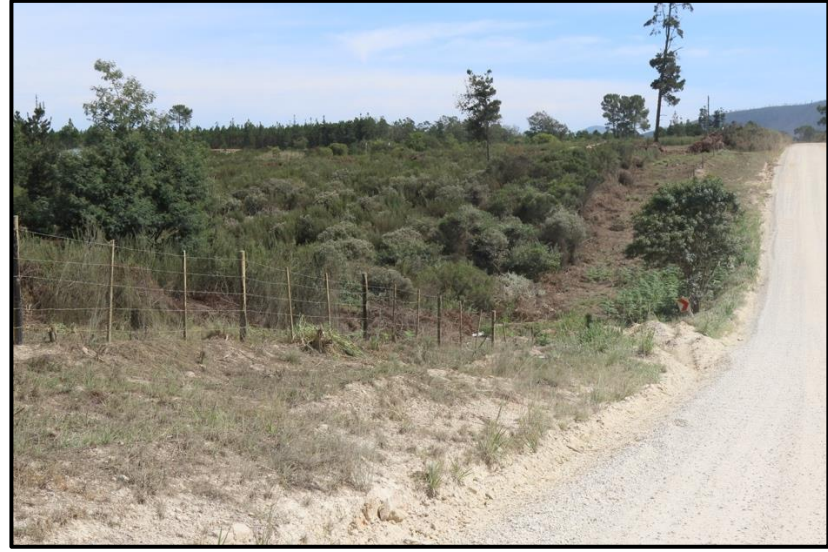
<p>RDF6: S 33° 56' 56.7" E 23° 28' 07.3"</p>	<p>Northeast side: Dense ericaceous fynbos (Tsitsikamma Sandstone Fynbos) dominated by <i>Erica discolor</i> and <i>Erica canaliculata</i>. Other species include, <i>Acacia mearnsii</i> (seedling), <i>Aspalathus</i> sp. (tall), <i>Cheilanthes</i> sp., <i>Euryops virgineus</i>, <i>Halleria lucida</i>, <i>Helichrysum cymosum</i>, <i>Helichrysum foetidum</i>, <i>Helichrysum petiolare</i>, <i>Searsia chirindensis</i>, <i>Stenotaphrum secundatum</i>.</p> <p>This vegetation extends in a northerly direction beyond the entrance to 'The Perfect Place'.</p>

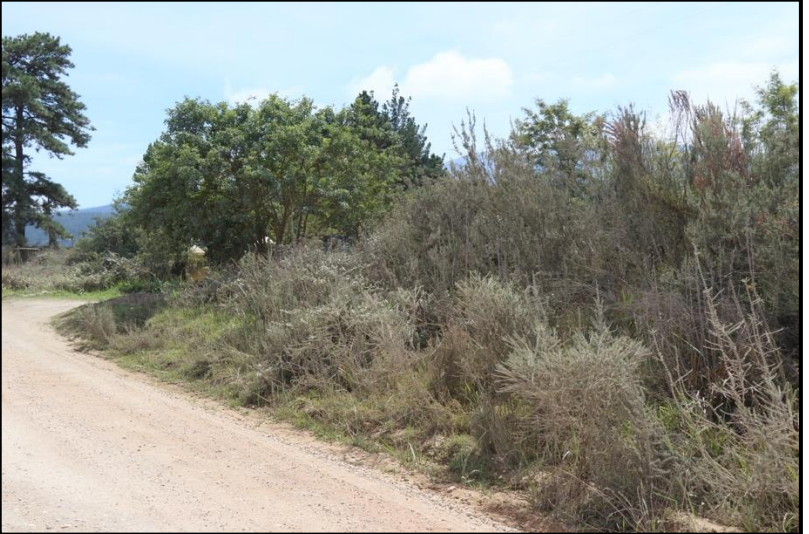
<p>RDF6: S 33° 56' 56.7" E 23° 28' 07.3"</p>	<p>Southwest side: The southwest side also has dense ericaceous fynbos that is moderately disturbed and not sensitive. Similar vegetation extends on the southwest side to beyond the 1 km marker post. Species recorded include,</p> <p><i>Anthospermum aethiopicum</i>, <i>Cassythia ciliolata</i>, <i>Cliffortia</i> sp., <i>Digitaria eriantha</i>, <i>Erica discolor</i>, <i>Helichrysum cymosum</i>, <i>Helichrysum petiolare</i>, <i>Lobelia coronopifolia</i>, <i>Metalasia densa</i>, <i>Passerina rigida</i>, <i>Polygala</i> sp., <i>Senecio hastatus</i>, <i>Stenotaphrum secundatum</i>.</p>

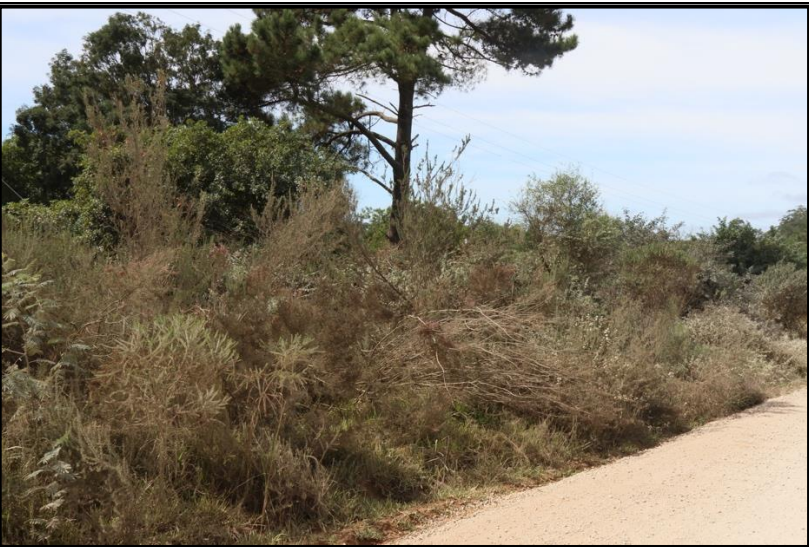
<p>RDF7: S 33° 56' 48.5" E 23° 27' 57.3"</p>	<p>Northeast side: The northeast side of the road has been heavily disturbed and now has low shrubs of <i>Aspalathus</i> sp. and <i>Helichrysum cymosum</i>. <i>Aloe</i> sp. (cf. <i>Aloe ferox</i>) has been planted.</p> <p>The road reserve here has low sensitivity.</p>

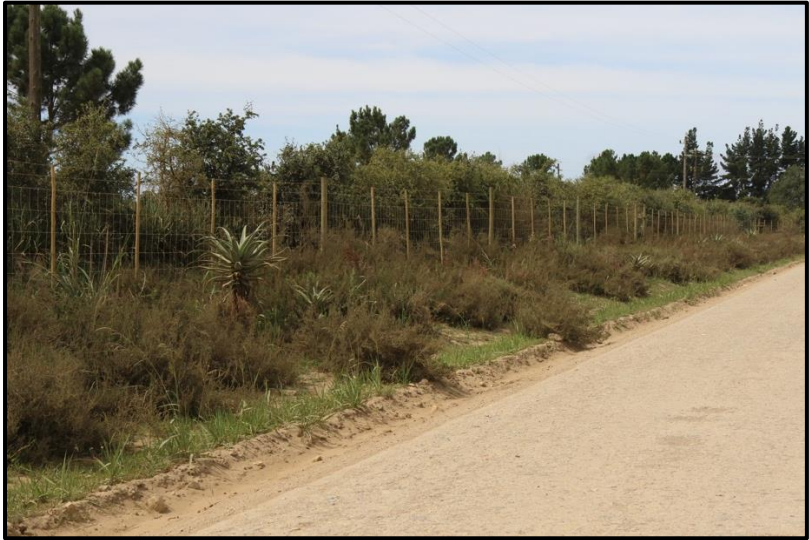
<p>RDF7: S 33° 56' 48.5" E 23° 27' 57.3"</p>	<p>Southwest side: The vegetation on the south-west side is very grassy; dominated by <i>Eragrostis curvula</i>. Other species include, <i>Acacia mearnsii</i> (seedlings), <i>Anigozanthos</i> sp. (kangaroo paw – invasive), <i>Bobartia</i> sp., <i>Calopsis membranaceus</i>, <i>Cynodon dactylon</i>, <i>Digitaria eriantha</i>, <i>Erica canaliculata</i>, <i>Helichrysum petiolare</i>, <i>Metalasia densa</i>, <i>Pentaschistis</i> sp., <i>Senecio hastatus</i>, <i>Stenotaphrum secundatum</i>, <i>Themeda triandra</i>.</p> <p>The road reserve vegetation is not sensitive.</p>

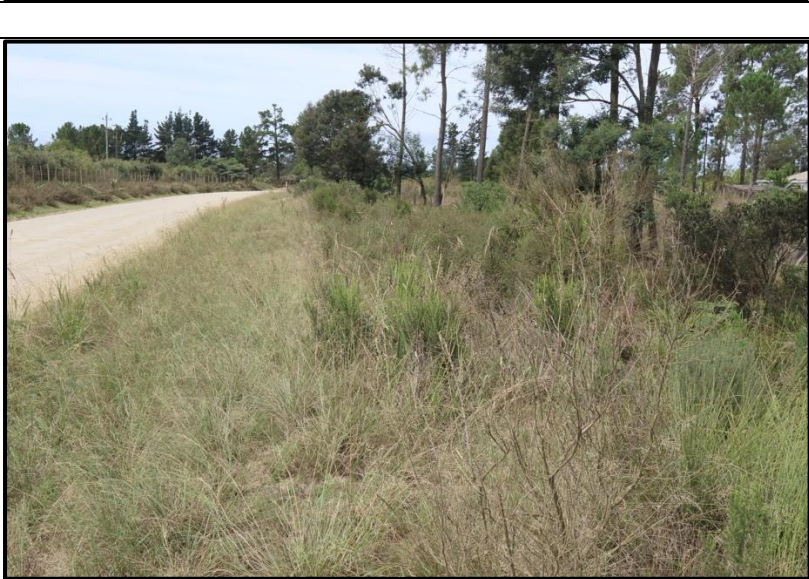
<p>RDF8: S 33° 56' 42.3" E 23° 27' 45.0"</p>	<p>Northeast side: No vegetation present. The road reserve has been cleared and is highly disturbed.</p>	 
<p>RDF8: S 33° 56' 42.3" E 23° 27' 45.0"</p>	<p>Southwest side: Within the road reserve indigenous vegetation is present with moderate disturbance and low sensitivity. Species recorded include, <i>Acacia mearnsii</i> (exotic invasive), <i>Cliffortia strobilifera</i>, <i>Digitaria eriantha</i>, <i>Eragrostis curvula</i>, <i>Erica canaliculata</i>, <i>Helichrysum petiolare</i>, <i>Pennisetum clandestinum</i> (exotic invasive), <i>Pteridium aquilinum</i>, <i>Rubus rigidus</i> (exotic invasive), <i>Stenotaphrum secundatum</i>.</p>

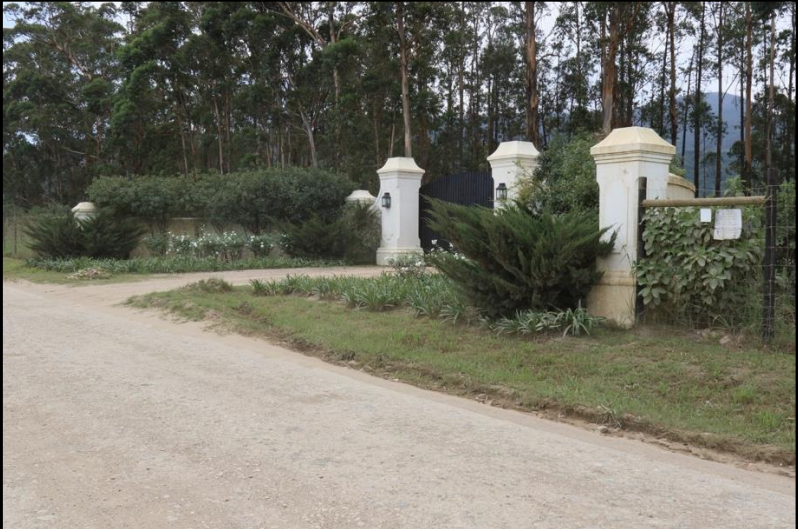
<p>RDF9: S 33° 56' 35.3" E 23° 27' 35.2"</p>	<p>Southwest side: At 2 km marker post, the vegetation has moderate to low sensitivity. Species recorded include, <i>Eragrostis curvula</i>, <i>Erica canaliculata</i>, <i>Osteospermum moniliferum</i>, <i>Helichrysum cymosum</i>, <i>Digitaria eriantha</i>, <i>Erica discolor</i>.</p>

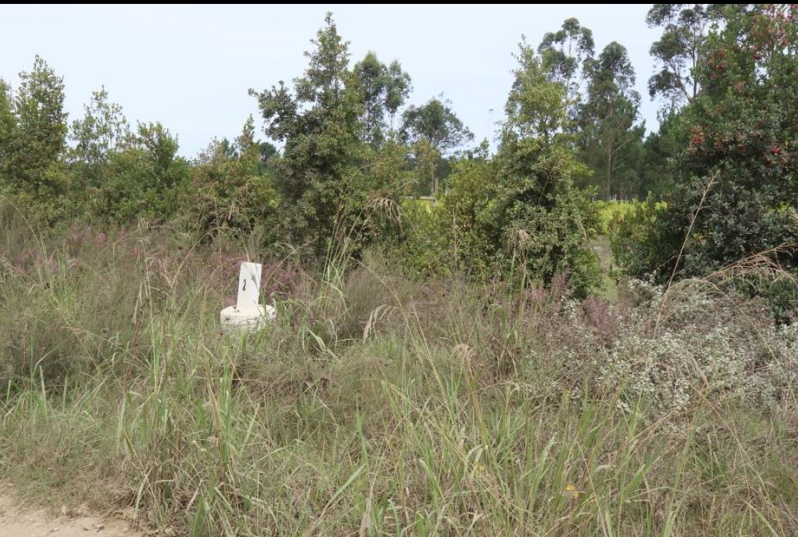
<p>RDF10: S 33° 56' 24.5" E 23° 27' 24.8"</p>	<p>Northeast side: Shrubby fynbos dominated by <i>Osteospermum moniliferum</i> and <i>Erica canaliculata</i>. Grassy understorey. Additional species are <i>Euryops virgineus</i> and <i>Lobelia coronopifolia</i>.</p> <p>The vegetation is moderately sensitive.</p>

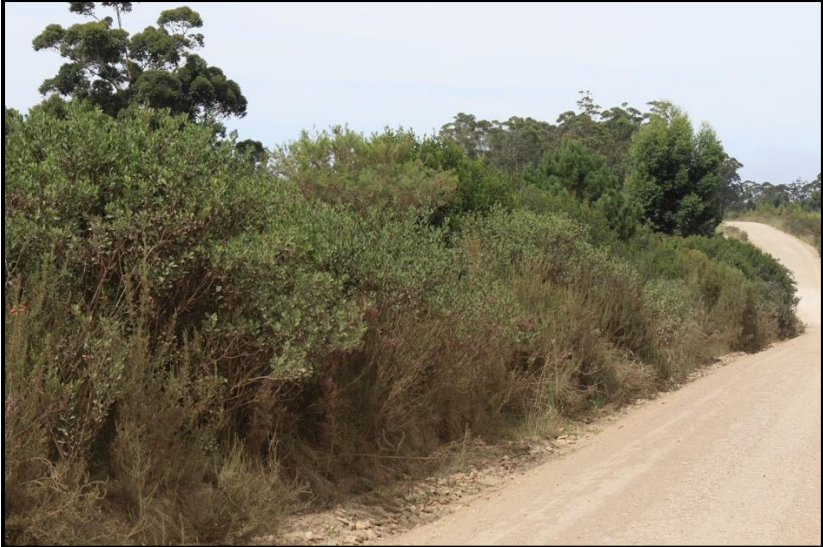
A photograph showing a dirt road on the right side, bordered by dense, green and brown shrubby fynbos vegetation. The background shows a clear sky and some distant trees.
<p>RDF10: S 33° 56' 24.5" E 23° 27' 24.8"</p>	<p>Southwest side: Similar fynbos occurs on the southwest side with a grassy understorey and the shrub <i>Passerina rigida</i> dominant. <i>Erica discolor</i> and <i>Erica canaliculata</i> are prominent.</p> <p>The vegetation is moderately sensitive.</p>

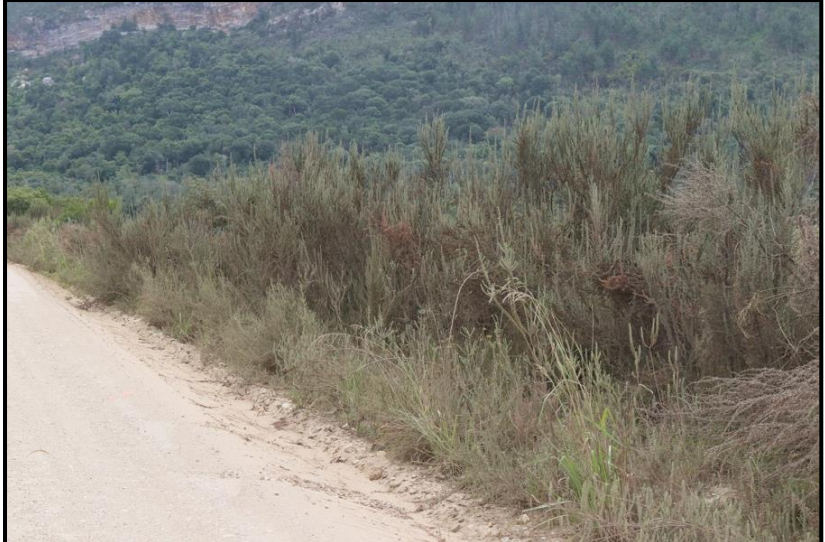
<p>RDF11: S 33° 56' 12.0" E 23° 27' 13.1"</p>	<p>Southwest side: The fynbos is lower on the southwest side than on the northeast side. It is also more disturbed with low sensitivity. It is grassy with emergent <i>Aspalathus sp.</i>, <i>Conyza scabrida</i>, <i>Erica canaliculata</i>, <i>Searsia chirindensis</i>.</p>

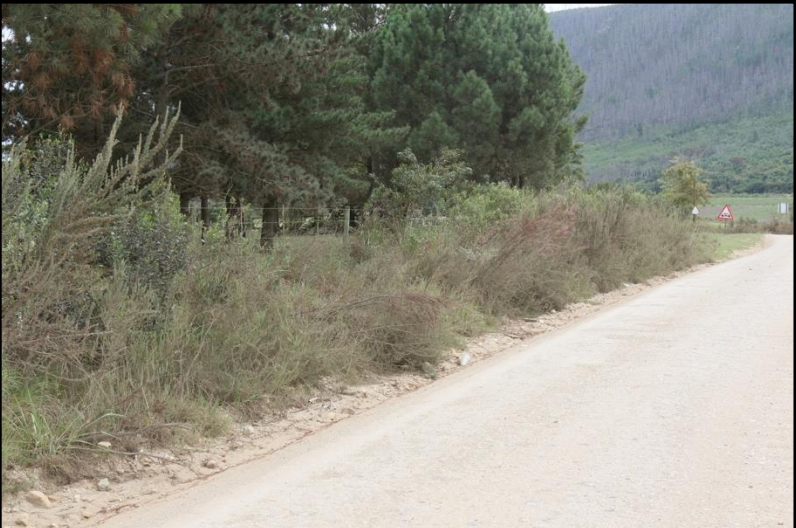
<p>RDF12: S 33° 56' 08.1" E 23° 27' 09.1"</p>	<p>Northeast side: At 3 km marker near the entrance to Redford House. The road runs through a depression with a dam on the east side.</p> <p>The same type scrubby fynbos (Tsitsikamma Sandstone Fynbos) as described from other waypoints with <i>Erica canaliculata</i>, <i>Aspalathus</i> sp. etc. <i>Watsonia knysnana</i> was recorded here.</p> <p>Low sensitivity.</p>

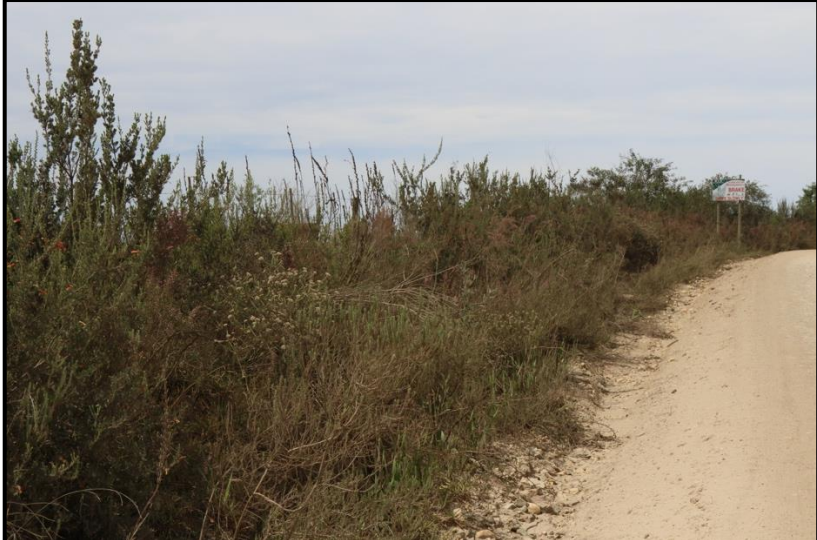
<p>RDF12: S 33° 56' 08.1" E 23° 27' 09.1"</p>	<p>Southwest side: The vegetation on the southwest side is thicket consisting of a dense stand of <i>Searsia lucida</i> and <i>Diospyros dichrophylla</i> with a low grass-dominated scrub immediately alongside the road that has low sensitivity.</p>

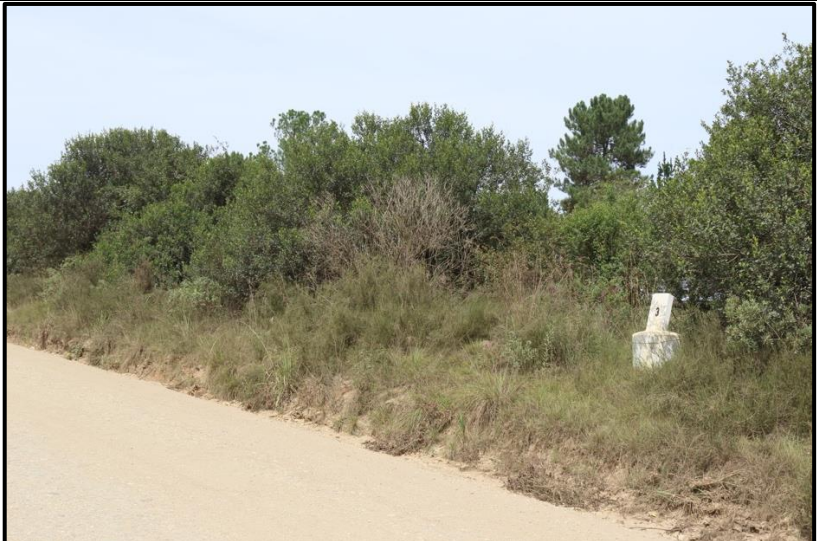
<p>RDF13: S 33° 56' 02.8" E 23° 27' 00.1"</p>	<p>Northeast side: Opposite the entrance to Simply Green Nursery. Small trees of <i>Searsia chirindensis</i> and <i>Dais cotinifolia</i> occur along the fence. The low vegetation is dominated by <i>Erica canaliculata</i>. Other species include <i>Cliffortia</i> sp., <i>Conyza scabrada</i>, <i>Digitaria eriantha</i>, <i>Eragrostis curvula</i>, <i>Searsia pallens</i>.</p> <p>Low sensitivity.</p> <p>(Further long on the NE side adjacent to Kleinberg Farm, the vegetation has been completely cleared in the road reserve).</p>

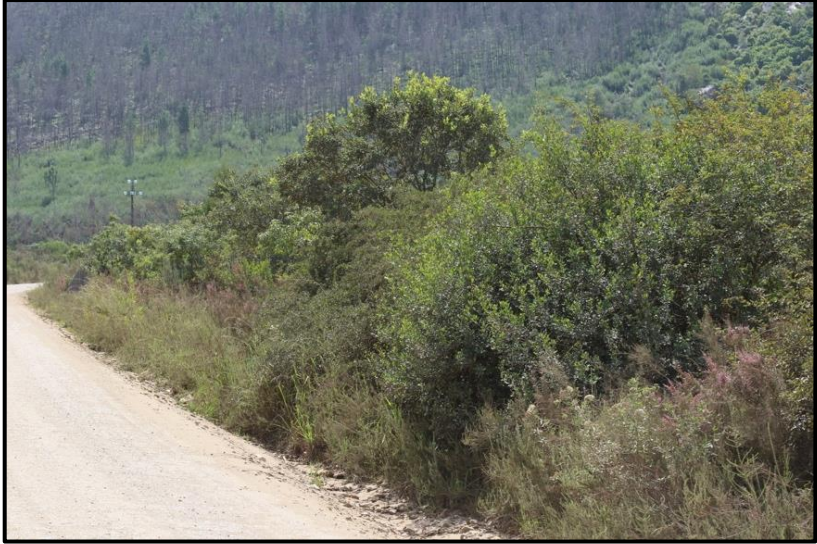
<p>RDF13: S 33° 56' 02.8" E 23° 27' 00.1"</p>	<p>Southwest side: The vegetation is dense tall thicket on the boundary of Simply Green Nursery. It consists of a mix of forest elements and plants grown as ornamentals. Species recorded here include, <i>Dais cotinifolia</i>, <i>Podocarpus falcatus</i>, <i>Searsia chirindensis</i>, <i>Searsia pallens</i>, <i>Tecoma capensis</i>.</p> <p>The vegetation has low sensitivity but disturbance of the <i>Afrocarpus falcatus</i> (Outeniqua yellowwood) trees must be avoided.</p>

- No rare or threatened plant species were found during the survey. However, a specimen of *Afrocarpus falcatus* (protected tree species) is located at S 33°56' 2.8" E 23° 27' 0.5" and must be avoided. In addition, a cheesewood tree (*Pittosporum viridiflorum*) was found at S 33° 57' 0.8" E 23° 28' 11.5" and must also be avoided.

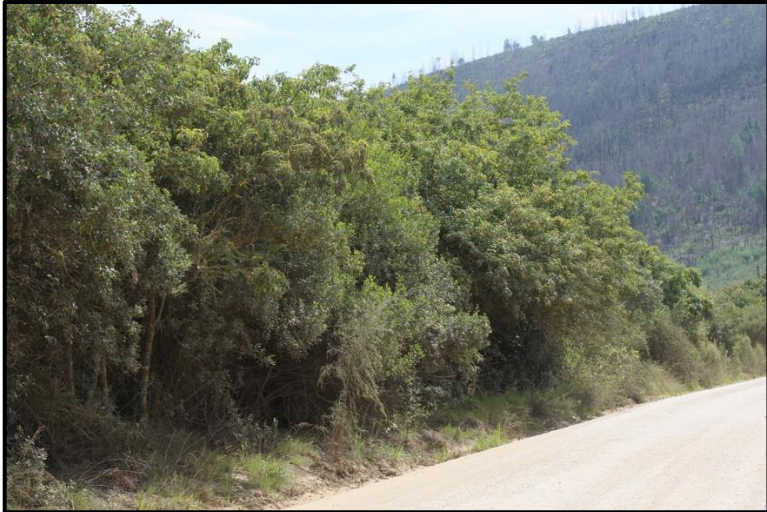
<p>RDF14: S 33° 55' 51.7" E 23° 26' 52.8"</p>	<p>Northeast side: The waypoint is on the edge of a wide firebreak on the lower slopes of Kleinberg. The edge of the firebreak has dense <i>Pteridium aquilinum</i> (bracken fern) and <i>Digitaria eriantha</i>.</p> <p>Low sensitivity.</p>

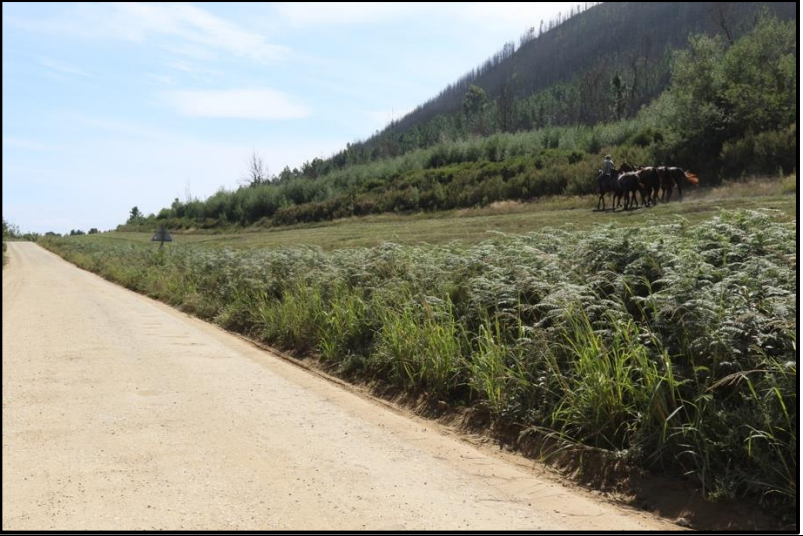
<p>RDF14: S 33° 55' 51.7" E 23° 26' 52.8"</p>	<p>Southwest side: The vegetation here is remnant Southern Afromontane Forest. It is not well-developed. Species recorded include, <i>Diospyros dichrophylla</i>, <i>Halleria lucida</i>, <i>Osteospermum moniliferum</i>, <i>Rapanea melanophloeos</i>, <i>Searsia chirindensis</i>, <i>Searsia lucida</i>, <i>Trimeria grandifolia</i>.</p> <p>Low sensitivity.</p>

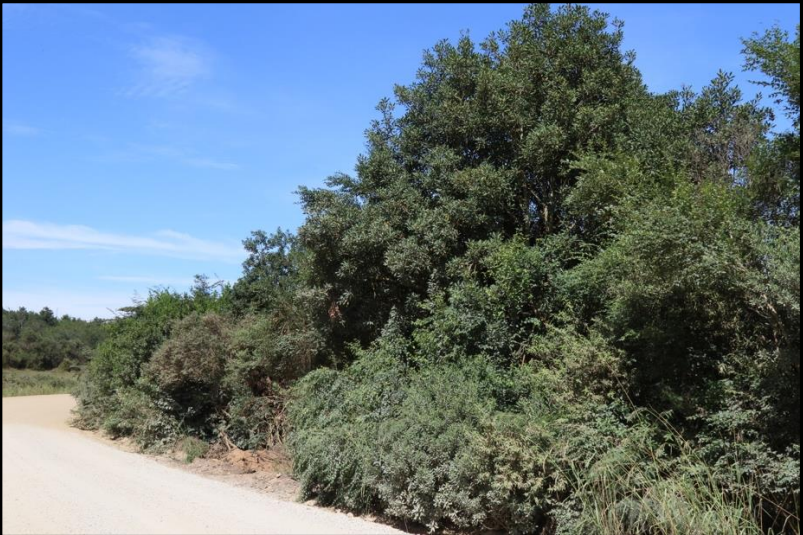
<p>RDF15: S 33° 55' 50.4" E 23° 26' 41.8"</p>	<p>Northeast side: Cleared firebreak. Low grassy fynbos along verge. Low sensitivity.</p>

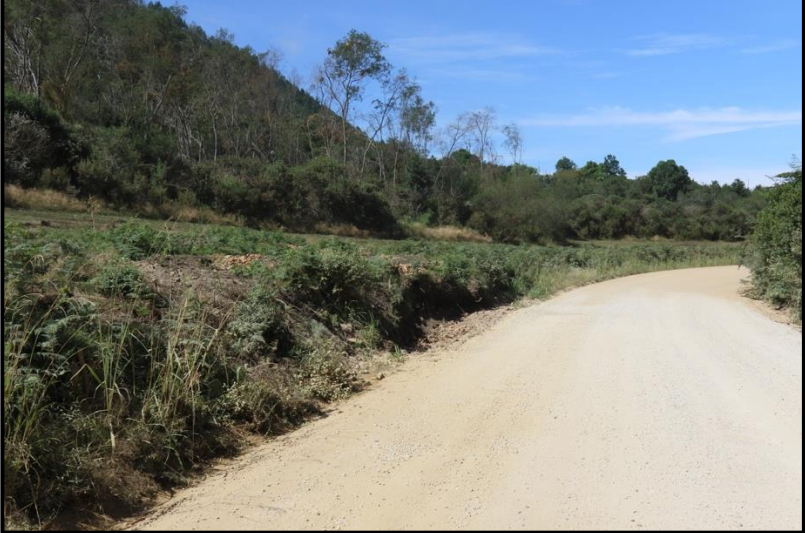
<p>RDF15: S 33° 55' 50.4" E 23° 26' 41.8"</p>	<p>Southwest side: Fynbos / thicket at the 4 km marker. Species recorded include, <i>Cannomois sp.</i>, <i>Conyza scabrida</i>, <i>Digitaria eriantha</i>, <i>Erica canaliculata</i>, <i>Halleria lucida</i>, <i>Laurophyllus capensis</i>, <i>Polygala myrtifolia</i>, <i>Pteridium aquilinum</i>, <i>Searsia chirindensis</i>, <i>Searsia lucida</i>. Low sensitivity.</p>

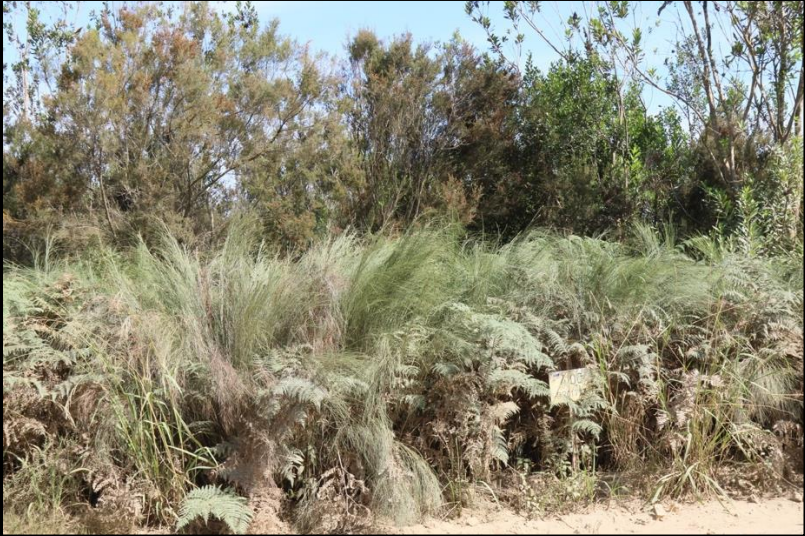
<p>RDF16: S 33° 55' 39.3" E 23° 26' 12.1"</p>	<p>Northeast side: At the end of the route at the entrance to the Lottering Plantations. The vegetation of the firebreak was burnt and is now recovering.</p> <p>Low sensitivity.</p>

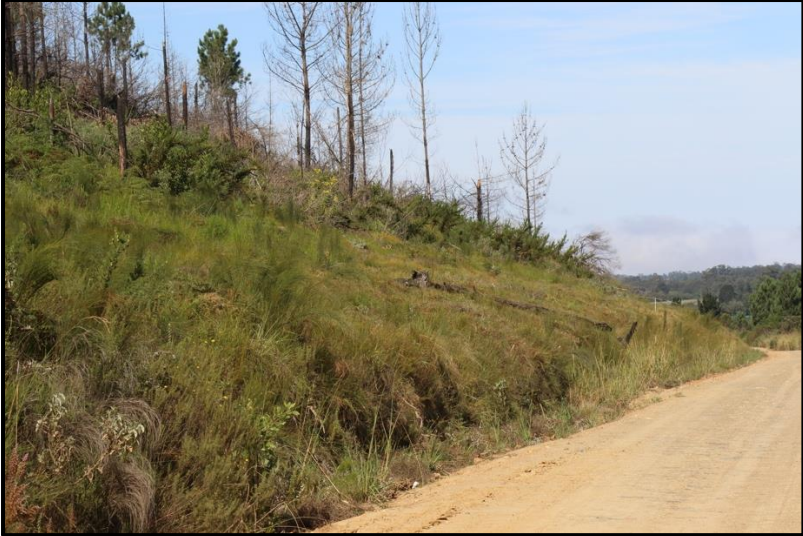
A photograph showing a dirt road on the right side, leading up a grassy hillside. The vegetation is a mix of green grasses and some taller, thin trees, indicating a recovering firebreak. The sky is clear and blue.
<p>RDF16: S 33° 55' 39.3" E 23° 26' 12.1"</p>	<p>Southwest side: The west side of the road was also burnt. The vegetation is now extremely weedy with young black wattle (<i>Acacia mearnsii</i>), <i>Eucalyptus</i> sp., <i>Paraserianthes lophantha</i> (stinkbean) etc.</p> <p>Low sensitivity.</p>

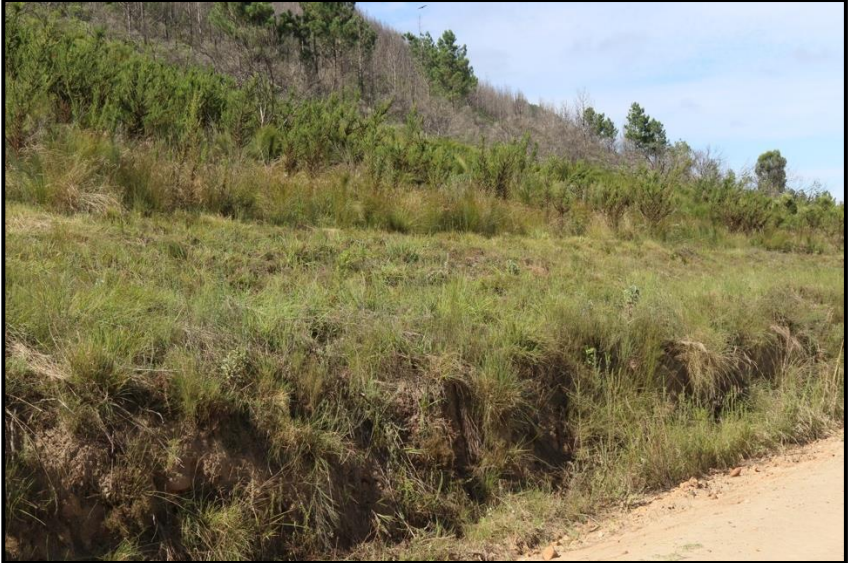
<p>RDF17: S 33° 55' 43.9" E 23° 26' 20.6"</p>	<p>Southwest side: Highly disturbed by alien vegetation and fire. The dominant species is the grass <i>Digitaria eriantha</i>.</p> <p>Low to very low sensitivity.</p>

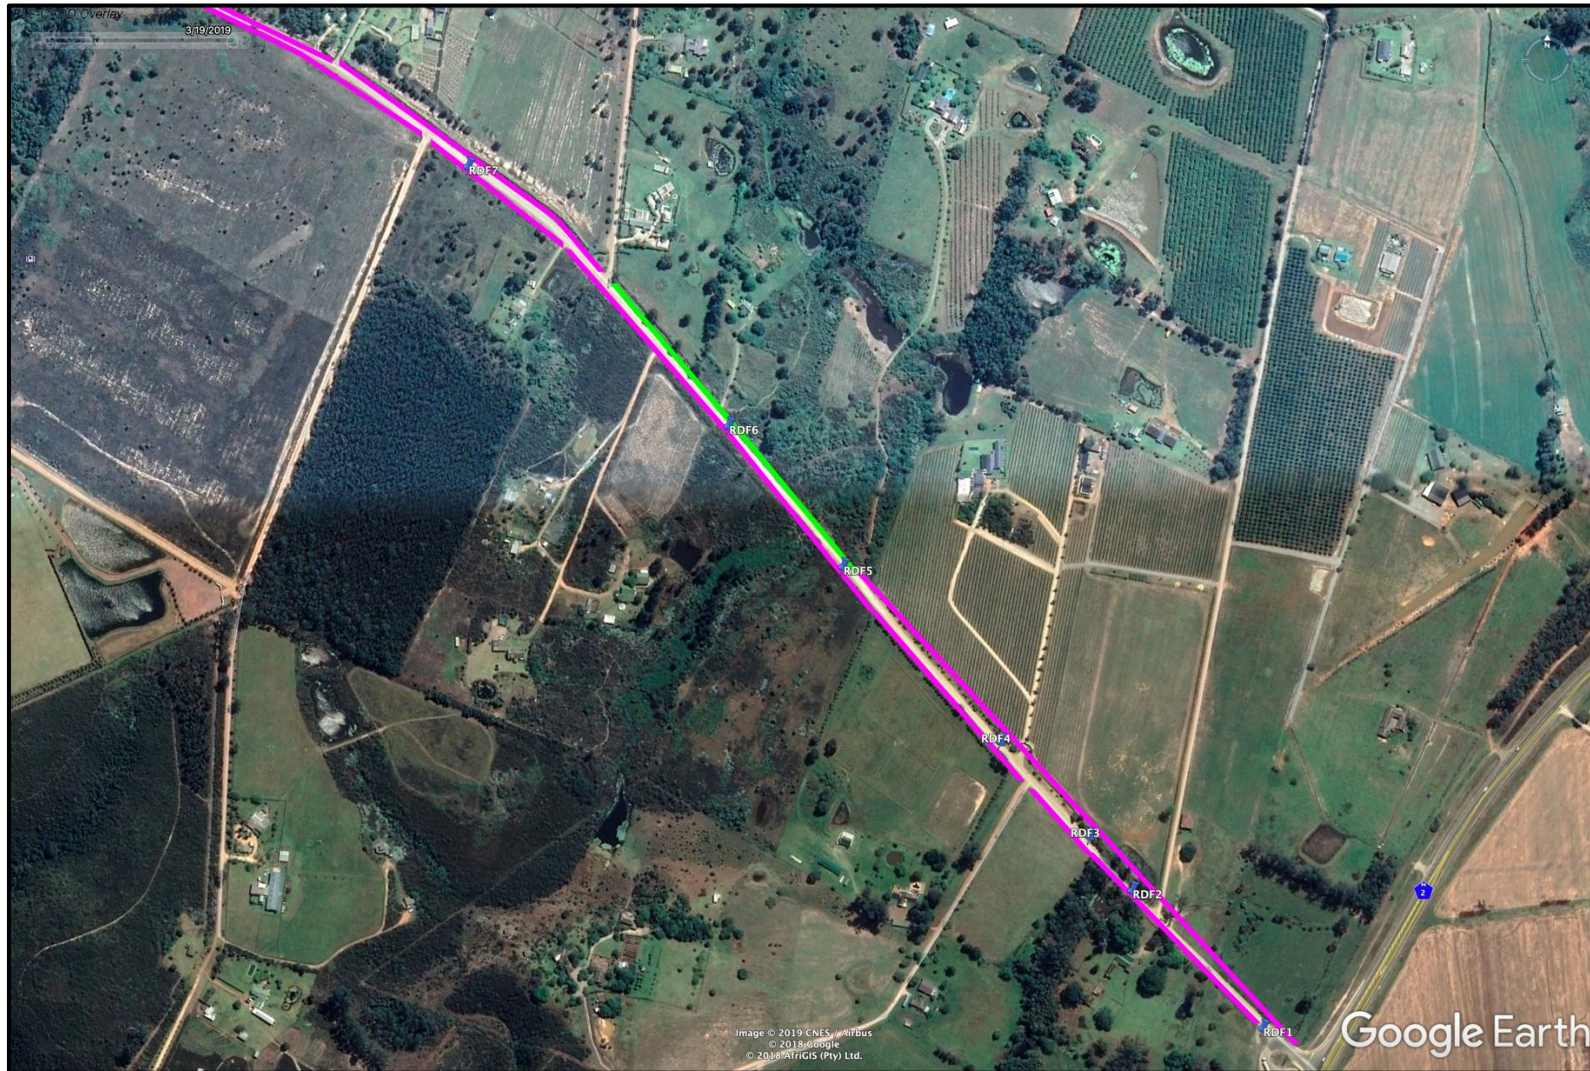
Figure 8. Aerial image (Google Earth™) of the DR1797 Route (Section 1) showing the sensitivity of the habitat. Pink = not sensitive; Green = low sensitivity to moderate sensitivity with indigenous vegetation present.

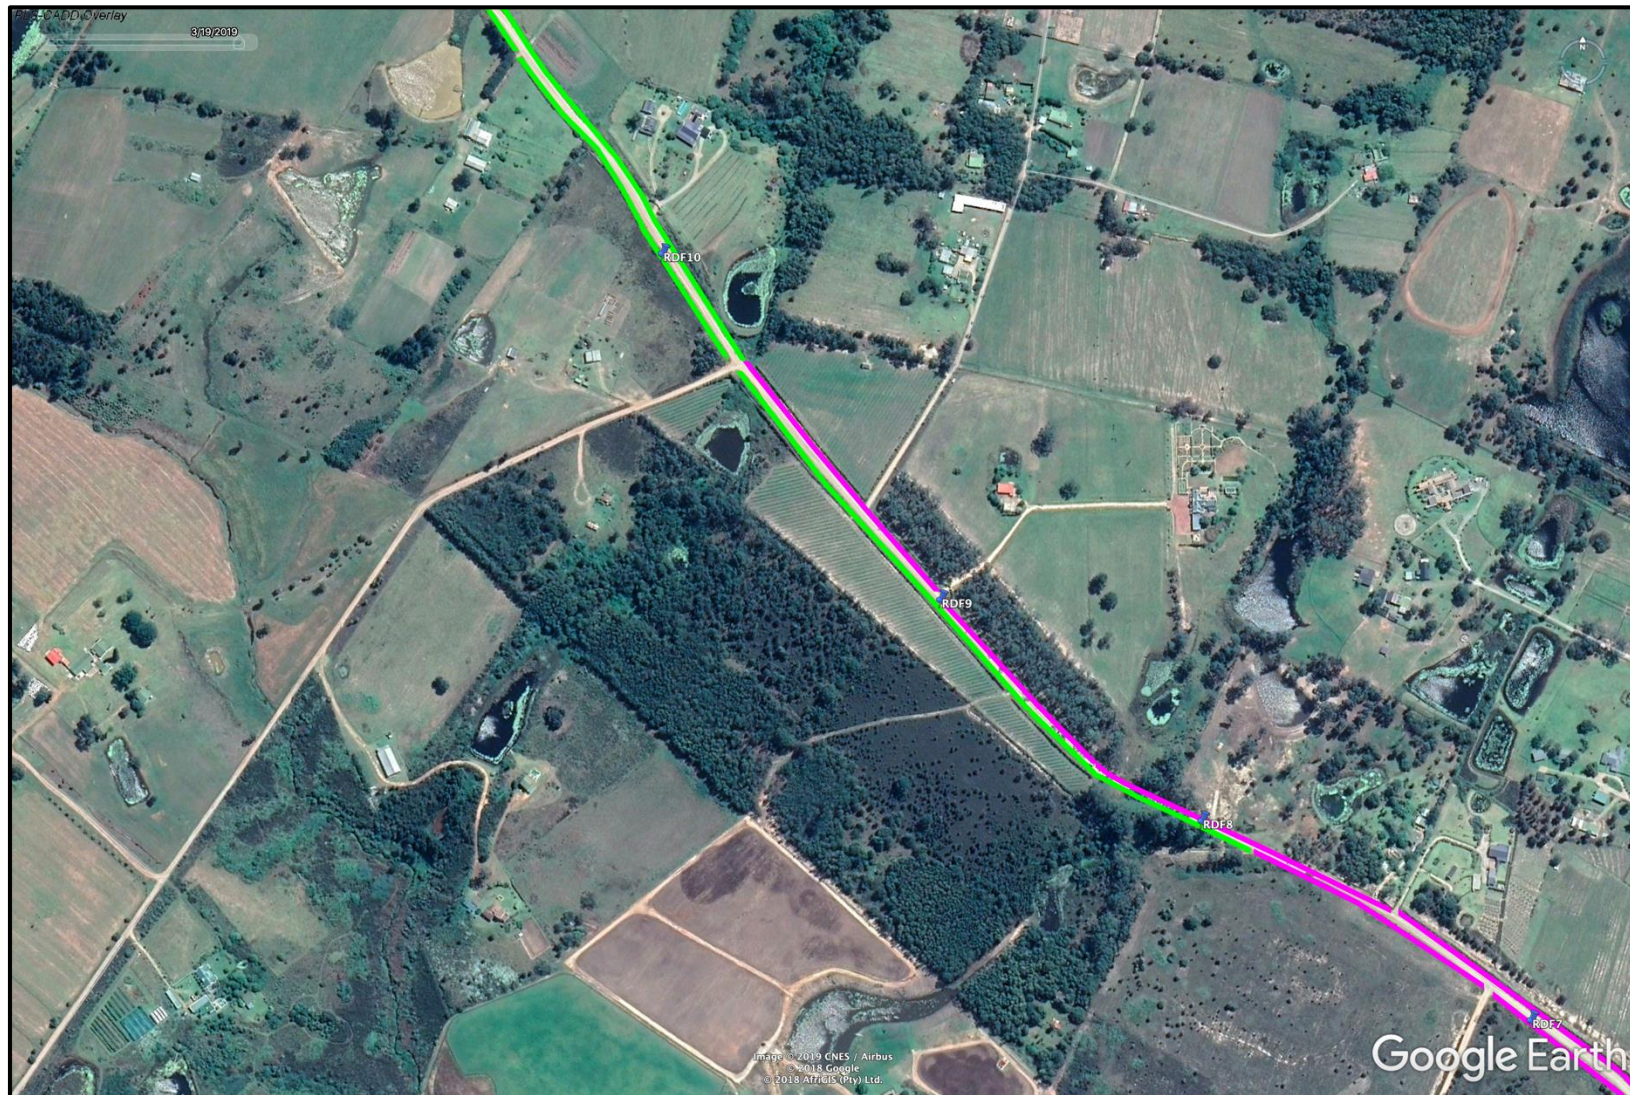
Figure 9. Aerial image (Google Earth™) of the DR1797 Route (Section 2) showing the sensitivity of the habitat. Pink = not sensitive; Green = low sensitivity to moderate sensitivity with indigenous vegetation present.
