**Botanical Assessment
for the proposed upgrading of the DR1797
Road (Redford Road), Kurland,
Western Cape Province**

Prepared for HATCH

April 2019

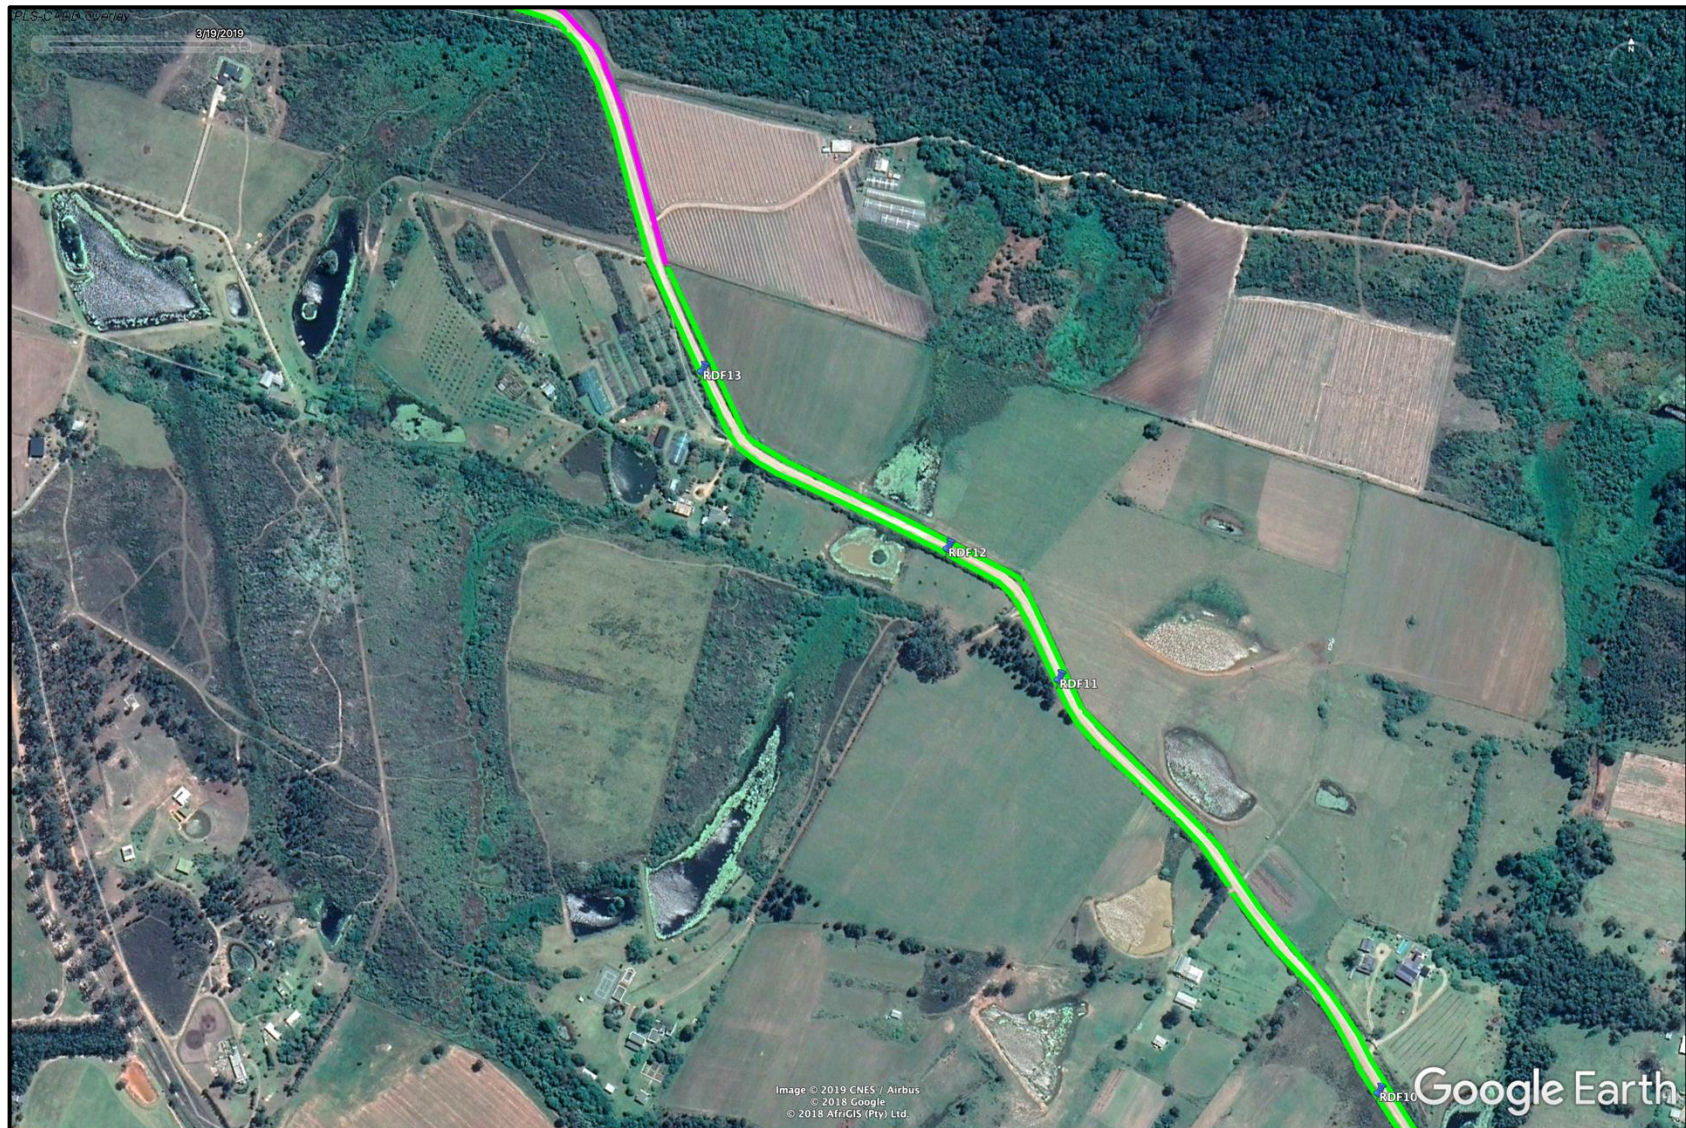
Fynbos 10. Aerial image (Google Earth™) of the DR1797 Route (Section 3) showing the sensitivity of the habitat. Pink = not sensitive; Green = low sensitivity to moderate sensitivity with indigenous vegetation present.

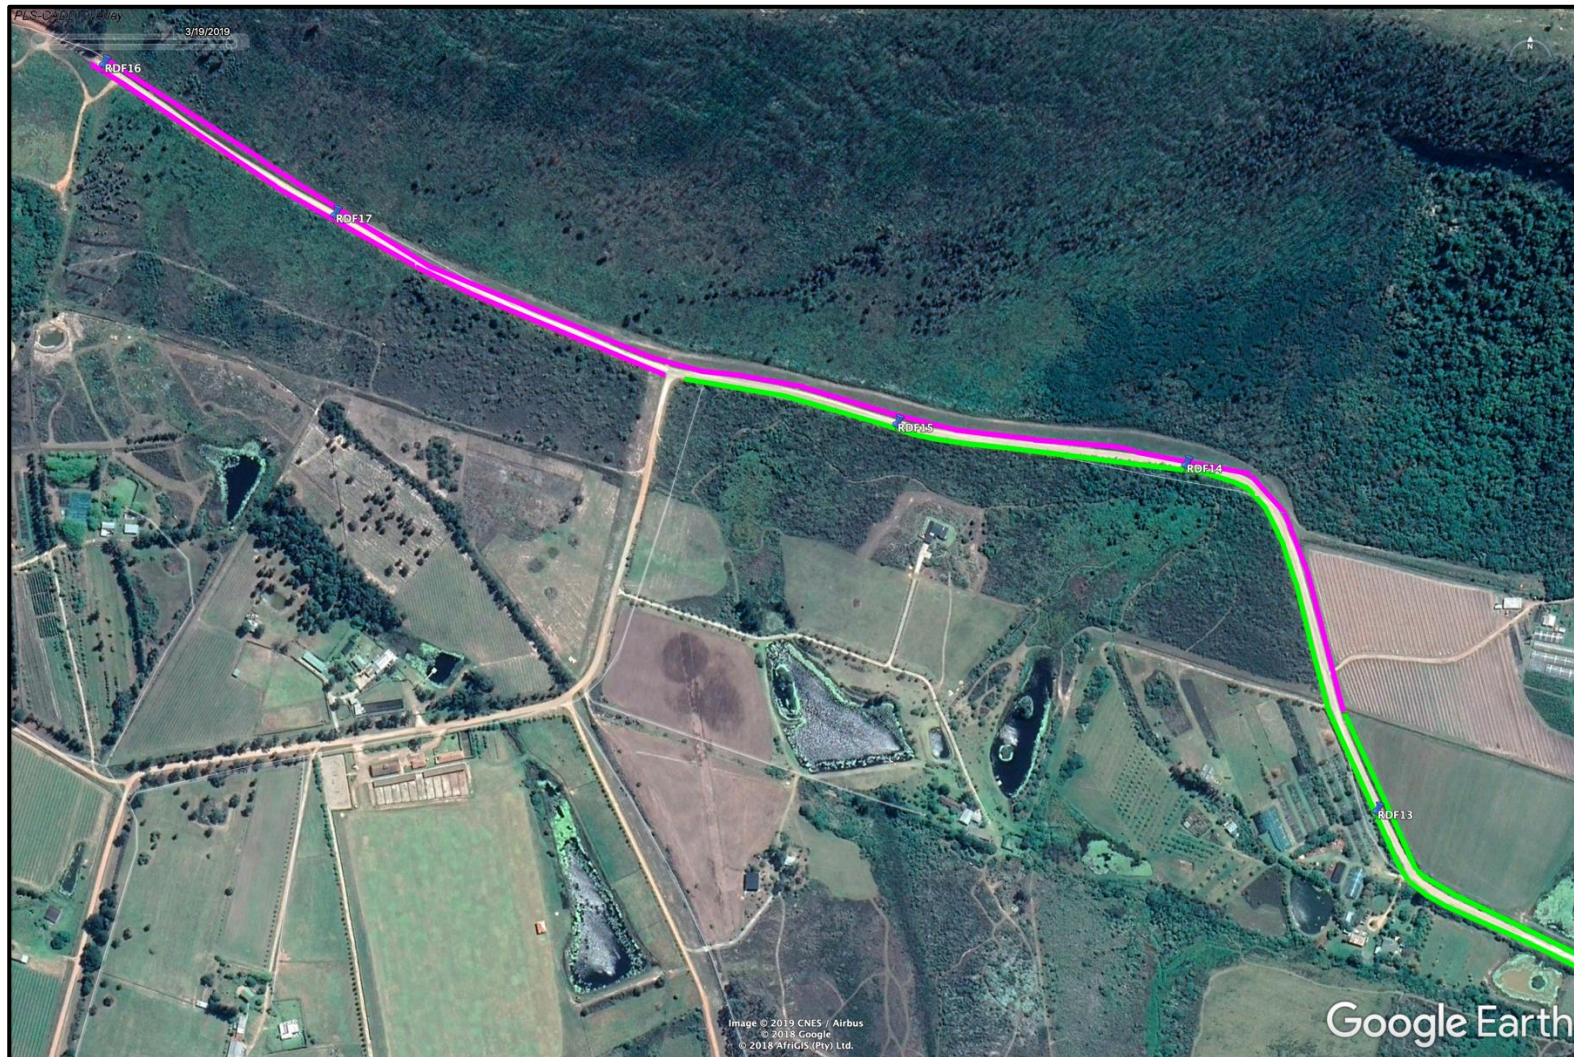
Figure 11. Aerial image (Google Earth™) of the DR1797 Route (Section 4) showing the sensitivity of the habitat. Pink = not sensitive; Green = low sensitivity to moderate sensitivity with indigenous vegetation present.

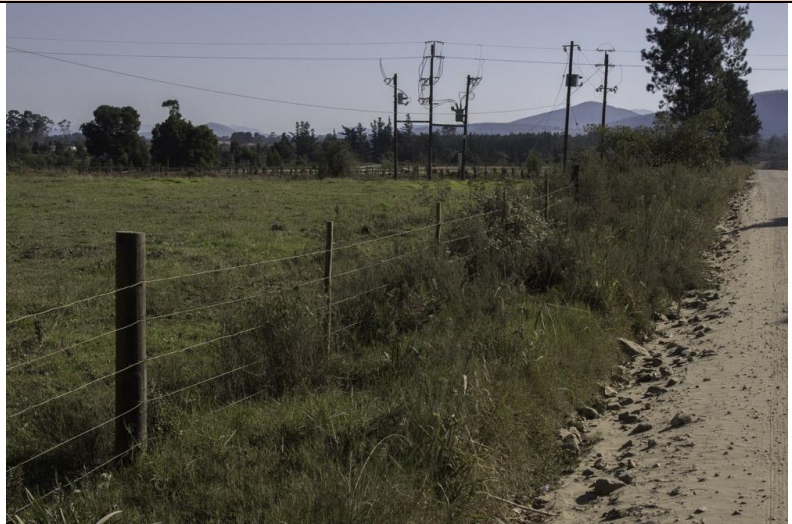
1a2	<p>RED2: S33.952307 E 23.471947</p>	<p>At a side-road intersection with the Redford Road. The photo is the view looking back over the paddock of Section 1. Low sensitivity.</p>

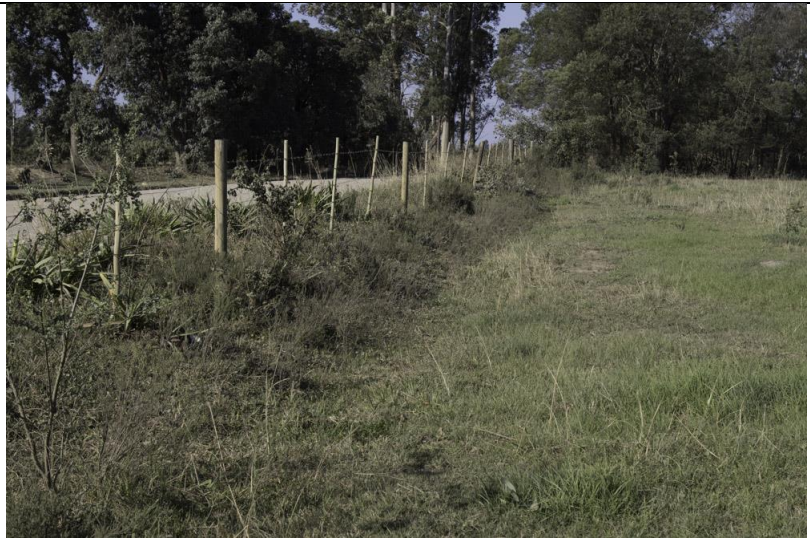
<p>2a1</p>	<p>RED3: S33.951057 E 23.470570</p>	<p>An electric fence is present at Section 2A. Young plants of exotic <i>Syzigium paniculatum</i> (brush cherry) have been planted inside the fence to establish a hedge. These plants would have to be moved. The other vegetation is a dense stand of the grass <i>Eragrostis curvula</i>. Low sensitivity.</p>

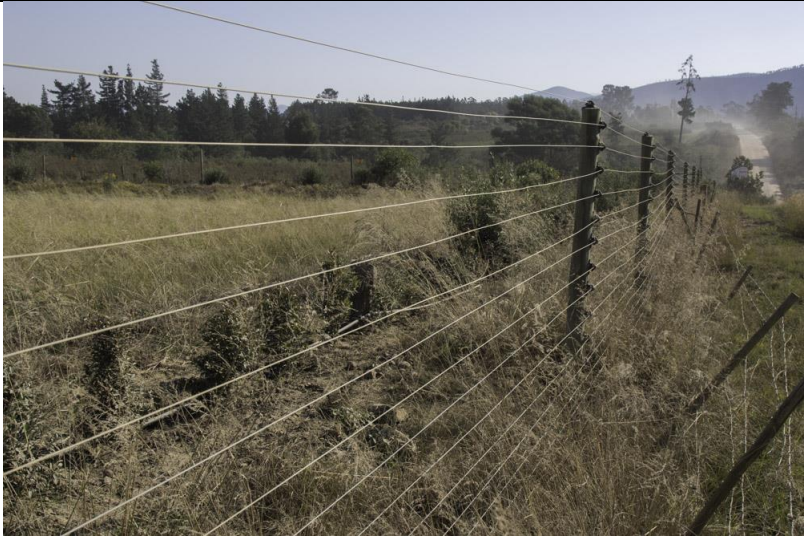
<p>2a2</p>	<p>RED4: S33.950813 E 23.470340</p>	<p>The vegetation is the same as that at waypoint RED3. The entire section has low sensitivity.</p>

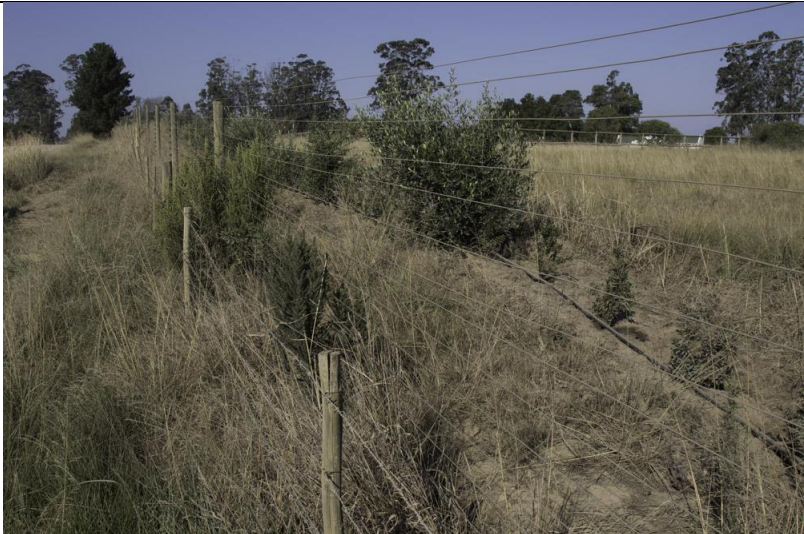
<p>3a1</p>	<p>RED5: S33.950680 E 23.470255</p>	<p>At this waypoint the vegetation is relatively undisturbed natural veld. There is an abundance of <i>Watsonia</i> sp. <u>These plants MUST be rescued and replanted at a safe site.</u> The section has moderate sensitivity.</p>

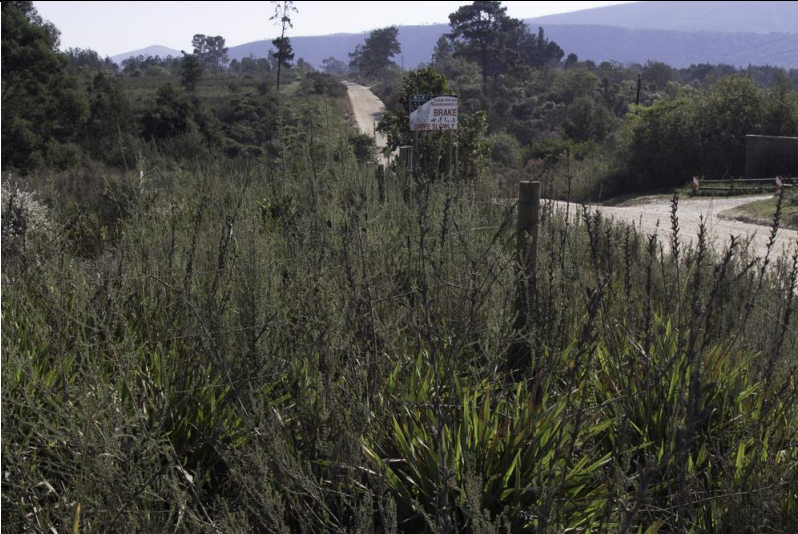
<p>3a2</p>	<p>RED6: S33.949394 E 23.468966</p>	<p>This location is on the north side of the stream depression where the road dips significantly. All the vegetation is indigenous and of moderate sensitivity. As above all <i>Watsonia</i> sp. and other geophytes (bulbous plants) must be saved and transplanted at a safe site. (<i>The Simply Green Nursery could be approached for assistance with this operation</i>).</p>

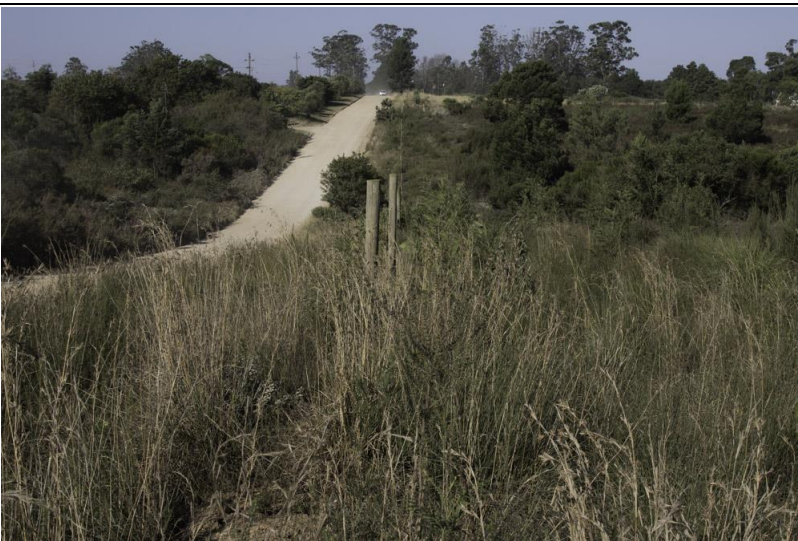
<p>3b1</p>	<p>RED7: S33.950405 E 23.470060</p>	<p>This waypoint is on the NE side of the road at the entrance to Parklands. There is mostly indigenous vegetation of moderate to high sensitivity. <u>The <i>Watsonia</i> sp. and <i>Kniphofia</i> sp. (red-hot pokers) must be rescued.</u></p>

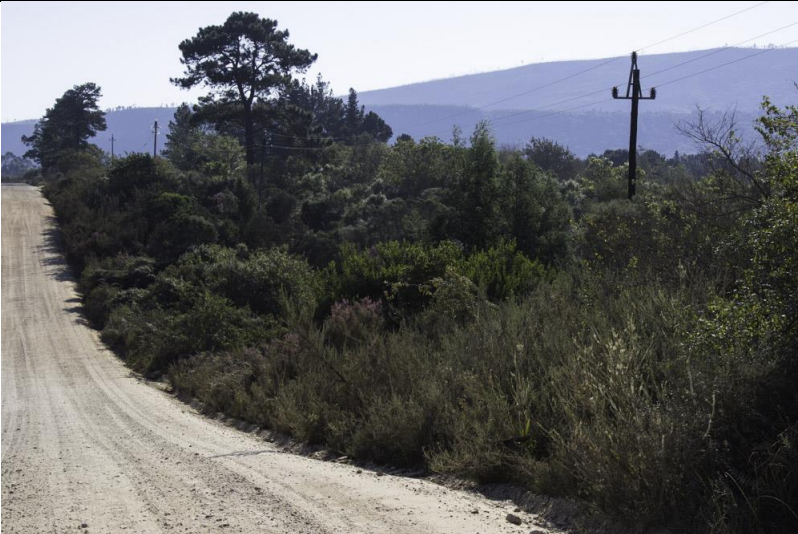
<p>3b2</p>	<p>RED8: S33.949689 E 23.469298</p>	<p>At this waypoint at the end of Section 3 there is tall, old fynbos with <i>Erica canaliculata</i>, <i>Erica discolor</i>, <i>Helichrysum crispum</i> and <i>Watsonia</i> sp. The sensitivity is moderate to high. It would not be possible to salvage the fynbos species, but the geophytes must be saved.</p>

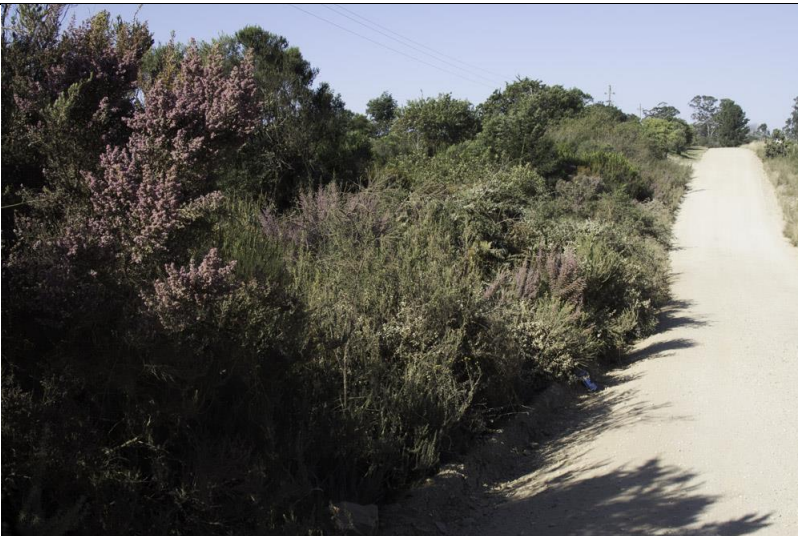
<p>4b1</p>	<p>RED9: S33.947191 E 23.466651</p>	<p>Hybrid aloes (<i>Aloe ferox</i> x <i>Aloe arborescens</i>) have been planted in the road reserve and the vegetation is semi-natural. It has moderate sensitivity. All the aloes must be carefully removed and kept for replanting. Inside the fence, the landowner has planted a hedge of <i>Dovyalis caffra</i> (Kei apple) for security purposes (This species has significant thorny spines). Arrangements would have to be made with the landowner as to the how these plants will be saved for later planting to restore the security hedge.</p>

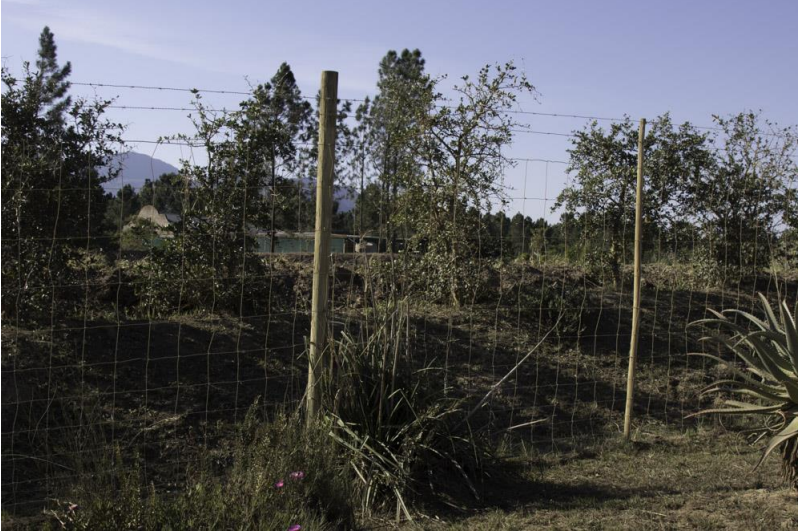
5b1	RED11: S33.945035 E 23.461321	The fynbos in the road reserve is not sensitive. The expropriation would require removal of some exotic <i>Eucalyptus</i> trees. This section has low sensitivity.

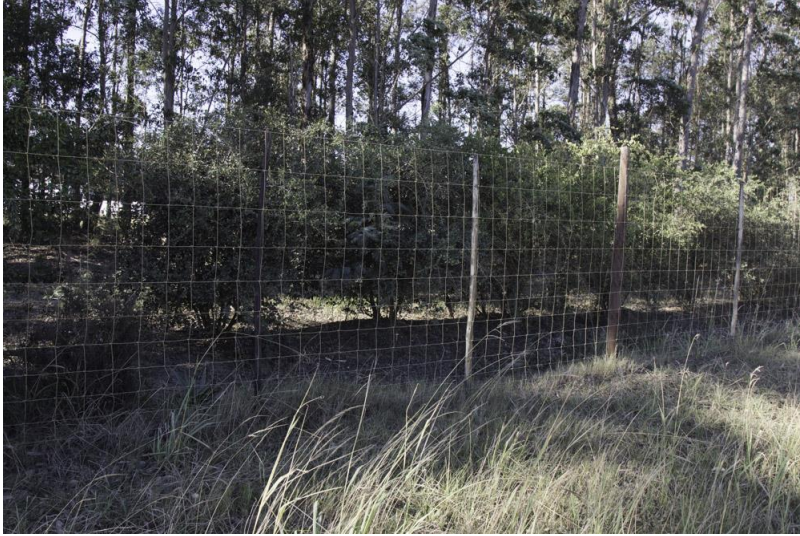
<p>6a1</p>	<p>RED13: S33.940776 E 23.457341</p>	<p>At this location dense fynbos is found in the road reserve characterized by <i>Erica canaliculata</i>, <i>Erica discolor</i> and <i>Diospyros dichrophylla</i>. Inside the fence is a narrow firebreak and then old fynbos that also contains geophytes that need search and rescue. THIS SECTION IS SENSITIVE.</p>

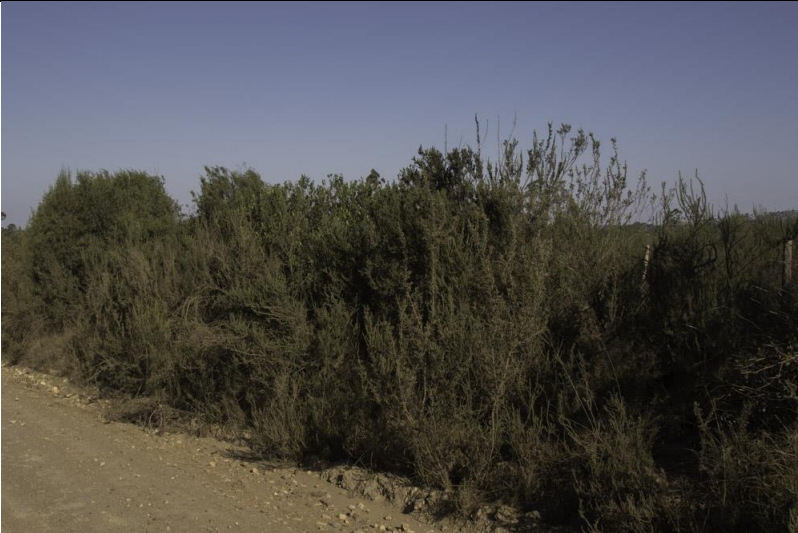
<p>6a2</p>	<p>RED14: S33.940214 E 23.456913</p>	<p>Similar to the vegetation at the start of the section at RED13 but with the addition of <i>Osteospermum moniliferum</i> and <i>Searsia pallens</i> and a fair amount of <i>Anthospermum aethiopicum</i>.</p>

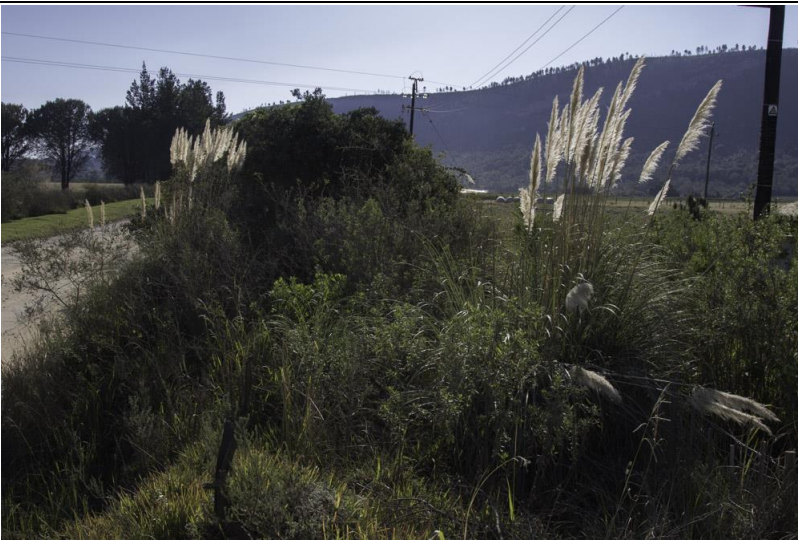
<p>7b1</p>	<p>RED15: S33.939272 E 23.456232</p>	<p>At the start of Section 7b there is natural vegetation in the road reserve that includes the following species; <i>Cortaderia selloana</i> (exotic pampas grass), <i>Cliffortia</i> sp., <i>Diospyros dichrophylla</i>, <i>Erica canaliculata</i>, <i>Erica discolor</i>, <i>Nuxia floribunda</i>, <i>Searsia chirindensis</i>, <i>Stenotaphrum secundatum</i>, <i>Stoebe</i> sp.</p>

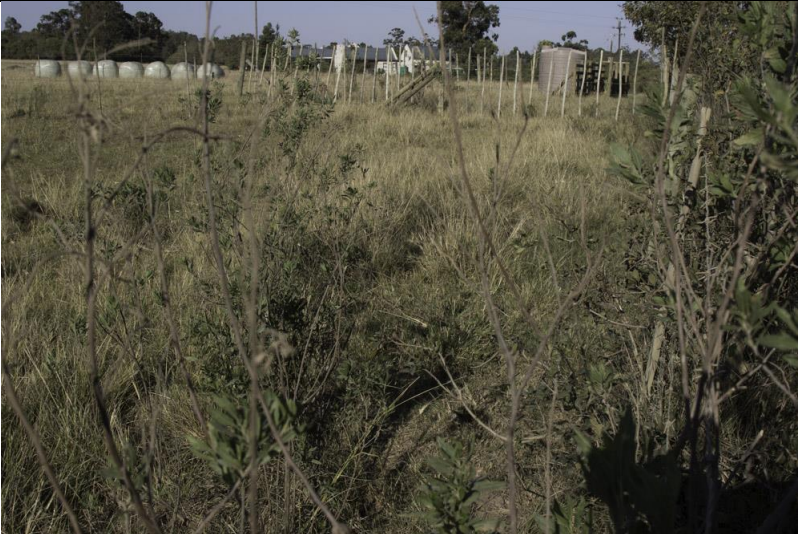
<p>8b1</p>	<p>RED17: S33.936996 E 23.453821</p>	<p>This waypoint is at the central point of the Section (NE side) . The vegetation in the road reserve is a mix of Kikuyu grass (<i>Pennisetum clandestinum</i>) and degraded fynbos. It has low sensitivity. Over the fence is cultivated land with very low sensitivity.</p>

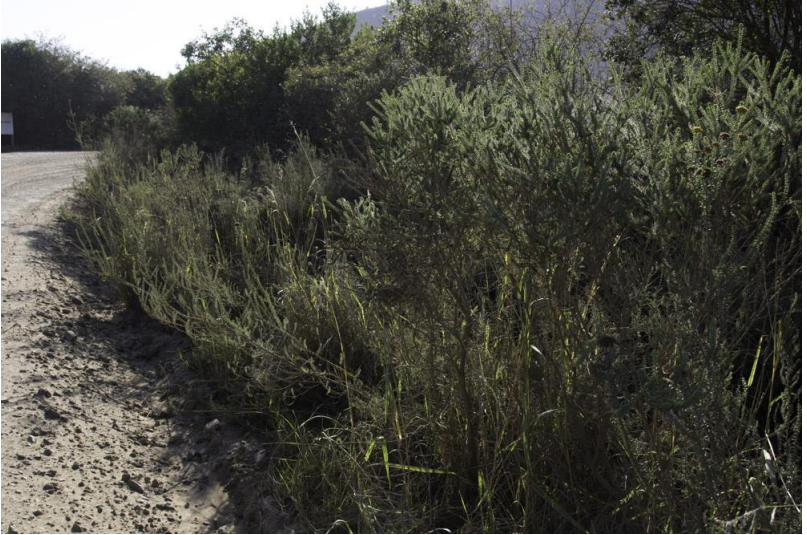
<p>9b2</p>	<p>RED19: S33.934283 E 23.450157</p>	<p>The vegetation at this waypoint is much the same as that at waypoint RED18.</p>

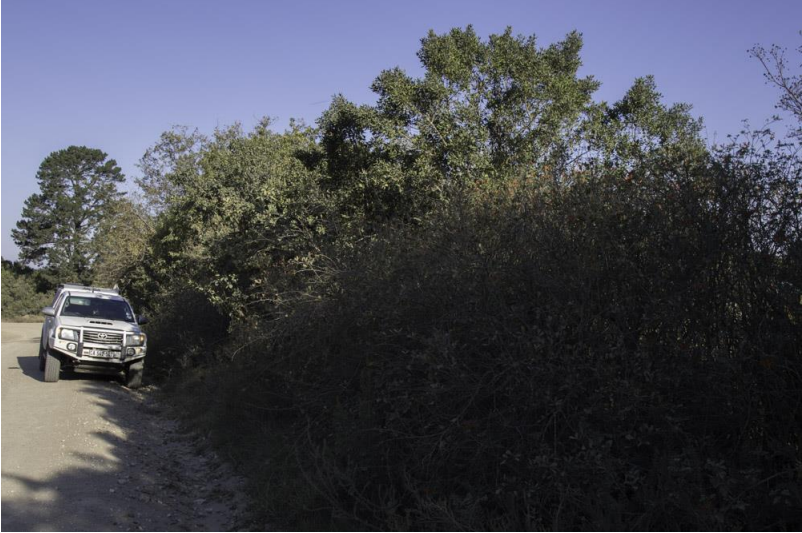
<p>9a1</p>	<p>RED20: S33.934403 E 23.450245</p>	<p>Section 9a (southwest side) has a very dense stand of natural vegetation including two <u>protected tree species</u> namely <i>Pittosporum viridiflorum</i> (cheesewood) and <i>Afrocarpus falcatus</i> (Outeniqua yellowwood). This section of dense vegetation is alongside Simply Green Nursery and it is sensitive. The nursery operation is immediately inside the fence on the private land.</p>

The main conclusion is that the majority of the locations where expropriation is proposed would be acceptable from a botanical viewpoint as long as mitigation measures are strictly applied. There is only one Section that is not recommended for expropriation and in fact strongly discouraged and that is Section 9a, along the boundary of Simply Green Nursery. Disturbance of this would result in the unnecessary loss of semi-natural vegetation including two trees that are **protected** in terms of the National Forests Act 1998 (Act No. 84 of 1998) namely *Afrocarpus falcatus* (Outeniqua Yellowwood) and *Pittosporum viridiflorum* (Cheesewood). Permits would be required from the Department of Environment, Forestry and Fisheries for disturbance (cutting or removal) of these trees.

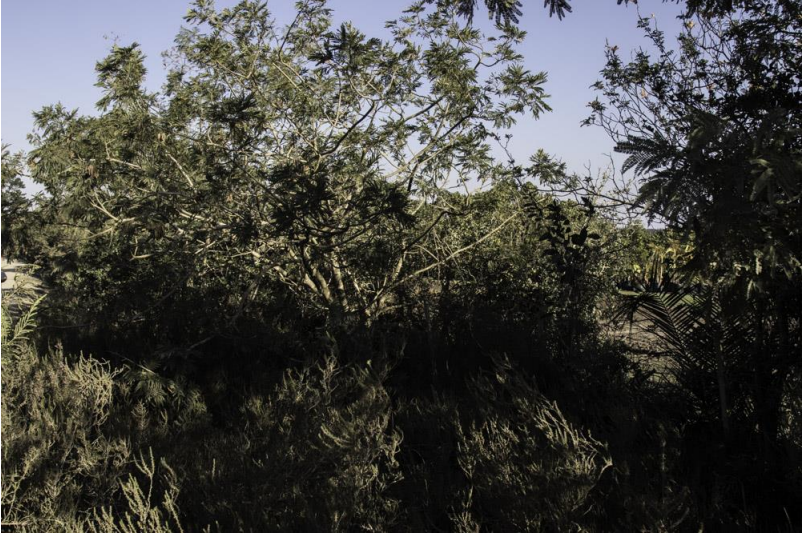
<p>9a2</p>	<p>RED21: S33.933281 E 23.449647</p>	<p>This waypoint is near the 'back' entrance to Simply Green Nursery. The entire section of the road reserve is sensitive.</p>
