Botanical Assessment for Flood Damage Repairs to Structures on MR309 in Seweweekspoort, Eden District and Central Karoo District Municipalities

Prepared for HATCH Africa (Pty) Ltd

December 2016

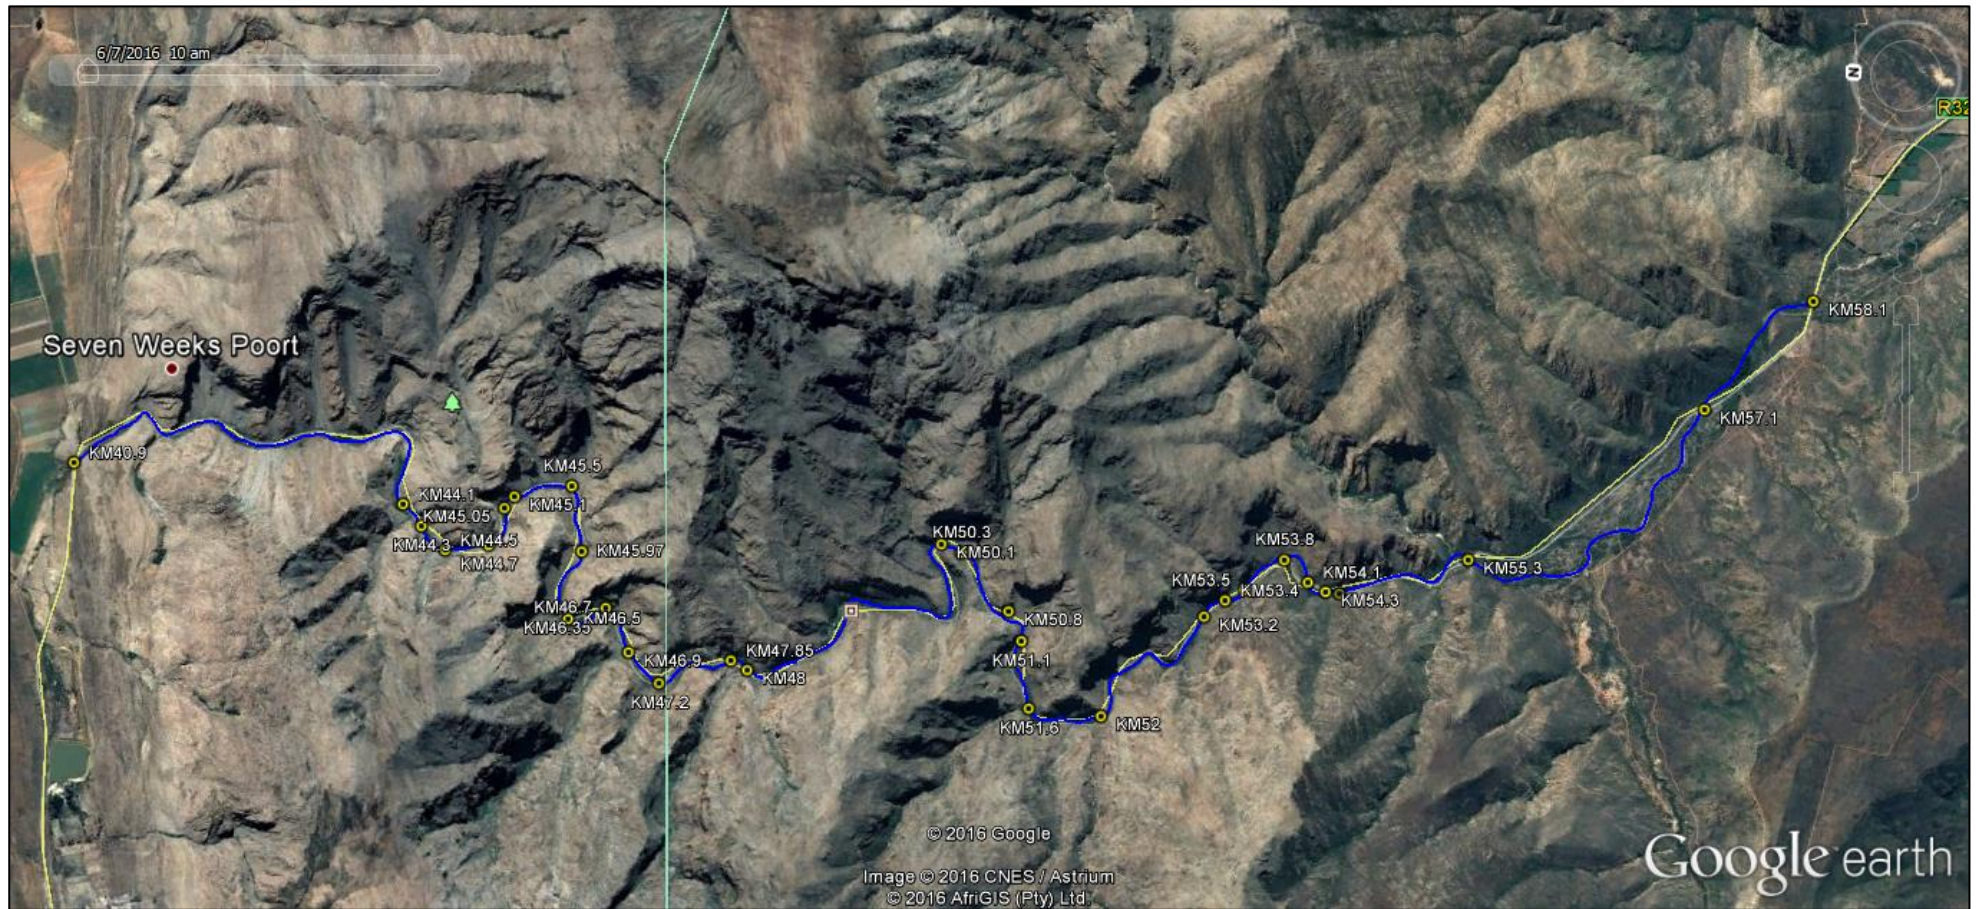
Figure 3. Google Earth™ aerial image showing study area with the locations of the structures (numbered yellow circle icons) through Seweweekspoort. The blue line represents the Huis River. Note the position of north on the rotated image.

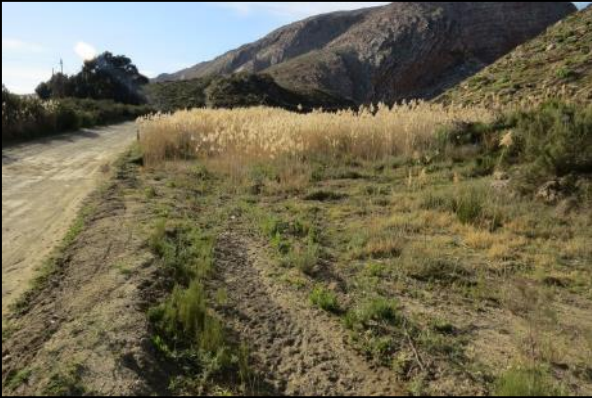
<p data-bbox="172 674 772 730">Figure 9.1. Waypoint 001 (33° 21 '41.05" S; 21° 24' 34.36" E). North side of crossing on RHS (looking east).</p>

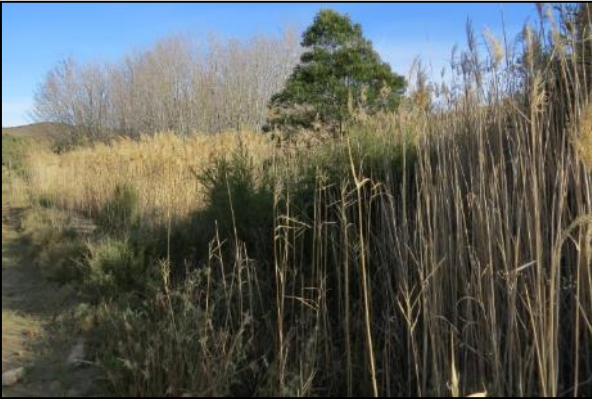
<p data-bbox="172 1205 772 1285">Figure 9.2. Waypoint 003 (33°21'41.13"S; 21°24'35.55"E). South side of crossing on LHS (looking west).</p>	<p data-bbox="804 271 900 297">KM40.9</p> <p data-bbox="804 315 922 342">Crossing</p> <p data-bbox="804 409 1437 853">River crossing dominated by common reed (<i>Phragmites australis</i>) on both sides of the road and crossing. Other dominants include <i>Cliffortia strobilifera</i>, <i>Elytropappus rhinocerotis</i>, <i>Juncus effusus</i>, <i>Conyza scabrada</i>, and several weeds and grasses in disturbed area. Additional species include <i>Lessertia frutescens</i>, <i>Acacia mearnsii</i> (invasive), <i>Erica</i> sp., <i>Plantago lanceolata</i> (weed). The RHS is more disturbed than the LHS, specifically on the north side of the crossing at waypoint 001 (Figure 9.1).</p>

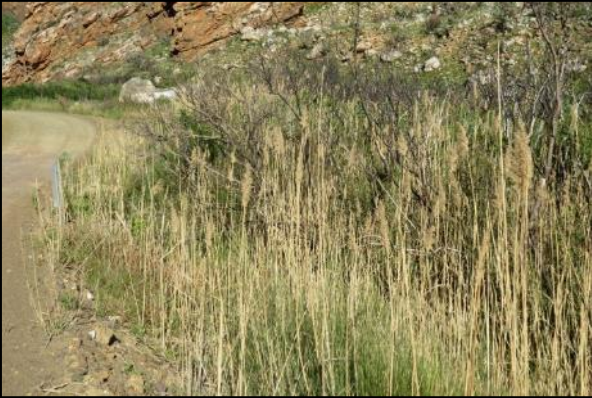
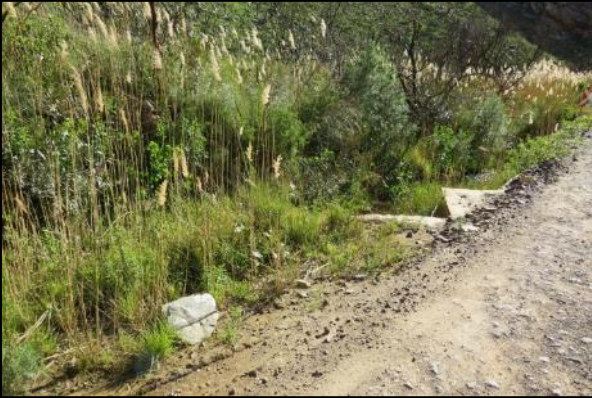
<p data-bbox="172 674 719 725">Figure 9.3. North side of crossing on RHS (looking east).</p>

<p data-bbox="172 1205 507 1234">Figure 9.4. LHS (looking east).</p>	<p data-bbox="804 271 900 300">KM44.1</p> <p data-bbox="804 315 922 344">Crossing</p> <p data-bbox="804 409 1437 987"> RHS: On the RHS of the road a streamlet runs parallel to and within 1m of the road edge. The habitat supports intact wetland/dryland mosaic, with the riparian habitat supporting stands of the riverine tree <i>Brachylaena neriifolia</i>. The species burnt in a recent fire and is currently regenerating (resprouting). The trees will only regain their original height in several years' time. The dead branches of <i>Brachylaena neriifolia</i> are visible in the background of Figure 9.3. The vegetation is very dense and dominated by <i>Ehrharta ramosa.</i>, <i>Phragmites australis</i>, <i>Psoralea cf. affinis</i>, <i>Osteospermum moniliferum</i>, <i>Pelargonium glutinosum</i> and <i>Juncus cephalotes</i>. </p> <p data-bbox="804 1099 1437 1442"> LHS: The LHS is dominated by similar species and ecological condition (i.e. intact) as the RHS but does not contain a streamlet next to the roadside. Dominant species include <i>Cliffortia strobilifera</i>, <i>Ehrharta ramosa</i>, <i>Elytropappus rhinocerotis</i>, <i>Mentha longifolia</i>, <i>Osteospermum moniliferum</i>, <i>Othonna parviflora</i>, <i>Pennisetum macrourum</i> and <i>Pelargonium glutinosum</i>. </p>

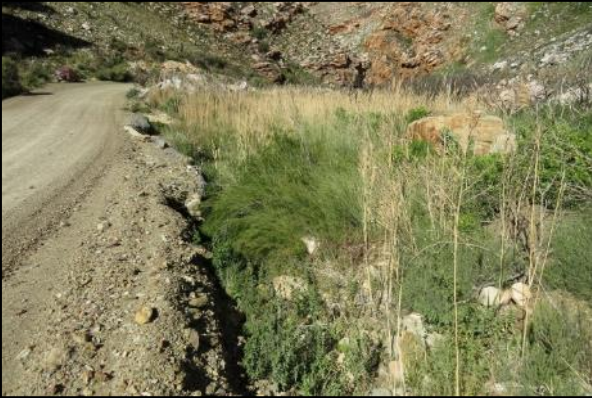
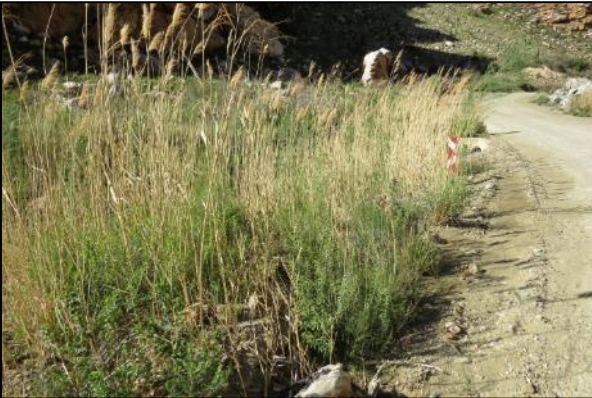
<p data-bbox="172 674 596 701">Figure 9.5. RHS (looking downstream).</p>

<p data-bbox="172 1176 596 1202">Figure 9.6. LHS (looking downstream).</p>	<p data-bbox="804 271 900 297">KM44.3</p> <p data-bbox="804 315 922 342">Crossing</p> <p data-bbox="804 409 1442 667">RHS: Intact riparian vegetation dominated by <i>Phragmites australis</i>, <i>Calopsis paniculata</i>, <i>Ehrharta ramosa</i>, <i>Osteospermum moniliferum</i>, <i>Othonna parviflora</i>, <i>Searsia lucida</i>. The terrestrial communities are dominated by <i>Osyris compressa</i> and <i>Buddleja salvifolia</i>, with <i>Aloe ferox</i> occurring in places.</p> <p data-bbox="804 730 1442 987">LHS: Dominated by <i>Calopsis paniculata</i>, <i>Phragmites australis</i>, <i>Psoralea affinis</i>, <i>Cliffortia strobilifera</i>, <i>Ehrharta ramosa</i>, and <i>Searsia lucida</i>. Additional species include <i>Osteospermum moniliferum</i>, <i>Pelargonium glutinosum</i>, <i>Phylica</i> sp. and <i>Lobostemon stachydeus</i>.</p> <p data-bbox="804 1050 1442 1218">Midstream habitat: Dominated by <i>Gunnera perpensa</i> (DECLINING), <i>Isolepis</i> sp., <i>Juncus cephalotes</i>, <i>Juncus capensis</i>, <i>Juncus effusus</i>, <i>Mentha longifolia</i> and <i>Carpha glomerata</i>.</p>

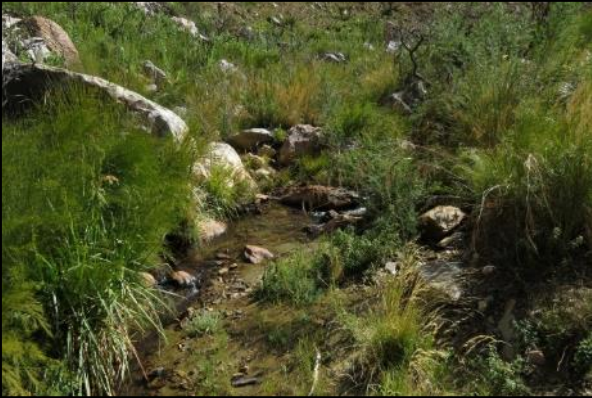
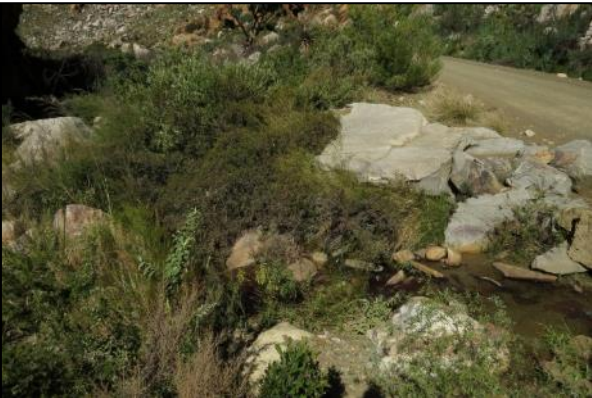
<p data-bbox="172 674 596 701">Figure 9.7. RHS (looking downstream).</p>

<p data-bbox="172 1178 596 1205">Figure 9.8. LHS (looking downstream).</p>	<p data-bbox="802 271 903 297">KM44.5</p> <p data-bbox="802 315 922 342">Crossing</p> <p data-bbox="802 409 1437 712">RHS: Previously disturbed road edge with intact riparian vegetation dominated by <i>Calopsis paniculata</i>, <i>Carpha glomerata</i>, <i>Ehrharta</i> sp., <i>Othonna parviflora</i>, <i>Pelargonium glutinosum</i>, <i>Psoralea affinis</i>, <i>Searsia lucida</i> and <i>Eragrostis</i> sp. Additional species include <i>Brachylaena nerifolia</i>, <i>Osteospermum moniliferum</i> and <i>Zantedeschia aethiopica</i>.</p> <p data-bbox="802 779 1437 1081">LHS: Previously disturbed road edge with lower vegetation cover and several large boulders on the south side of the crossing. Dominant species include <i>Buddleja salvifolia</i>, <i>Calopsis paniculata</i>, <i>Juncus effusus</i> and <i>Ehrharta ramosa</i>. Additional species include <i>Erica caffra</i>, <i>Morella serrata</i>, <i>Searsia lucida</i> and <i>Salix mucronata</i>.</p> <p data-bbox="802 1149 1437 1346">Note: previous disturbance is due to past flood damage and piling of flood alluvium along the road edge. Disturbance has led to the invasive feather top grass (<i>Pennisetum setaceum</i>) colonizing the road edge.</p>

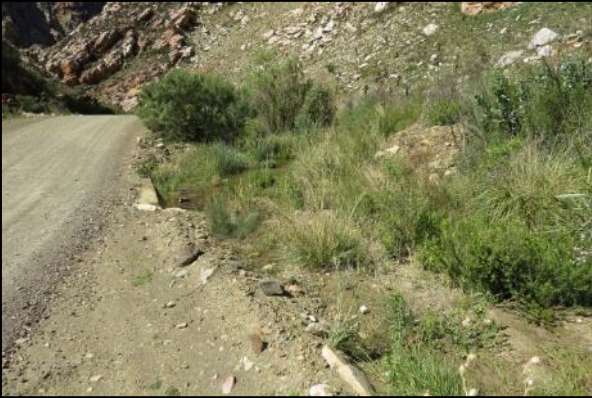
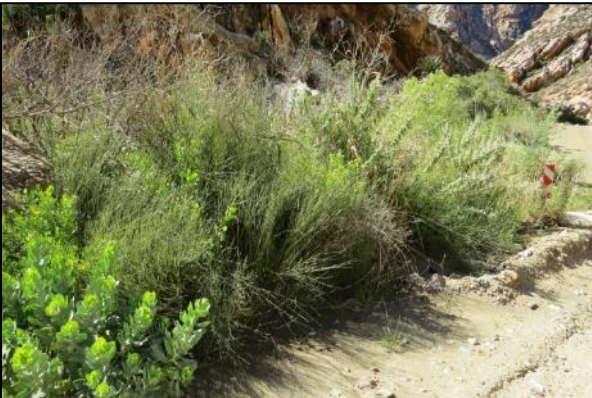
<p data-bbox="172 674 596 701">Figure 9.9. RHS (looking downstream).</p>

<p data-bbox="172 1133 608 1160">Figure 9.10. LHS (looking downstream).</p>	<p data-bbox="804 271 900 297">KM44.7</p> <p data-bbox="804 315 922 342">Crossing</p> <p data-bbox="804 409 1442 848">RHS: The north side of the crossing is disturbed within 2-3m of the road edge. Dominant species include <i>Cliffortia strobilifera</i>, <i>Eragrostis chloromelas</i>, <i>Juncus lomatophyllus</i>, <i>Mentha longifolia</i>, <i>Pelargonium crispum</i>, <i>Pennisetum macrourum</i> and <i>Othonna parviflora</i>. Additional species include <i>Anthospermum aethiopicum</i>, <i>Carpha glomerata</i> and <i>Pelargonium glutinosum</i>. Large shrubs and trees, including <i>Salix mucronata</i> and <i>Dodonaea angustifolia</i> occur on the south side of the crossing.</p> <p data-bbox="804 913 1442 1308">LHS: Dominant species include <i>Buddleja salvifolia</i>, <i>Eragrostis</i> sp., <i>Eragrostis chloromelas</i>, <i>Juncus effusus</i>, <i>Osteospermum moniliferum</i> and <i>Carpha glomerata</i>. Additional species include <i>Dodonaea angustifolia</i>, <i>Othonna parviflora</i> and mature Cape willow (<i>Salix mucronata</i>) at waypoint 023 (33°23'8.13"S; 21°24'22.00"E). Large plants of <i>Diospyros dichrophylla</i> and <i>Aloe ferox</i> occur at waypoint 026 (33°23'8.50"S; 21°24'22.53"E).</p>

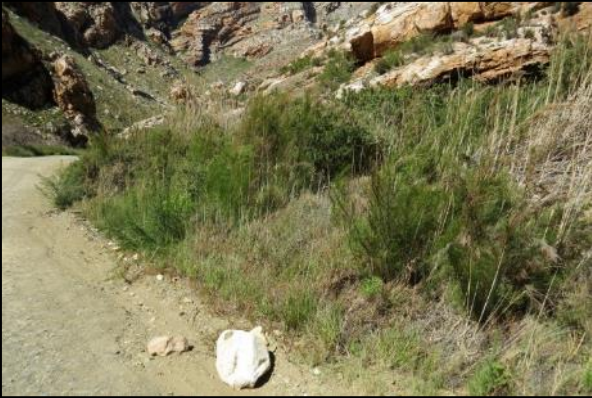
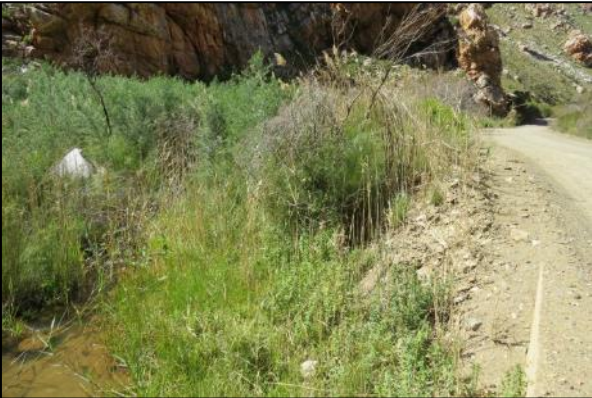
<p data-bbox="172 674 609 701">Figure 9.11. RHS (looking downstream).</p>

<p data-bbox="172 1133 609 1160">Figure 9.12. LHS (looking downstream).</p>	<p data-bbox="804 271 932 297">KM445.05</p> <p data-bbox="804 315 922 342">Crossing</p> <p data-bbox="804 409 1442 667">RHS: Dominant species include <i>Anthospermum aethiopicum</i>, <i>Calopsis paniculata</i>, <i>Cliffortia strobilifera</i>, <i>Morella serrata</i>, <i>Phylica</i> sp. and <i>Stoebe</i> sp. The instream communities include <i>Gunnera perpensa</i> (DECLINING), <i>Phragmites australis</i> and <i>Isolepis</i> sp.</p> <p data-bbox="804 730 1442 943">LHS: Dominant species include <i>Cliffortia strobilifera</i>, <i>Eragrostis</i> sp., <i>Morella serrata</i>, <i>Osteospermum moniliferum</i>, <i>Psoralea affinis</i> and <i>Phragmites australis</i>. Additional species include <i>Diospyros dichrophylla</i>, <i>Othonna parviflora</i> and <i>Searsia lucida</i>.</p>

45.05	LHS	4m clearing width		
45.1	RHS	4m clearing width	Move structure 5-6m south. <i>Brachylaena neriifolia</i> trees to be pruned but not removed

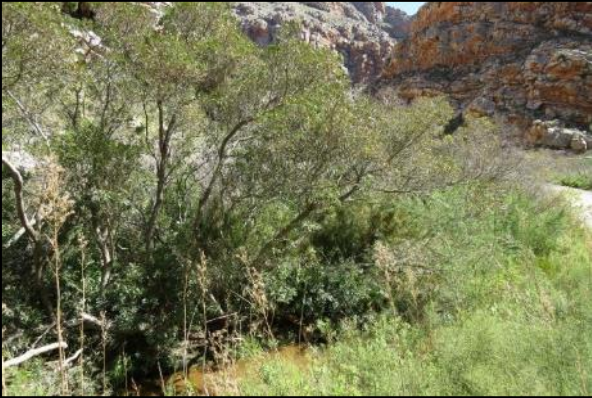
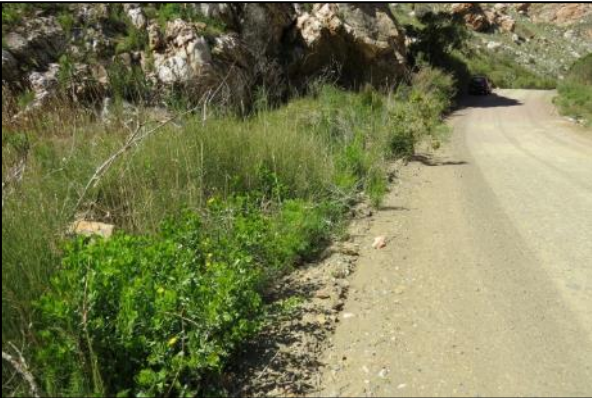
<p data-bbox="172 674 534 701">Figure 9.13. RHS (looking north).</p>

<p data-bbox="172 1176 608 1202">Figure 9.14. LHS (looking downstream).</p>	<p data-bbox="804 271 900 297">KM45.1</p> <p data-bbox="804 315 922 342">Crossing</p> <p data-bbox="804 409 1439 618">RHS: The habitat is characterized by high numbers of <i>Brachylaena neriifolia</i> on the south and north sides of the crossing (Figure 9.13). Other dominants include <i>Anthospermum aethiopicum</i>, <i>Calopsis paniculata</i>, <i>Othonna parviflora</i> and <i>Searsia lucida</i>.</p> <p data-bbox="804 685 1439 804">LHS: Dominant species include <i>Osteospermum moniliferum</i>, <i>Othonna parviflora</i>, <i>Phragmites australis</i> and <i>Searsia lucida</i>.</p>

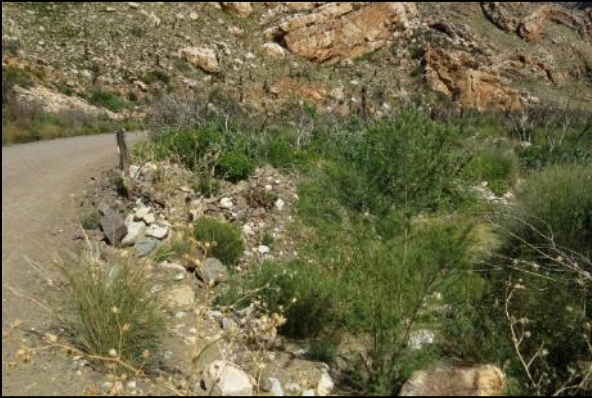
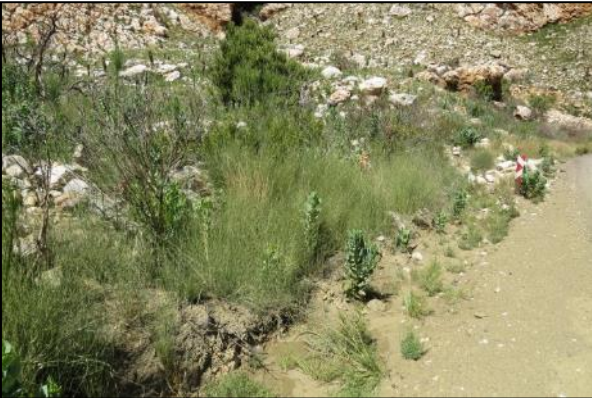
<p data-bbox="172 674 608 701">Figure 9.15. RHS (looking downstream).</p>

<p data-bbox="172 1133 608 1160">Figure 9.16. LHS (looking downstream).</p>	<p data-bbox="804 271 900 297">KM45.5</p> <p data-bbox="804 315 922 342">Crossing</p> <p data-bbox="804 409 1437 667">RHS: Crossing at side tributary previously disturbed and dominated by <i>Cyperus textilis</i>, <i>Diospyros dichrophylla</i>, <i>Othonna parviflora</i>, <i>Osteospermum moniliferum</i>, <i>Nemesia fruticans</i> and <i>Searsia lucida</i>. The invasive common thorn apple (<i>Datura stramonium</i>) occurs along the road edge.</p> <p data-bbox="804 730 1437 1126">LHS: Dominant species include <i>Eragrostis</i> sp., <i>Othonna parviflora</i> and <i>Searsia lucida</i>. Several large <i>Aloe ferox</i> trees occur at waypoint 047 (33°23'24.32"S; 21°24'38.39"E). A large rock candlewood (<i>Maytenus oleoides</i>) occurs at waypoint 048 (33°23'24.67"S; 21°24'38.27"E). Piles of flood alluvium occur on the north side of the crossing within the vegetation. Several plants of <i>Anginon difforme</i> occur in these rocky areas.</p>

45.5	RHS	4m clearing width		
45.97	LHS	4m clearing width	Avoid <i>Salix mucronata</i> tree.

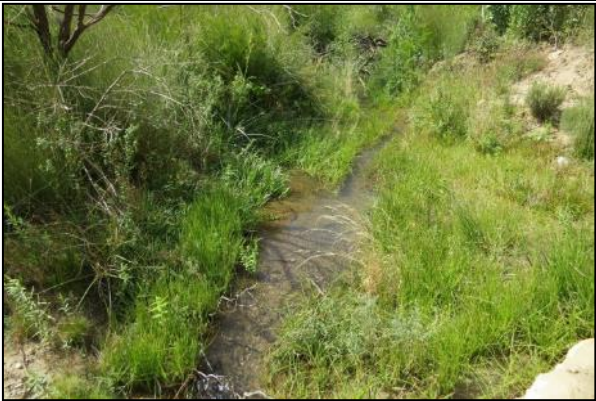
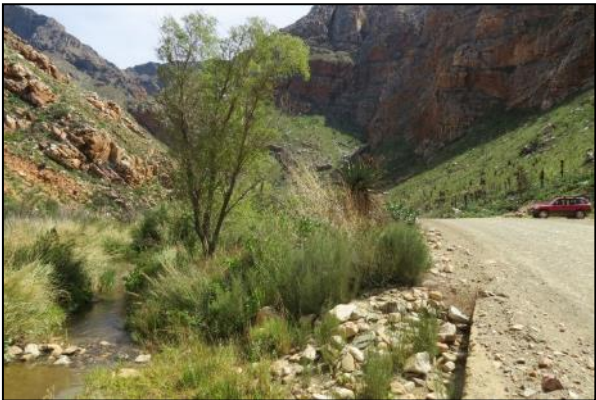
<p data-bbox="172 672 614 698">Figure 9.17. RHS (looking downstream).</p>

<p data-bbox="172 1131 614 1158">Figure 9.18. LHS (looking downstream).</p>	<p data-bbox="805 268 917 295">KM45.97</p> <p data-bbox="805 313 925 340">Crossing</p> <p data-bbox="805 403 1444 757">RHS: Intact riverine vegetation dominated by <i>Gunnera perpensa</i> (DECLINING), <i>Juncus capensis</i>, <i>Juncus cephalotes</i> and <i>Isolepis</i> sp. The road edge is disturbed and dominated by <i>Eragrostis</i> sp., <i>Cirsium vulgare</i> (invasive weed), <i>Othonna parviflora</i>, <i>Rubus</i> sp. (invasive weed) and <i>Stoebe</i> sp. Additional species include <i>Arctotheca calendula</i>, <i>Carpobrotus</i> sp. and <i>Lobostemon stachydeus</i>.</p> <p data-bbox="805 817 1444 1120">LHS: The same instream species occur on the LHS of the crossing with the addition of a single <i>Salix mucronata</i> tree. Dominant terrestrial species include <i>Elytropappus rhinocerotis</i>, <i>Othonna parviflora</i>, <i>Searsia lucida</i> and <i>Stoebe</i> sp. Additional species include <i>Oedera squarrosa</i> and <i>Osteospermum moniliferum</i>.</p>

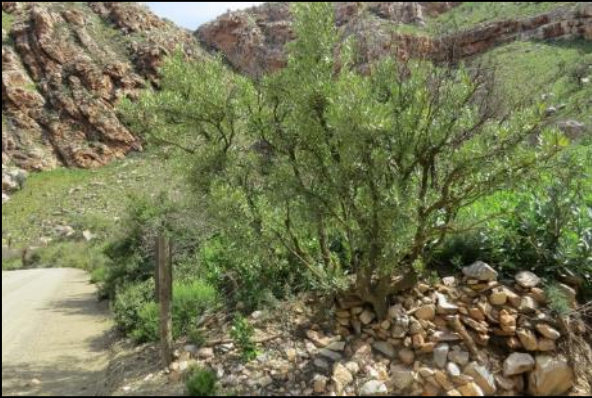
<p data-bbox="172 674 611 701">Figure 9.19. RHS (looking downstream).</p>	<p data-bbox="804 271 916 297">KM46.35</p> <p data-bbox="804 315 922 342">Crossing</p> <p data-bbox="804 409 1439 846">RHS: The river crossing is concrete and clear of riverine vegetation along the edges. A large <i>Maytenus oleoides</i> tree occurs on the south side of the road and may need to be removed for the proposed structure upgrade. An effort should, however, be made to protect the tree. The dominant terrestrial species on either side of the crossing include <i>Diospyros dichrophylla</i>, <i>Othonna parviflora</i> and <i>Searsia lucida</i>. Additional species include <i>Crassula rupestris</i> and <i>Crassula cf. arborescens</i>.</p> <p data-bbox="804 913 1439 1216">LHS: Narrow crossing will dense terrestrial vegetation along the road edge on either side of the crossing. Dominant species include <i>Diospyros dichrophylla</i> and <i>Searsia lucida</i>. Additional species include <i>Asparagus</i> sp., <i>Elytropappus rhinocerotis</i>, <i>Eragrostis cf. namaquensis</i>, <i>Osteospermum moniliferum</i>, <i>Osyris compressa</i> and <i>Phyllica</i> sp.</p>

46.35	N/A	No bypass	Structure to be constructed in half widths with no bypass.

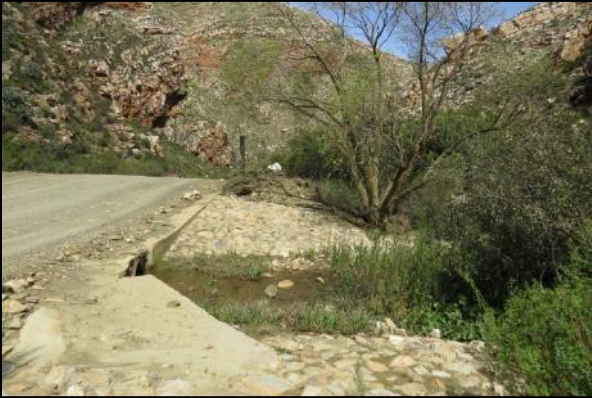
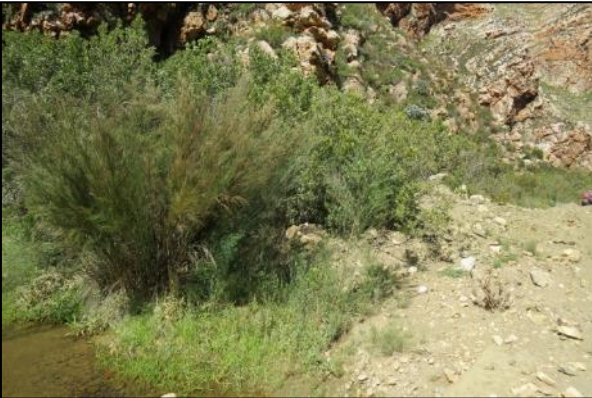
<p data-bbox="172 674 608 701">Figure 9.20. RHS (looking downstream).</p>

<p data-bbox="172 1133 608 1160">Figure 9.21. LHS (looking downstream).</p>	<p data-bbox="804 271 900 297">KM46.5</p> <p data-bbox="804 315 922 342">Crossing</p> <p data-bbox="804 409 1442 943">RHS: Paved area with a large Cape willow (<i>Salix mucronata</i>) tree on the south side of the crossing. The terrestrial habitat on either side of the crossing is dominated by dense vegetation with <i>Diospyros dichrophylla</i>, <i>Eragrostis</i> sp., <i>Othonna parviflora</i>, <i>Osteospermum moniliferum</i>, <i>Osyris compressa</i>, <i>Phyllica</i> sp. and <i>Searsia lucida</i>. Additional species include <i>Brachylaena neriifolia</i>, <i>Dodonaea angustifolia</i>, <i>Juncus effusus</i> and <i>Pelargonium</i> sp. The instream communities are dominated by <i>Erica caffra</i>, <i>Gunnera perpensa</i>, <i>Juncus capensis</i>, <i>Juncus cephalotes</i>, <i>Isolepis</i> sp. and <i>Mentha longifolia</i>.</p> <p data-bbox="804 1003 1442 1211">LHS: The same instream species occur on the LHS of the crossing. Dominant riparian species include <i>Diospyros dichrophylla</i>, <i>Dodonaea angustifolia</i>, <i>Osyris compressa</i>, <i>Calopsis paniculata</i> and <i>Searsia lucida</i>.</p>

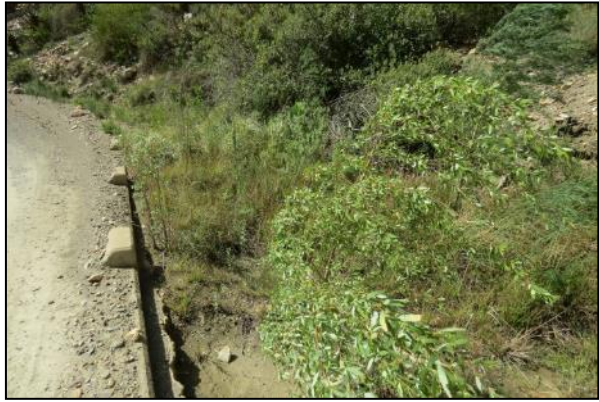
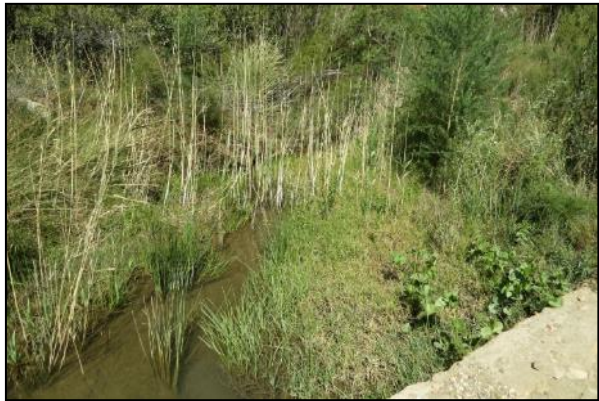
<p data-bbox="172 723 614 750">Figure 9.22. RHS (looking downstream).</p>

<p data-bbox="172 1182 614 1209">Figure 9.23. LHS (looking downstream).</p>	<p data-bbox="802 320 901 347">KM46.7</p> <p data-bbox="802 365 922 392">Crossing</p> <p data-bbox="802 454 1439 712">RHS: Previously disturbed riparian habitat with a young Cape willow (<i>Salix mucronata</i>) tree occurring in the river channel. Dominant dryland species on either side of the crossing include <i>Diospyros dichrophylla</i>, <i>Eragrostis</i> sp., <i>Psoralea affinis</i>, <i>Searsia lucida</i> and <i>Stoebe</i> sp.</p> <p data-bbox="802 775 1439 1263">LHS: Previously disturbed 2.5m high cut-away occurs on the north side of the crossing. Dominant species occurring on either side of the crossing include <i>Diospyros dichrophylla</i>, <i>Othonna parviflora</i>, <i>Osteospermum moniliferum</i> and <i>Searsia lucida</i>. Additional species include <i>Brachylaena neriifolia</i>, <i>Dodonaea angustifolia</i>, <i>Maytenus oleoides</i>, <i>Oedera squarrosa</i>. The riparian and instream communities are characterized by <i>Brachylaena neriifolia</i>, <i>Juncus cephalotes</i>, <i>Isolepis</i> sp., <i>Psoralea affinis</i> and <i>Phragmites australis</i>.</p>

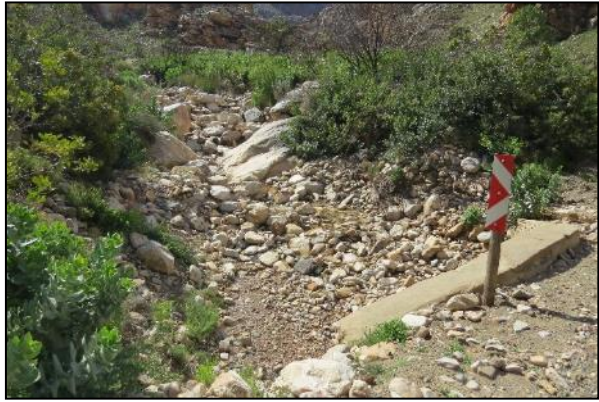
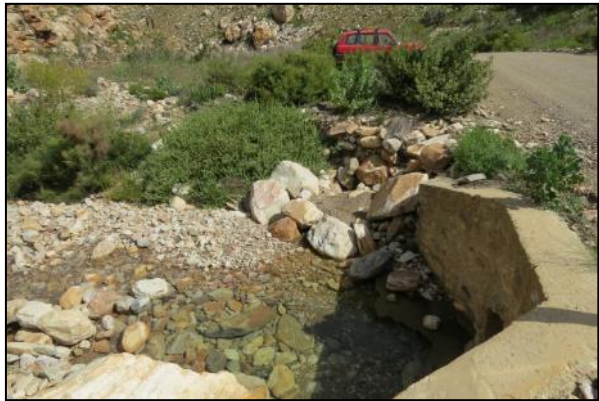
<p data-bbox="172 723 375 750">Figure 9.24. RHS.</p>

<p data-bbox="172 1182 606 1209">Figure 9.25. LHS (looking downstream).</p>	<p data-bbox="802 320 877 347">KM48</p> <p data-bbox="802 365 922 392">Crossing</p> <p data-bbox="802 459 1437 853">RHS: Dense vegetation occurs along the edge of the road (terrestrial habitat) whereas the side tributary does not support any riparian vegetation on the steep banks. Dominant shrubs along the road occurring on either side of the crossing include <i>Anthospermum aethiopicum</i>, <i>Dodonaea angustifolia</i>, <i>Osteospermum moniliferum</i>, <i>Othonna parviflora</i> and <i>Searsia lucida</i>. Additional species include <i>Diospyros glabra</i> and <i>Maytenus oleoides</i>.</p> <p data-bbox="802 913 1437 1173">LHS: The side tributary and steep river bank does not support any riparian vegetation. The roadside vegetation is dominated by <i>Diospyros glabra</i>, <i>Phyllica</i> sp., <i>Pteridium aquilinum</i> and <i>Searsia lucida</i>. Additional species include <i>Aloe ferox</i>, <i>Osyris compressa</i> and <i>Osteospermum moniliferum</i>.</p>

48	LHS	4m clearing width	Avoid <i>Aloe ferox</i> on north side of structure. Transplant aloe if necessary.

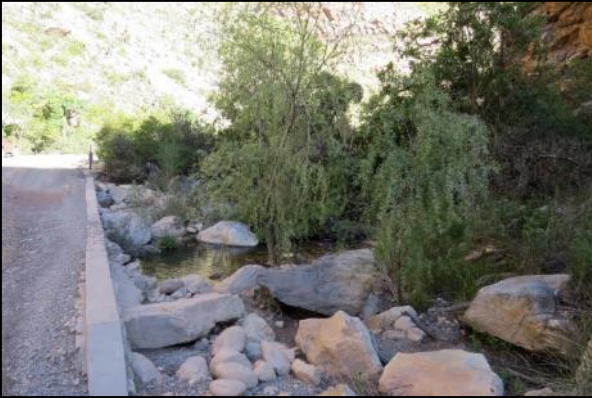
<p data-bbox="172 674 609 701">Figure 9.26. RHS (looking downstream).</p>   <p data-bbox="172 1133 576 1160">Figure 9.27. LHS (looking upstream).</p>	<p data-bbox="804 271 900 297">KM50.1</p> <p data-bbox="804 315 922 342">Crossing</p> <p data-bbox="804 409 1442 801">RHS: Narrow section of the poort supporting several Cape willow (<i>Salix mucronata</i>) trees within 2-4 m of the existing crossing. The river supports a number of established riverine trees including Cape holly (<i>Ilex mitis</i>) and <i>Brachylaena neriifolia</i>, with terrestrial trees including <i>Aloe ferox</i> and <i>Cussonia paniculata</i>. Several large bergkiepersol (<i>Cussonia paniculata</i>) occur on the north side of the crossing close to the road.</p> <p data-bbox="804 869 1442 1305">LHS: Dense riparian vegetation occurs within about 4m from the road edge, with a large Cape holly (<i>Ilex mitis</i>) occurring about 6m upstream (i.e. from the crossing). The dominant species along the stream is <i>Calopsis paniculata</i>. Dominant species associated with the dryland habitats include <i>Aloe ferox</i>, <i>Buddleja salvifolia</i>, <i>Calopsis paniculata</i>, <i>Diospyros glabra</i>, <i>Diospyros dichrophylla</i>, <i>Eragrostis cf. namaquensis</i>, <i>Othonna parviflora</i>, <i>Pelargonium glutinosum</i>, <i>Phylica</i> sp. and <i>Searsia lucida</i>.</p>

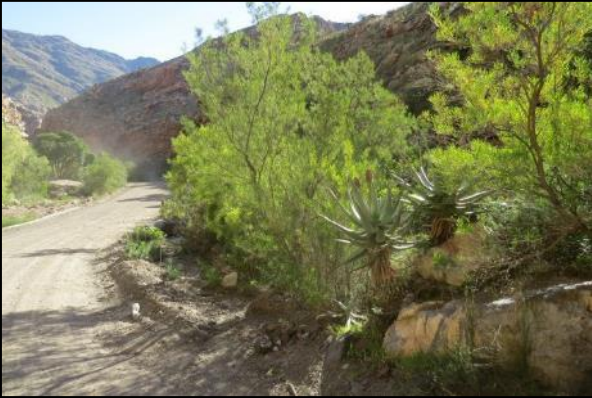
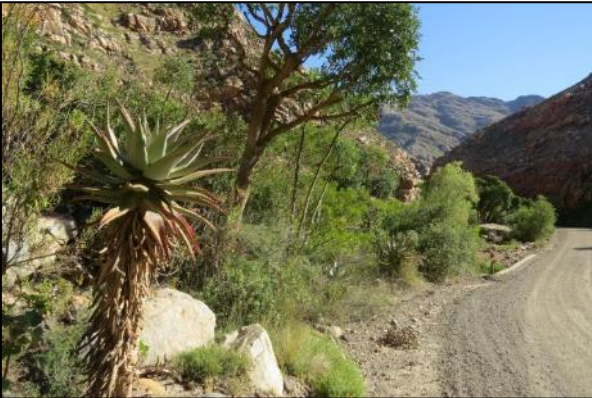
<p data-bbox="172 674 608 701">Figure 9.28. RHS (looking downstream).</p>

<p data-bbox="172 1133 608 1160">Figure 9.29. LHS (looking downstream).</p>	<p data-bbox="804 271 903 297">KM50.3</p> <p data-bbox="804 315 922 342">Crossing</p> <p data-bbox="804 409 1437 712">RHS: Dense, tall vegetation occurs on along the road edge, with the riparian habitat dominated by <i>Buddleja salvifolia</i>, <i>Calopsis paniculata</i> and <i>Searsia lucida</i>. The dominant terrestrial species include <i>Diospyros dichrophylla</i>, <i>Dodonaea angustifolia</i>, <i>Eragrostis</i> cf. <i>namaquensis</i>, <i>Gymnosporia buxifolia</i> and several large bergkiepersol (<i>Cussonia paniculata</i>) trees.</p> <p data-bbox="804 779 1437 1081">LHS: The terrestrial habitat along the road on either side of the crossing includes dominants such as <i>Aloe ferox</i>, <i>Cussonia paniculata</i>, <i>Dodonaea angustifolia</i>, <i>Pelargonium glutinosum</i> and <i>Searsia lucida</i>. The riparian habitat is dominated by <i>Calopsis paniculata</i>, with instream species including <i>Isolepis</i> sp. and <i>Juncus cephalotes</i>.</p>

50.1	RHS	2-3m		
50.3	RHS	4m clearing width	Move road alignment on LHS in by about 2m. Avoid bergkiepersol (<i>Cussonia paniculata</i>). Use topsoil from south side of structure on LHS to rehabilitate bypass.

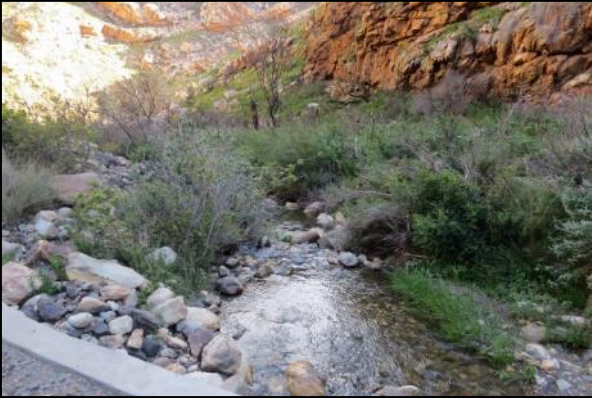
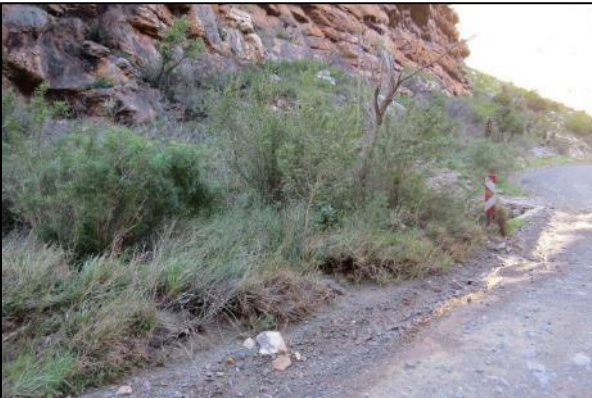
<p data-bbox="172 674 608 701">Figure 9.30. RHS (looking downstream).</p>

<p data-bbox="172 1133 608 1160">Figure 9.31. LHS (looking downstream).</p>	<p data-bbox="804 271 903 297">KM50.8</p> <p data-bbox="804 315 922 342">Crossing</p> <p data-bbox="804 409 1437 712">RHS: Intact riparian vegetation dominated by <i>Brachylaena neriifolia</i>, <i>Diospyros dichrophylla</i>, <i>Pelargonium glutinosum</i>, and <i>Searsia lucida</i>. Additional cover includes <i>Cliffortia ruscifolia</i>, <i>Halleria lucida</i> and <i>Peucedanum</i> sp. Mature bergkiepersol (<i>Cussonia paniculata</i>) trees occurs close to the road edge on the north side of the crossing.</p> <p data-bbox="804 779 1437 1440">LHS: A small stream runs parallel to the road where a narrow band of dense riparian vegetation occurs between the road and stream on the north side of the crossing. The habitat on the opposite side of the stream also comprise dense riparian vegetation. Dominant species include in the riparian and terrestrial mosaic on both sides of the crossing include <i>Aloe ferox</i>, <i>Buddleja salvifolia</i>, <i>Calopsis paniculata</i>, <i>Cliffortia strobilifera</i>, <i>Diospyros dichrophylla</i>, <i>Othonna parviflora</i>, <i>Virgilia divaricata</i>. A mature bergkiepersol (<i>Cussonia paniculata</i>) tree occurs at waypoint 114. Groups of <i>Aloe ferox</i> occur at waypoint 111, 112 and 113. Plants of black wattle (<i>Acacia mearnsii</i>) were recorded on the south side of the crossing.</p>

50.8	RHS	4m clearing width	Avoid <i>Cussonia paniculata</i> on north side of structure. Avoid <i>Aloe ferox</i> on south side of structure. Transplant aloe if necessary.

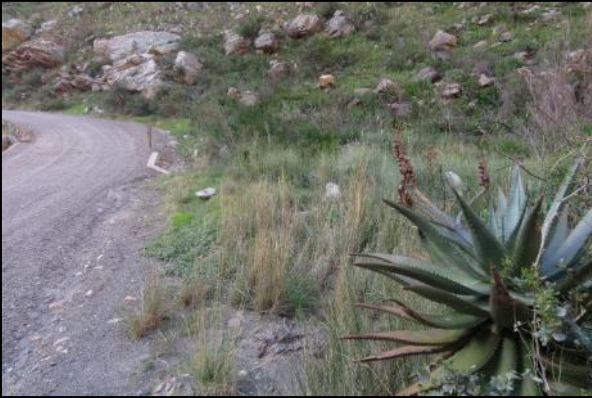
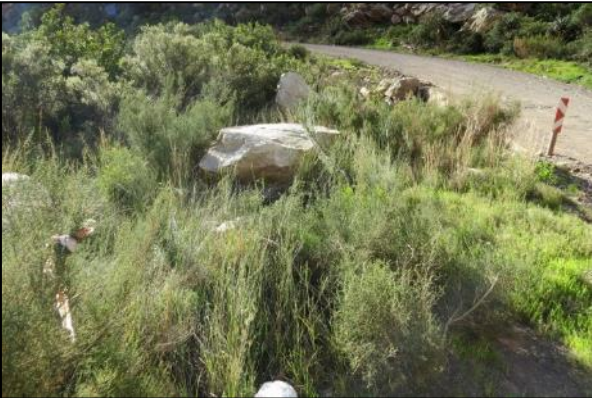
<p data-bbox="172 674 608 701">Figure 9.32. RHS (looking downstream).</p>

<p data-bbox="172 1133 608 1160">Figure 9.33. LHS (looking downstream).</p>	<p data-bbox="804 271 916 297">KM51.10</p> <p data-bbox="804 315 922 342">Crossing</p> <p data-bbox="804 409 1437 801">RHS: Previously disturbed roadside on either side of the road crossing with intact riparian vegetation. Dominant species include <i>Arctotheca calendula</i>, <i>Brachylaena neriifolia</i>, <i>Calopsis paniculata</i>, <i>Diospyros dichrophylla</i>, <i>Eragrostis sp.</i>, <i>Freylinia lanceolata</i>, <i>Hyparrhenia hirta</i>, <i>Psoralea affinis</i> and <i>Searsia lucida</i>. Additional species include <i>Buddleja salvifolia</i>, <i>Cliffortia ruscifolia</i>, <i>Othonna parviflora</i> and <i>Pelargonium glutinosum</i>.</p> <p data-bbox="804 869 1437 1211">LHS: The road side is heavily disturbed on the south side of the crossing next to the road where rocks have been piled. The road edge supports dominants such as <i>Anginon difforme</i>, <i>Calopsis paniculata</i>, <i>Brachylaena neriifolia</i>, <i>Hyparrhenia hirta</i>, <i>Pelargonium glutinosum</i>, <i>Phylica sp.</i> and <i>Stoebe sp.</i> The dominant instream species include <i>Isolepis sp.</i> and <i>Mentha longifolia</i>.</p>

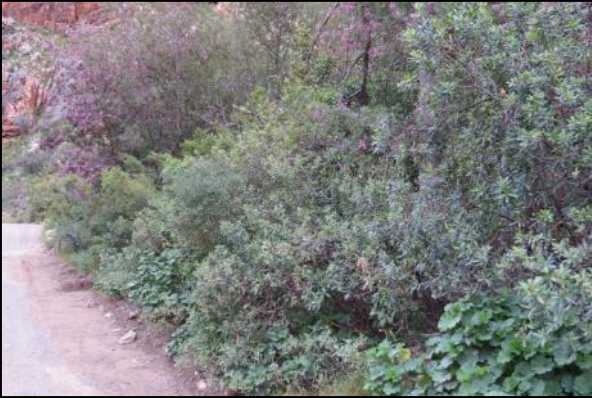
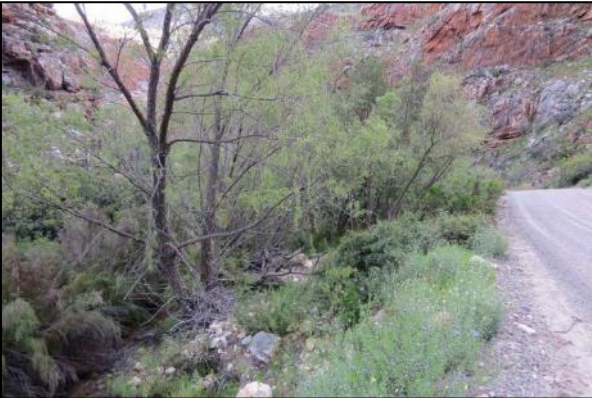
<p data-bbox="172 674 608 701">Figure 9.34. RHS (looking downstream).</p>

<p data-bbox="172 1133 608 1160">Figure 9.35. LHS (looking downstream).</p>	<p data-bbox="804 271 903 297">KM51.6</p> <p data-bbox="804 315 922 342">Crossing</p> <p data-bbox="804 409 1442 757">RHS: Intact, dense riparian thicket with keurboom (<i>Virgilia divaricata</i>), <i>Calopsis paniculata</i> <i>Diospyros dichrophylla</i>, <i>Diospyros glabra</i> and <i>Pelargonium glutinosum</i>. On the south side of the crossing approximately ten mature <i>Aloe ferox</i> plants occur in the terrestrial habitat. Additional species include <i>Othonna parviflora</i>, <i>Pelargonium cf. zonale</i> and <i>Zantedeschia aethiopica</i>.</p> <p data-bbox="804 824 1442 1081">LHS: A side stream that runs parallel to the road, is lined with mature Cape willow (<i>Salix mucronata</i>) trees, forming the dominant cover. Additional species include <i>Diospyros dichrophylla</i>, <i>Lobostemon stachydeus</i>, <i>Pelargonium cf. zonale</i> and <i>Nemesia fruticans</i> (along the road edge).</p> <p data-bbox="804 1144 1086 1171">Sensitivity rating = High</p>

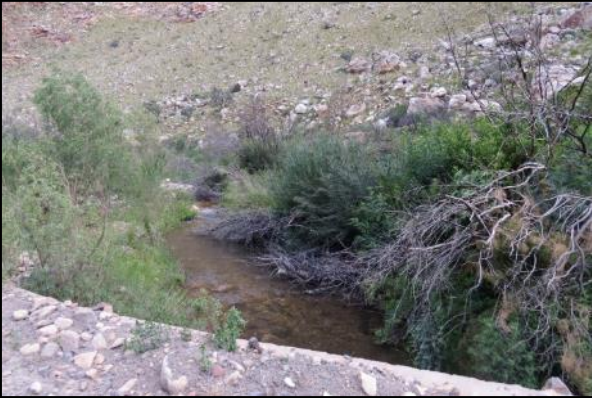
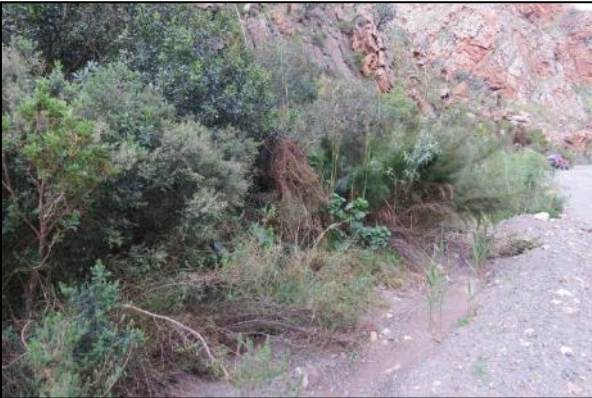
<p data-bbox="172 674 608 701">Figure 9.36. RHS (looking downstream).</p>

<p data-bbox="172 1133 608 1160">Figure 9.37. LHS (looking downstream).</p>	<p data-bbox="804 271 900 297">KM52.0</p> <p data-bbox="804 315 922 342">Crossing</p> <p data-bbox="804 409 1439 712">RHS: The roadside is previously disturbed but the riparian habitat is intact and comprises of dense vegetation. The intact terrestrial habitat is several metres from the road edge. Dominant species include, <i>Freylinia lanceolata</i>, <i>Pelargonium zonale</i>, <i>Salix mucronata</i> and <i>Virgilia divaricata</i>. The instream species include <i>Isolepis</i> sp. and <i>Mentha longifolia</i>.</p> <p data-bbox="804 779 1439 1081">LHS: Intact, dense riparian and terrestrial vegetation thicket vegetation dominated by <i>Brachylaena neriifolia</i>, <i>Buddleja salvifolia</i>, <i>Calopsis paniculata</i>, <i>Diospyros dichrophylla</i>, <i>Gymnosporia buxifolia</i>, <i>Phyllica</i> sp., <i>Psoralea affinis</i> and <i>Searsia lucida</i>. Approximately 20 mature <i>Aloe ferox</i> plants occur in the terrestrial habitat on the south side of the crossing.</p> <p data-bbox="804 1144 1086 1171">Sensitivity rating = High</p>

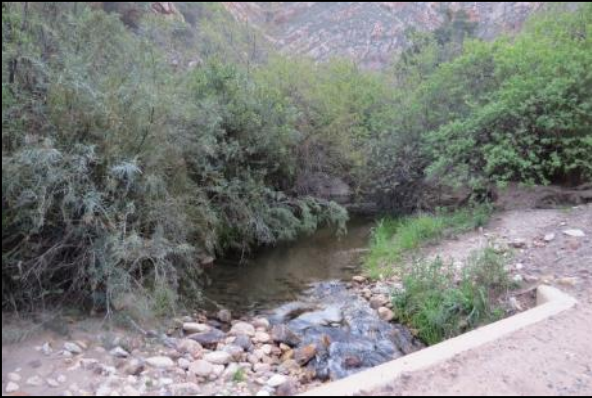
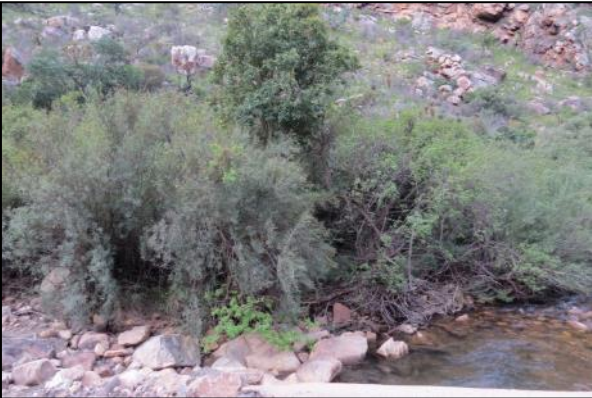
<p data-bbox="172 674 579 701">Figure 9.38. RHS (looking upstream).</p>

<p data-bbox="172 1133 608 1160">Figure 9.39. LHS (looking downstream).</p>	<p data-bbox="804 271 903 297">KM53.2</p> <p data-bbox="804 315 922 342">Crossing</p> <p data-bbox="804 409 1439 622">RHS: Intact, dense riparian and terrestrial mosaic vegetation dominated by <i>Calopsis paniculata</i>, <i>Diospyros dichrophylla</i> and <i>Searsia lucida</i>. A mature Cape holly (<i>Ilex mitis</i>) tree occurs near waypoint 156 (33°25'35.52"S; 21°24'15.50"E).</p> <p data-bbox="804 685 1439 987">LHS: Intact, dense riparian and terrestrial mosaic vegetation dominated by <i>Calopsis paniculata</i>, <i>Freylinia lanceolata</i>, <i>Maytenus oleoides</i> and <i>Searsia lucida</i>. A mature Cape holly tree occurs on the north side of the crossing near waypoint 151 (33°25'35.75"S; 21°24'16.80"E). The south side of the crossings is disturbed next to the road.</p> <p data-bbox="804 1050 1086 1077">Sensitivity rating = High</p>

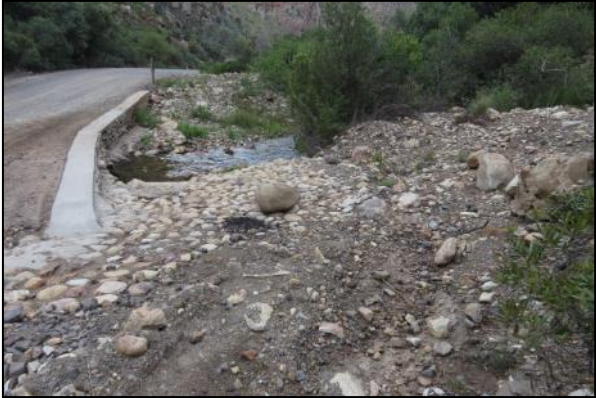
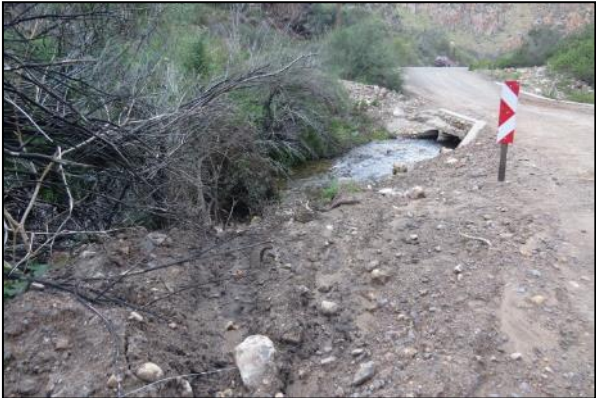
<p data-bbox="172 674 609 701">Figure 9.40. RHS (looking downstream).</p>

<p data-bbox="172 1133 609 1160">Figure 9.41. LHS (looking downstream).</p>	<p data-bbox="802 271 903 297">KM53.4</p> <p data-bbox="802 315 922 342">Crossing</p> <p data-bbox="802 409 1441 801">RHS: Disturbed and cleared vegetation occurs within 4 to 6m of the road edge and crossing. Intact vegetation occurs beyond this distance and occurs closer to the road with increasing distance away from the crossing on either direction (south and north). Dominant species in the intact vegetation include <i>Freylinia lanceolata</i>, <i>Maytenus oleoides</i>, <i>Pterocelastrus tricuspidatus</i>, <i>Searsia</i> sp. and <i>Searsia lucida</i>.</p> <p data-bbox="802 869 1441 1171">LHS: A similar disturbance distance to the RHS, with cleared area spanning 2 to 4 m near the crossing and narrowing with distance from the crossing on either side of the river. Dominant species include <i>Buddleja salvifolia</i>, <i>Diospyros dichrophylla</i>, <i>Eragrostis</i> sp., <i>Freylinia lanceolata</i>, <i>Psoralea affinis</i>, <i>Searsia</i> sp. and <i>Virgilia divaricata</i>.</p>

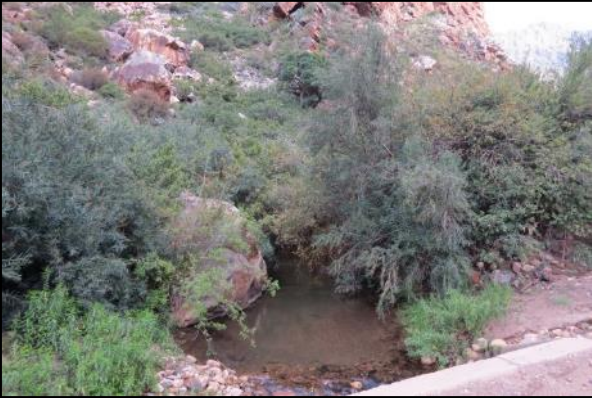
<p data-bbox="172 674 608 701">Figure 9.42. RHS (looking downstream).</p>	<p data-bbox="804 271 900 297">KM53.5</p> <p data-bbox="804 315 922 342">Crossing</p> <p data-bbox="804 409 1437 577">RHS: intact, dense riparian and terrestrial vegetation dominated by <i>Buddleja salvifolia</i>, <i>Diospyros dichrophylla</i>, <i>Freylinia lanceolata</i>, <i>Osyris compress</i>, <i>Pelargonium zonale</i>, <i>Searsia lucida</i> and <i>Searsia sp.</i></p> <p data-bbox="804 640 1086 667">Sensitivity rating = High</p>

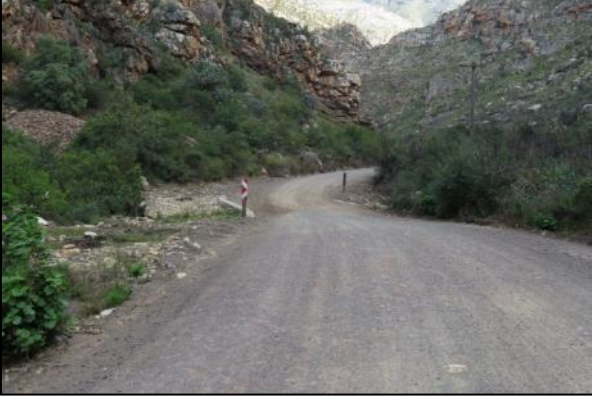
<p data-bbox="172 1137 608 1164">Figure 9.43. LHS (looking downstream).</p>	<p data-bbox="804 734 1437 1037">LHS: Disturbed roadside with riparian vegetation occurring within 5m of the crossing. Dominant species in the riparian habitat include <i>Calopsis paniculata</i>, <i>Eragrostis sp.</i>, <i>Freylinia lanceolata</i>, <i>Pelargonium glutinosum</i>, <i>Searsia lucida</i> and <i>Virgilia divaricata</i>. Additional species include <i>Othonna parviflora</i>, <i>Psoralea affinis</i> and <i>Scirpoides thunbergii</i>.</p> <p data-bbox="804 1099 1086 1126">Sensitivity rating = High</p>

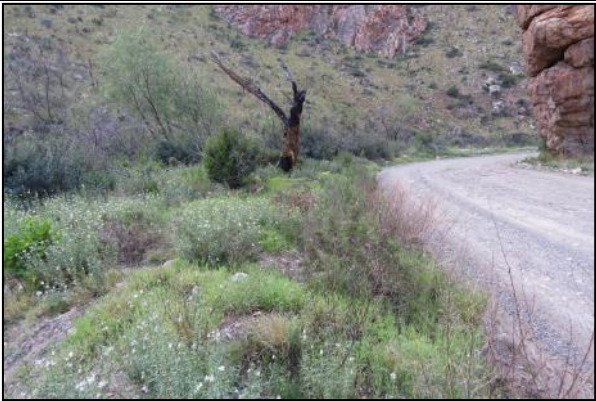
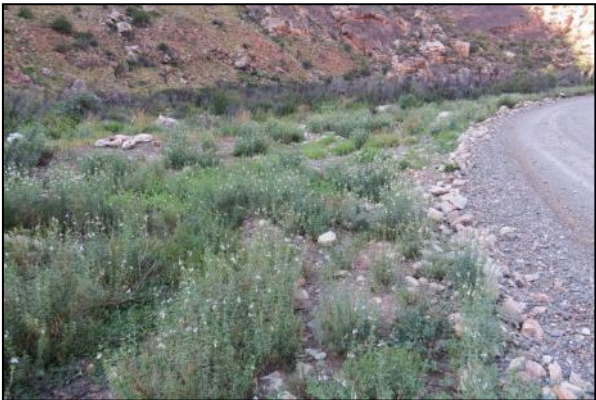
<p data-bbox="172 672 614 705">Figure 9.44. RHS (looking downstream).</p>

<p data-bbox="172 1131 614 1164">Figure 9.45. LHS (looking downstream).</p>	<p data-bbox="805 268 1109 347">KM53.8 Proposed retaining wall</p> <p data-bbox="805 403 1444 806">The proposed retaining wall would be aligned next to the left-hand-side road edge. The area within about 6 m of the road edge is mostly disturbed along the 100 m length of the proposed structure. Recently burnt riparian vegetation occurs along the parallel river channel further than 6m from the road edge. A large Cape willow that was killed by fire occurs within 3m of the road edge at waypoint 174 (33°25'50.37"S; 21°24'31.77"E).</p> <p data-bbox="805 862 1444 1086">The riparian vegetation is dominated by Cape willow and <i>Freylinia lanceolata</i> whereas the disturbed areas are covered with grasses and pioneer species such as <i>Eragrostis sp.</i>, <i>Hyparrhenia hirta</i>, <i>Stoebe sp.</i>, <i>Nemesia fruticosa</i> and <i>Pelargonium glutinosum</i>.</p>

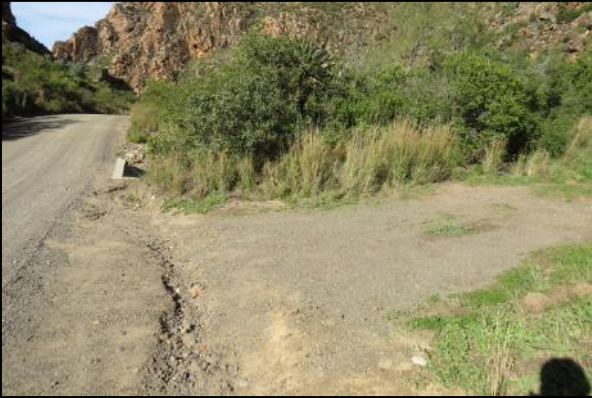
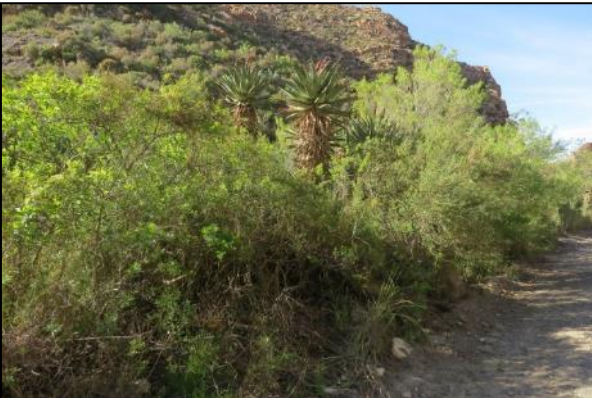
<p data-bbox="172 674 608 701">Figure 9.46. RHS (looking downstream).</p>

<p data-bbox="172 1133 608 1160">Figure 9.47. LHS (looking downstream).</p>	<p data-bbox="804 271 900 297">KM54.1</p> <p data-bbox="804 315 922 342">Crossing</p> <p data-bbox="804 409 1437 846">RHS: The crossing is located next to a picnic site access road. The riparian terrestrial vegetation on either side of the access road comprises thicket dominated by <i>Diospyros dichrophylla</i>, <i>Gymnosporia buxifolia</i>, <i>Osyris compressa</i>, <i>Maytenus oleoides</i> and <i>Searsia</i> sp.. Additional species include <i>Aloe ferox</i>. The riparian vegetation is intact and dominated by <i>Brachylaena neriifolia</i>, <i>Calopsis paniculata</i>, <i>Cliffortia strobilifera</i>, <i>Cussonia paniculata</i> and <i>Maytenus oleoides</i>.</p> <p data-bbox="804 913 1086 940">Sensitivity rating = High</p> <p data-bbox="804 1008 1437 1220">RHS: Dense terrestrial and riparian vegetation occur on the north side of the crossing, dominated by <i>Aloe ferox</i>, <i>Calopsis paniculata</i>, <i>Cussonia paniculata</i>, <i>Dodonaea angustifolia</i>, <i>Freylinia lanceolata</i> and <i>Maytenus oleoides</i>.</p> <p data-bbox="804 1288 1086 1314">Sensitivity rating = High</p>

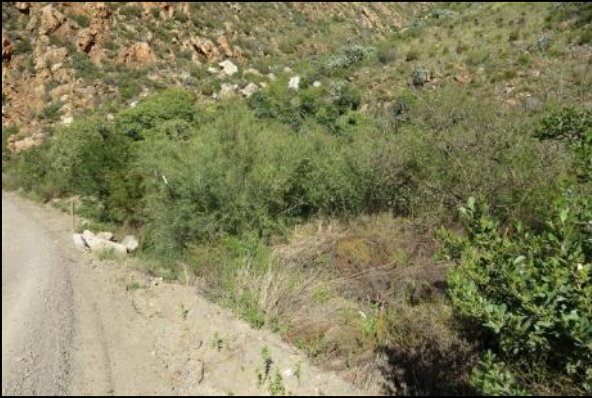
<p data-bbox="172 674 608 701">Figure 9.48. RHS (looking downstream).</p>	<p data-bbox="804 271 900 297">KM54.3</p> <p data-bbox="804 315 922 342">Crossing</p> <p data-bbox="804 409 1439 622">RHS: Dominated by <i>Calopsis paniculata</i>, <i>Dodonaea angustifolia</i>, <i>Freylinia lanceolata</i>, <i>Searsia lucida</i>, <i>Searsia</i> sp. and <i>Virgilia divaricata</i>. A mature rock candlewood (<i>Maytenus oleoides</i>) occurs on the south side of the crossing in the terrestrial habitat.</p> <p data-bbox="804 685 1086 712">Sensitivity rating = High</p>

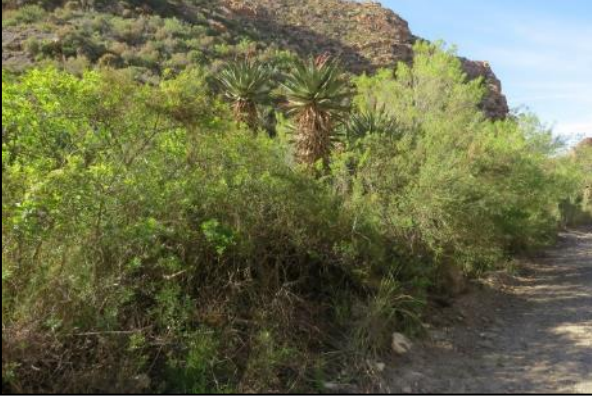
<p data-bbox="172 1137 608 1164">Figure 9.49. LHS (looking downstream).</p>	<p data-bbox="804 779 1439 992">RHS: Riparian and terrestrial habitat mosaic dominated by <i>Brachylaena neriifolia</i>, <i>Calopsis paniculata</i>, <i>Conyza</i> sp., <i>Diospyros dichrophylla</i>, <i>Pteridium aquilinum</i>, <i>Psoralea</i> sp., <i>Freylinia lanceolata</i>, <i>Searsia lucida</i> and <i>Virgilia divaricata</i>.</p> <p data-bbox="804 1055 1086 1081">Sensitivity rating = High</p>
