Botanical Assessment for Flood Damage Repairs to Structures on MR309 in Seweweekspoort, Eden District and Central Karoo District Municipalities

Prepared for HATCH Africa (Pty) Ltd

December 2016

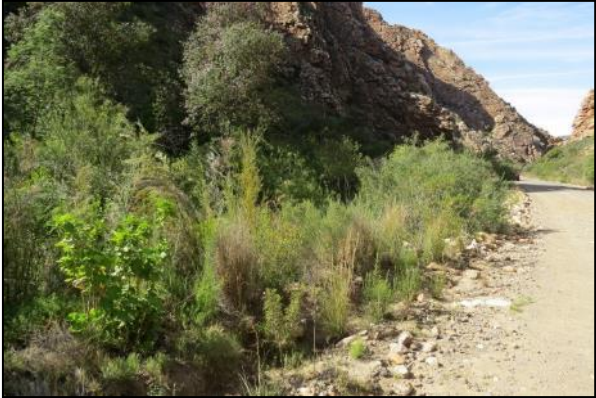
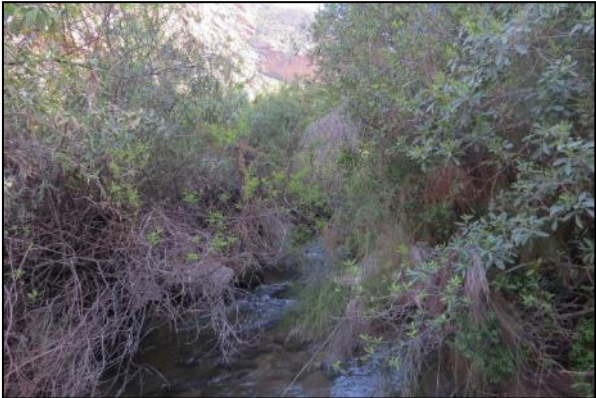
<p data-bbox="172 674 606 701">Figure 9.50. LHS (looking downstream).</p>

<p data-bbox="172 1131 606 1158">Figure 9.51. LHS (looking downstream).</p>   <p data-bbox="172 1621 606 1648">Figure 9.52. LHS (looking downstream).</p>	<p data-bbox="805 271 1189 344">KM54.4 Proposed 350m retaining wall</p> <p data-bbox="805 409 1437 943">The proposed retaining wall is on the LHS of the road in close proximity to the road between the road and river channel that runs parallel to the road. The river channel supports intact riverine thicket with dominants including <i>Brachylaena neriifolia</i>, <i>Buddleja salvifolia</i>, <i>Calopsis paniculata</i>, <i>Cliffortia strobilifera</i>, <i>Cussonia paniculata</i>, <i>Diospyros dichrophylla</i>, <i>Dodonaea angustifolia</i>, <i>Freylinia lanceolata</i>, <i>Gymnosporia buxifolia</i>, <i>Osyris compressa</i>, <i>Pelargonium glutinosum</i>, <i>Pelargonium zonale</i>, <i>Psoralea affinis</i>, <i>Pterocelastrus tricuspidatus</i>, <i>Searsia lucida</i>, <i>Searsia</i> sp. and <i>Virgilia divaricata</i>.</p> <p data-bbox="805 1005 1437 1126">A mature Cape holy (<i>Ilex mitis</i>) tree occurs close to the road at waypoint 201 (33°26'5.44"S; 21°24'25.35"E).</p> <p data-bbox="805 1189 1157 1216">Sensitivity rating = Very High</p>

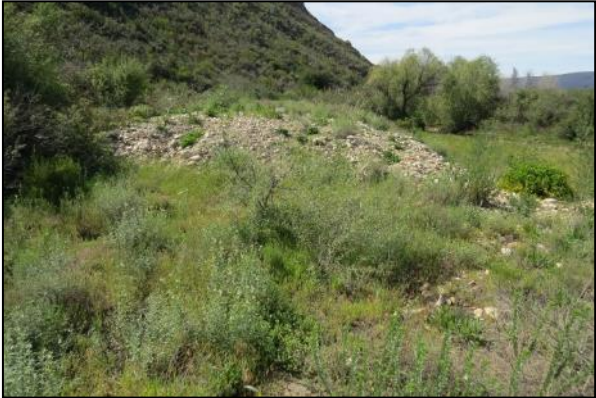
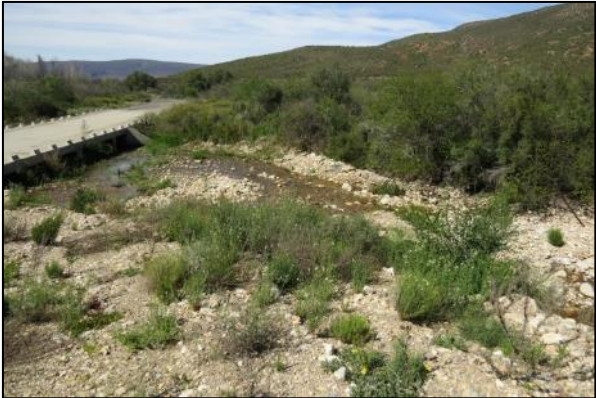
<p data-bbox="172 736 606 768">Figure 9.52. LHS (looking downstream).</p>

<p data-bbox="172 1252 606 1283">Figure 9.53. LHS (looking downstream).</p>	<p data-bbox="802 338 901 369">KM57.1</p> <p data-bbox="802 383 922 414">Crossing</p> <p data-bbox="802 472 1441 1010">LHS: Disturbed roadside vegetation dominated by weeds and disturbance-associated indigenous grasses, annuals and perennials, with high number of juvenile sweet thorn (<i>Acacia karoo</i>) indicating that the area is naturally recovering but subjected to flooding events. Clumps of shrubs with <i>Acacia karoo</i>, <i>Gymnosporia buxifolia</i>, <i>Searsia</i> sp. and <i>Searsia lucida</i> occur at waypoint 207 (33°27'13.66"S; 21°25'15.46"E). A well-defined patch of river grass (<i>Pennisetum macrourum</i>) occur at waypoint 208 (33°27'13.50"S; 21°25'15.90"E) in the lower floodplain.</p> <p data-bbox="802 1070 1441 1375">RHS: The same disturbance regime and array of species occur on the LHS, with tall terrestrial thicket occurring on the south side of the crossing. The thicket is dominated by large trees/shrubs of <i>Acacia karoo</i>, <i>Olea europaea subsp. africana</i>, <i>Freylinia lanceolata</i>, <i>Gymnosporia buxifolia</i> and <i>Searsia</i> sp.</p> <p data-bbox="802 1435 1093 1467">Sensitivity rating = High</p>

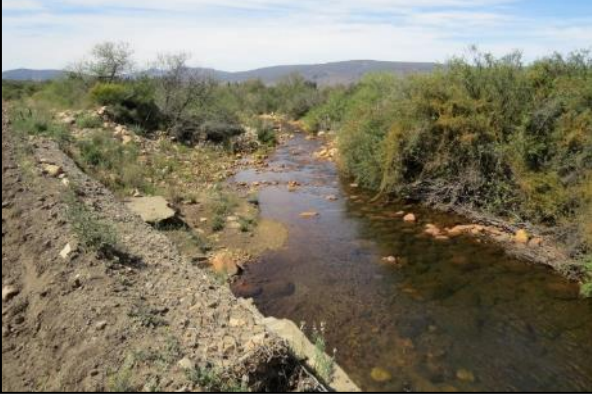
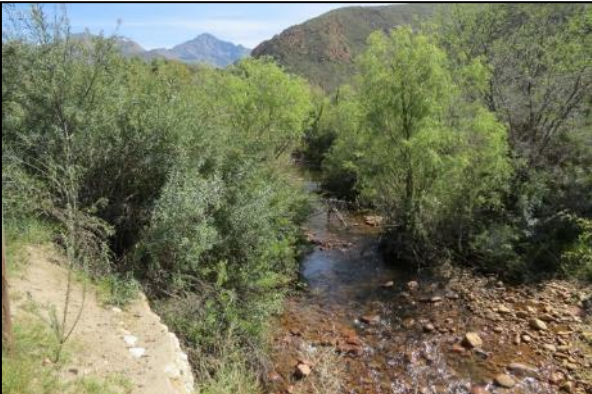
<p data-bbox="172 705 609 734">Figure 9.54. RHS (looking downstream).</p>

<p data-bbox="172 1216 576 1245">Figure 9.55. LHS (looking upstream).</p>	<p data-bbox="804 309 900 338">KM58.1</p> <p data-bbox="804 398 922 427">Crossing</p> <p data-bbox="804 488 1437 701">RHS: Highly degraded roadside vegetation dominated by weeds and disturbance-associated indigenous species. The riparian vegetation is intact and dominated by a dense cover of <i>Freylinia lanceolata</i> and <i>Salix mucronata</i>.</p> <p data-bbox="804 761 1437 929">LHS: The same disturbance regime as the RHS is found on this side. Riparian vegetation includes dense cover of <i>Freylinia lanceolata</i> and <i>Gymnosporia buxifolia</i>.</p> <p data-bbox="804 1037 1094 1066">Sensitivity rating = High</p>

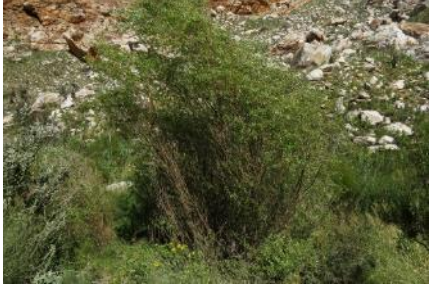
Structure	Preferred or constrained bypass side	Approximate clearing width	Key mitigation	Image
44.1	LHS	4m clearing width		
44.3	RHS	4.5m clearing width		
44.50	RHS	4m clearing width		
44.7	RHS	7m clearing width	Avoid <i>Salix mucronata</i> tree.

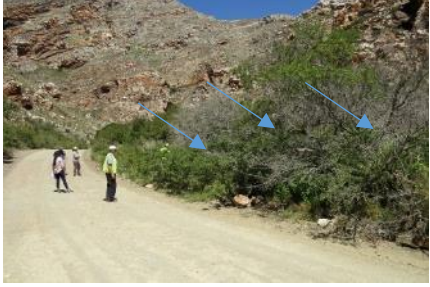
45.05	LHS	4m clearing width		
45.1	RHS	4m clearing width	Move structure 5-6m south. <i>Brachylaena neriifolia</i> trees to be pruned but not removed

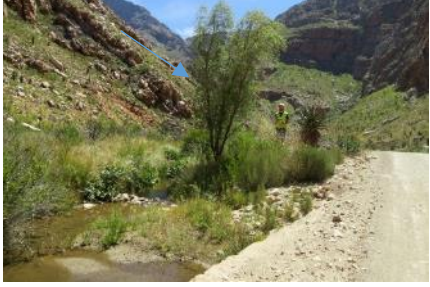
45.5	RHS	4m clearing width		
45.97	LHS	4m clearing width	Avoid <i>Salix mucronata</i> tree.

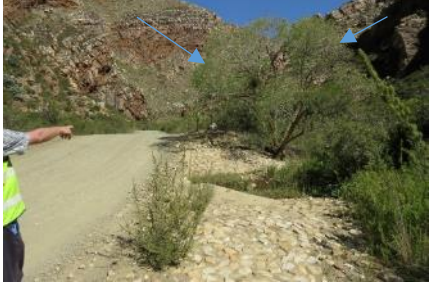
46.5	LHS	4m clearing width	Avoidance of <i>Salix mucronata</i> tree on RHS.

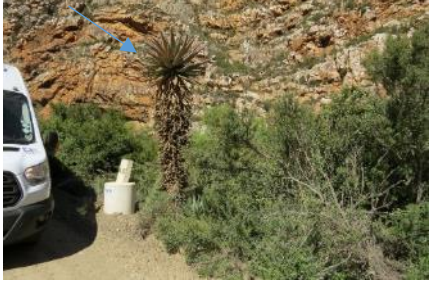
48	LHS	4m clearing width	Avoid <i>Aloe ferox</i> on north side of structure. Transplant aloe if necessary.

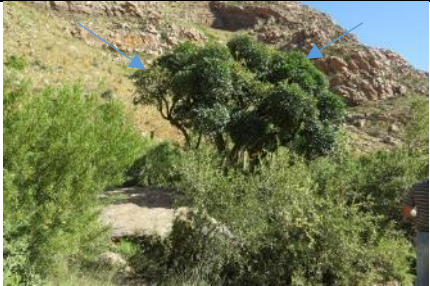
50.1	RHS	2-3m		
50.3	RHS	4m clearing width	Move road alignment on LHS in by about 2m. Avoid bergkiepersol (<i>Cussonia paniculata</i>). Use topsoil from south side of structure on LHS to rehabilitate bypass.

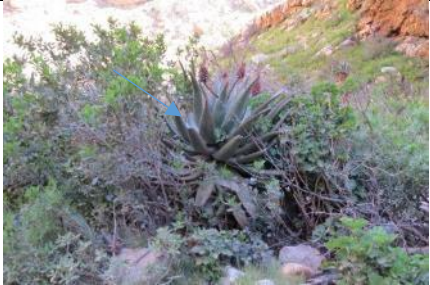
50.8	RHS	4m clearing width	Avoid <i>Cussonia paniculata</i> on north side of structure. Avoid <i>Aloe ferox</i> on south side of structure. Transplant aloe if necessary.

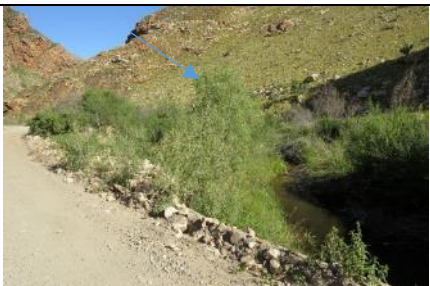
51.1	LHS	4m clearing width		
51.6	RHS	4m clearing width	Avoid <i>Salix mucronata</i> tree.

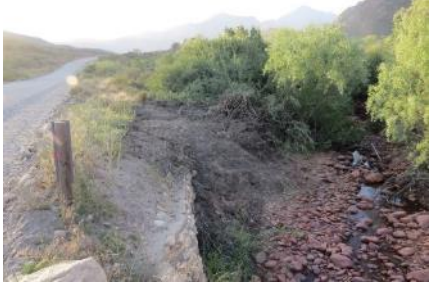
53.5	LHS	4m clearing width	Road to be moved upstream to avoid cutting into embankment	
54.1	RHS	4m clearing width		
54.3	LHS	4m clearing width	Structure to be moved upstream slightly.	
58.1	LHS	4m clearing width	Not applicable: area already cleared of <i>Salix mucronata</i> trees.
