FRESHWATER ASSESSMENT FOR THE PROPOSED FLOOD DAMAGE REPAIRS TO STRUCTURES ON MR309 IN SEWEWEEKSPOORT PASS

DECEMBER 2016

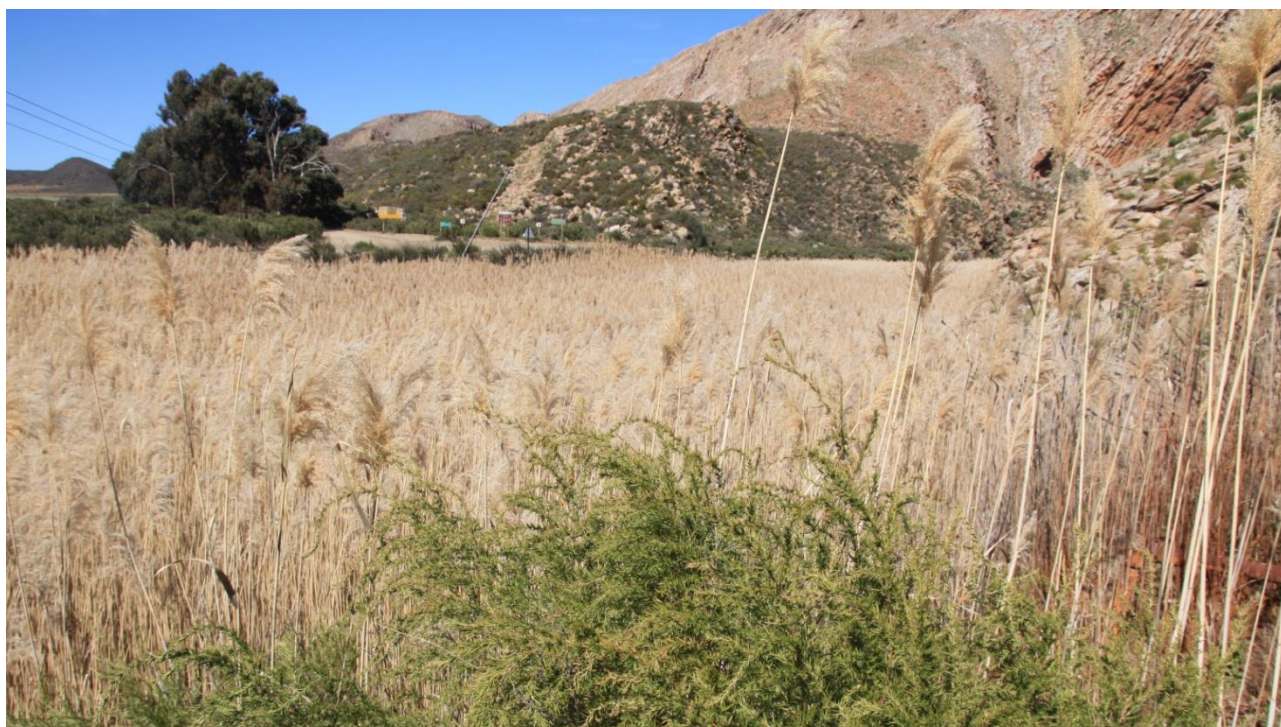
Figure 12. Seweweekspoort River as it enters the pass

The Seweweekspoort River is a southward flowing tributary of the Kobus River. The river is largely natural for much of its middle to upper reaches where it has carved a ravine through the Klein Swartberg Mountains. Only in its lower reaches have been impacted by agricultural activities.

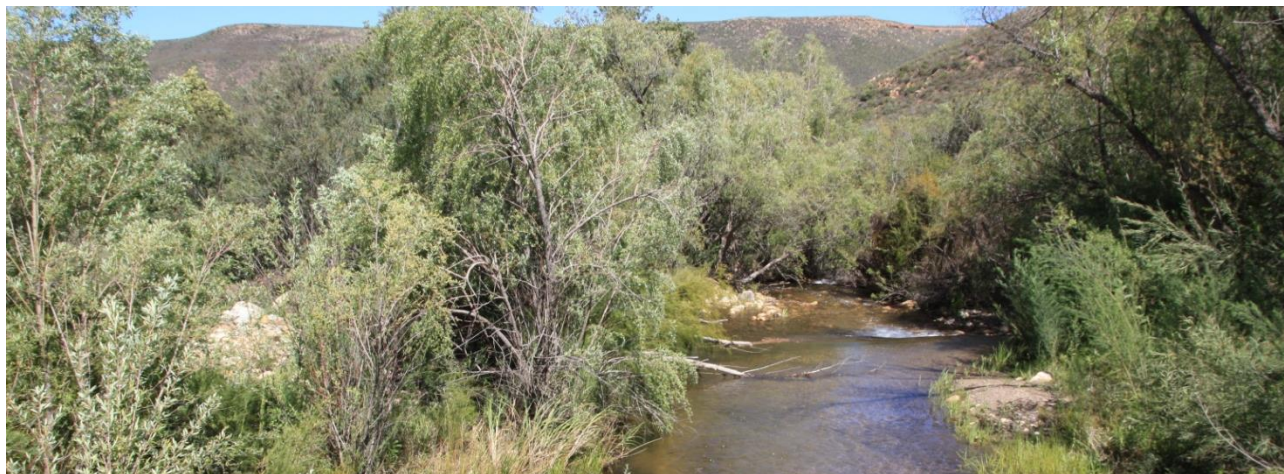
Figure 13. View of the Seweweekspoort River within the pass

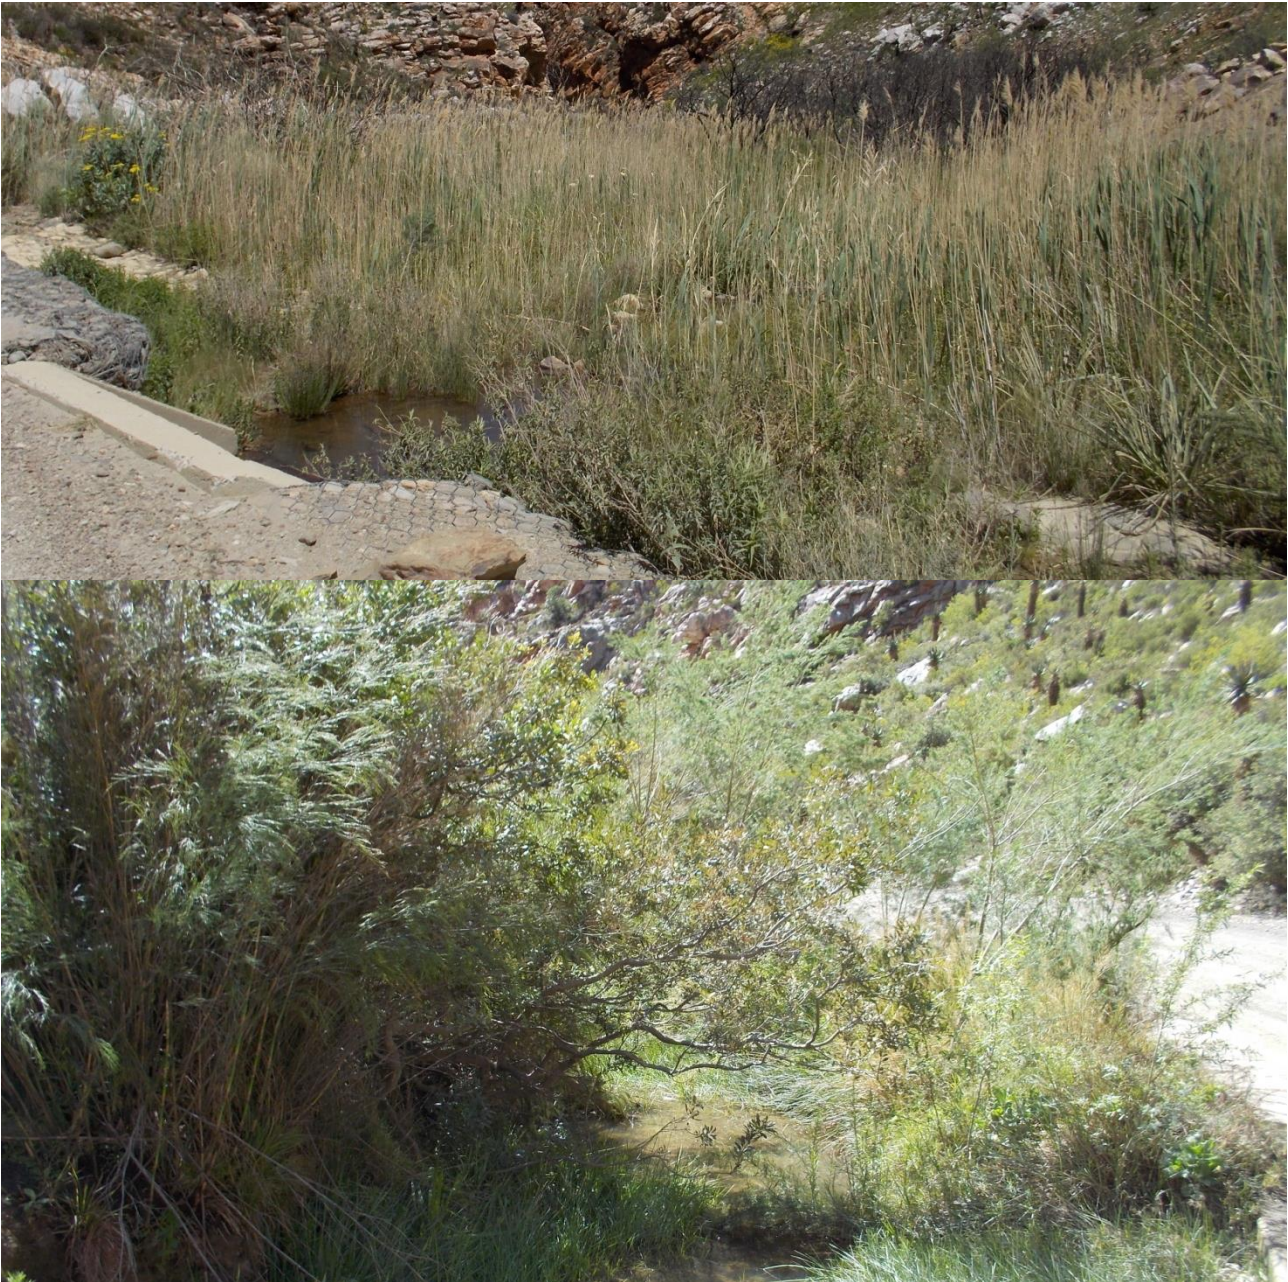
The valley bottom wetland areas within the study area are closely associated with the Seweweekspoort and occur along the length of the river where the valley is slightly wider and flatter and where flow in the river is slightly impeded by natural rock barriers. In the upper portion the wetland areas tend to be dominated by the common reed, *Phragmites australis*, as a result of the more brackish water quality and finer sediments that are influenced by the Great Karoo while the wetland areas in the lower section consist of rushes, sedges and restios such as *Isolepis* sp., broom restio (*Calopsis paniculata*), soft rush (*Juncus effuses*) as a result of the low conductivity and coarser sediments within the pass.

Figure 15. Valley bottom wetland in the upper (top) and lower (bottom) sections of the Seweweekspoort

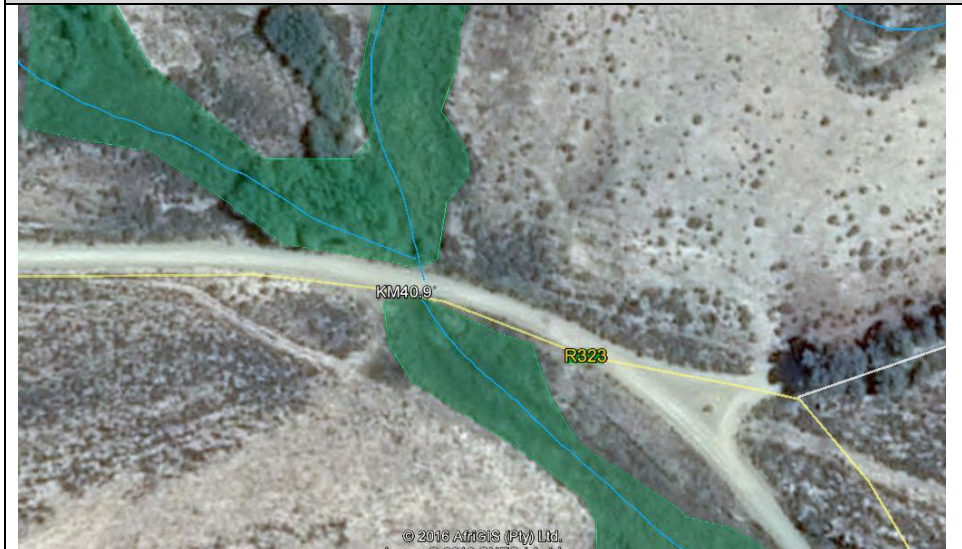
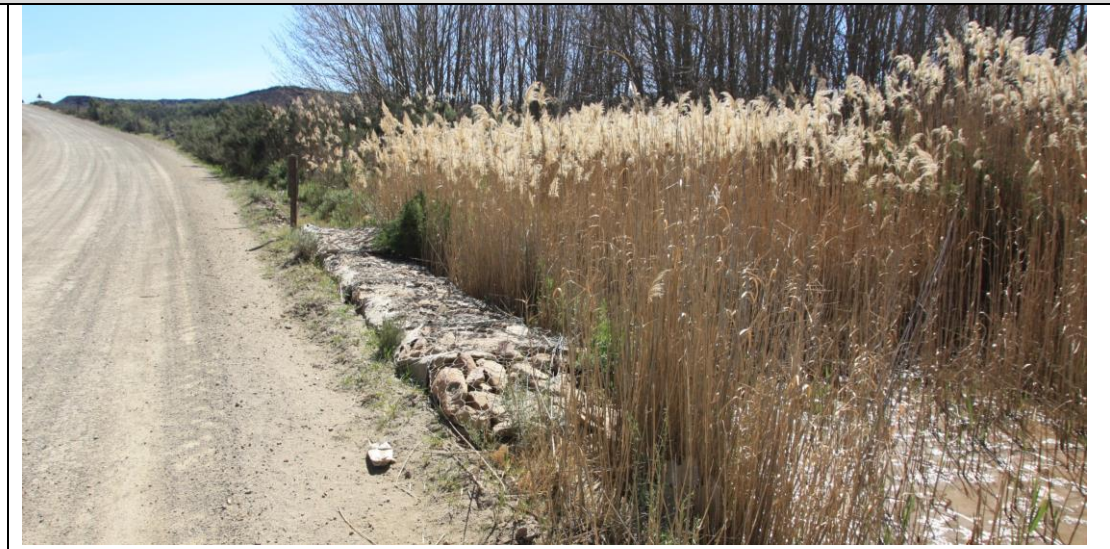
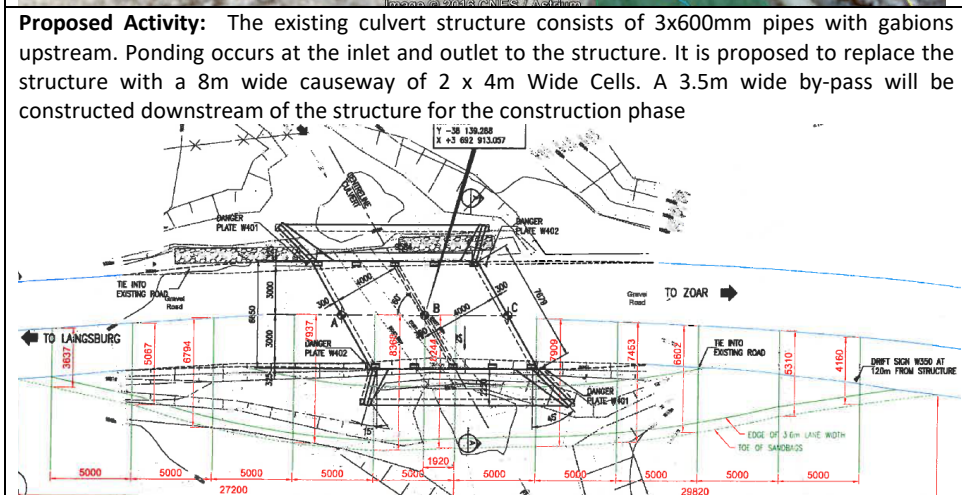
Km 40.9

<p>Proposed Activity: The existing culvert structure consists of 3x600mm pipes with gabions upstream. Ponding occurs at the inlet and outlet to the structure. It is proposed to replace the structure with a 8m wide causeway of 2 x 4m Wide Cells. A 3.5m wide by-pass will be constructed downstream of the structure for the construction phase</p>

<p>Site description: The river at the road crossing flows through a relatively flat landscape. Upstream of the crossing the riparian zone is invaded with invasive alien trees such as poplars and black wattle trees that surround a <i>Phragmites</i> reedbed. Downstream of the river channel consists of a large <i>Phragmites</i> reedbed. The upstream inlet has been stabilised by a low gabion wall.</p> <p>Specific Mitigation measures: Remove invasive alien vegetation (black wattle trees) within or immediately adjacent to the road reserve at the road crossing This site is specifically susceptible to the build up of sediment. The height and size of the culvert structure should ensure that the culverts do not become blocked with sediment on a regular basis. <i>Phragmites</i> reeds may need to be managed to ensure that the structure does not become blocked.</p>

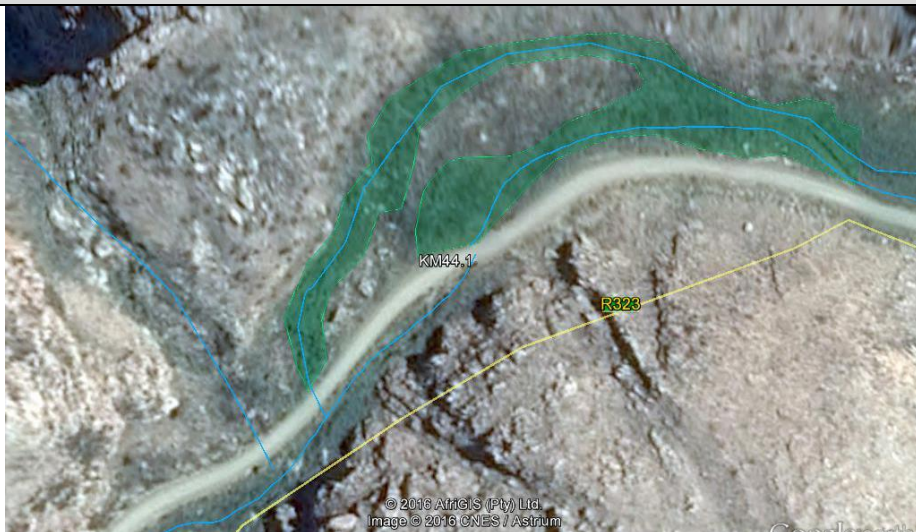
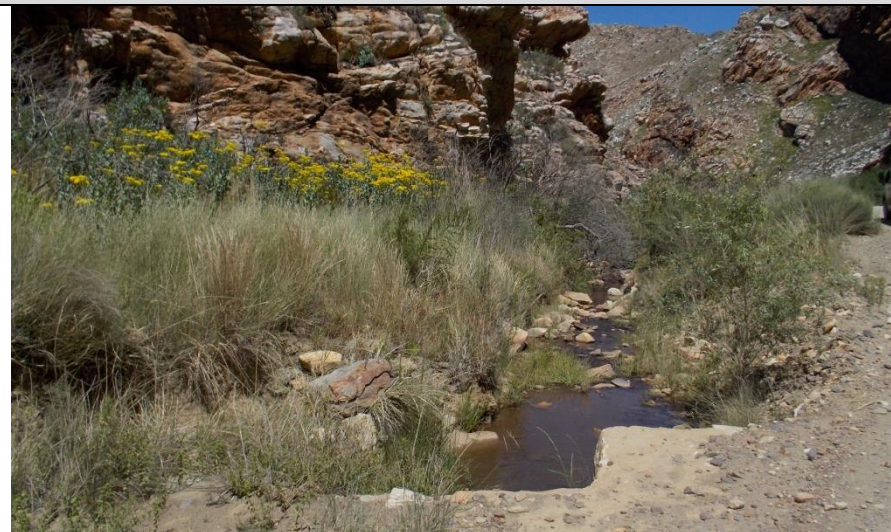
Km 44.1

Proposed Activity: The existing culvert structure consists of 2x600mm encased pipes that are orientated at an acute angle to the road. It is proposed to straighten the crossing by 7m and to replace the culvert structure with a 4m wide causeway. The upstream and downstream wingwalls will need to be extended to protect the banks from erosion. The temporary bypass will be placed downstream of the crossing.

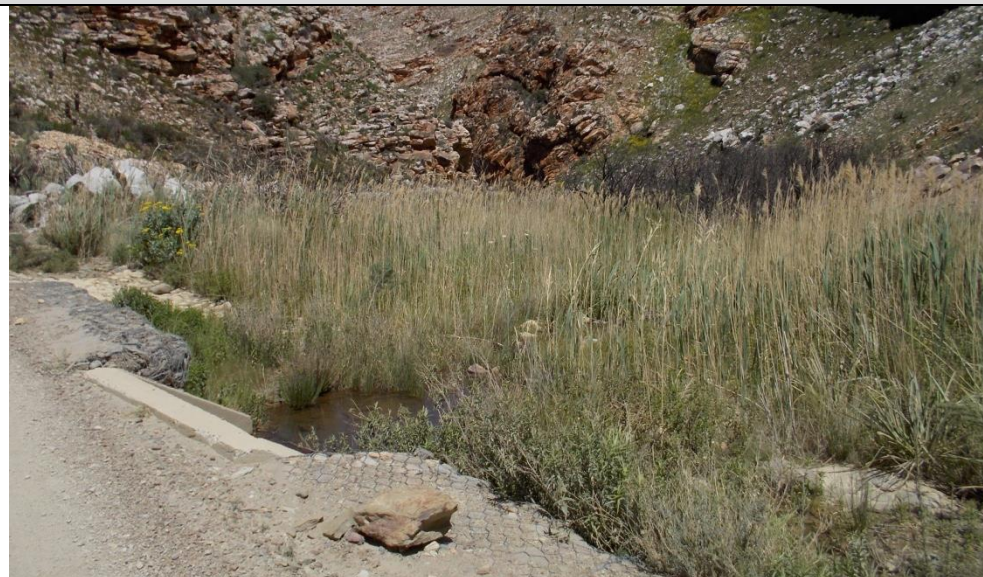
Km 44.3

Proposed Activity: The existing culvert structure consists of 2x600mm encased pipes, with wing walls and apron slabs. The gabions downstream have been damaged. It is proposed to replace the structure with a 6m wide causeway and to remove the gabions. The new structure will be aligned slightly upstream of its current location. A temporary bypass will be placed downstream of the crossing.

Site description: Upstream of the road crossing, the river channel is dominated by *Phragmites* reeds. Downstream of the structure, wetland vegetation such as vleibos (*Cliffortia strobilifera*), fountain bush (*Psoralea affinis*), broom restio (*Calopsis paniculata*), creeping rush (*Juncus lomtophyllus*), vlei sedge *Carpha glomerata*, river pumpkin (*Gunnera perpensa*), taaiblaarmalva (*Pelargonium glutinosum*) and arum lilies (*Zantheschia aethiopica*).

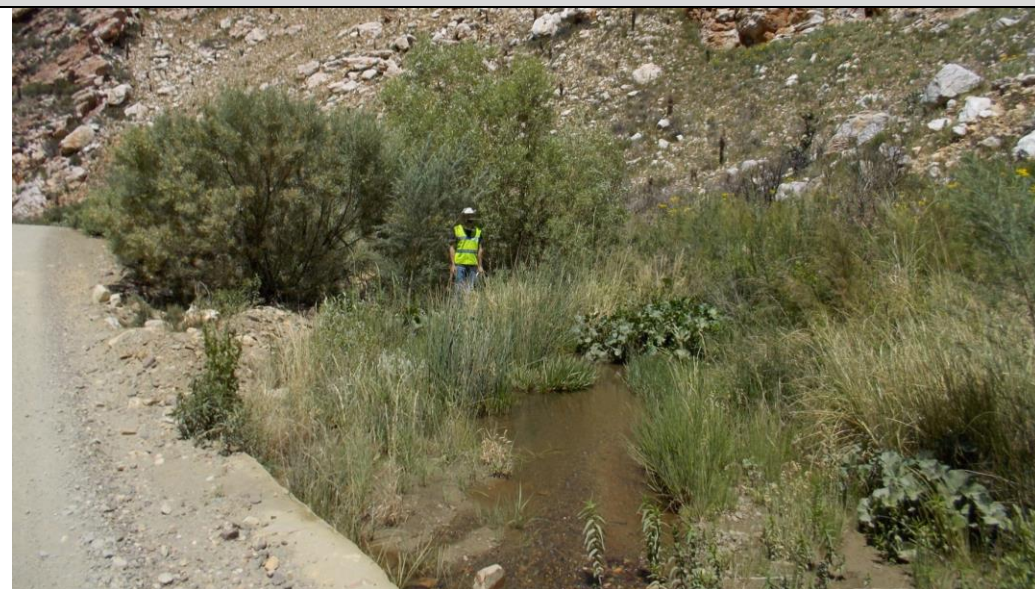
Km 44.7

Proposed Activity: The existing culvert structure consists of 2x600mm encased pipes that have been placed at a low level and been subjected to heavy siltation. The structure has also been placed at a low level. It is to be replaced with a 6m wide causeway. The temporary bypass is to be located on the downstream side of the crossing.

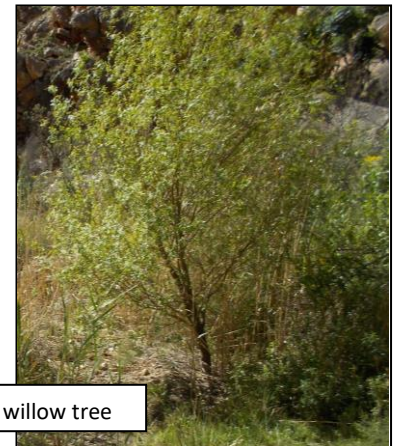
Cape willow tree

The dumped material from previous road repair works should be utilised as far as possible for the construction of the new crossing and the banks shaped to resemble that of the surrounding unimpacted banks. The mature Cape willow trees adjacent to the crossing should be avoided. Ongoing monitoring and clearing of any invasive alien plants within the disturbed areas should take place.

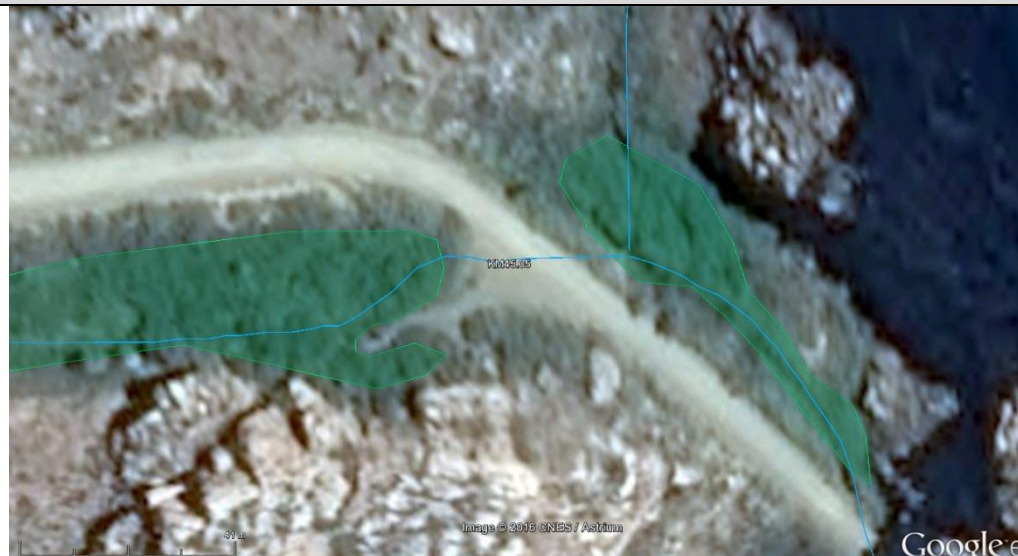
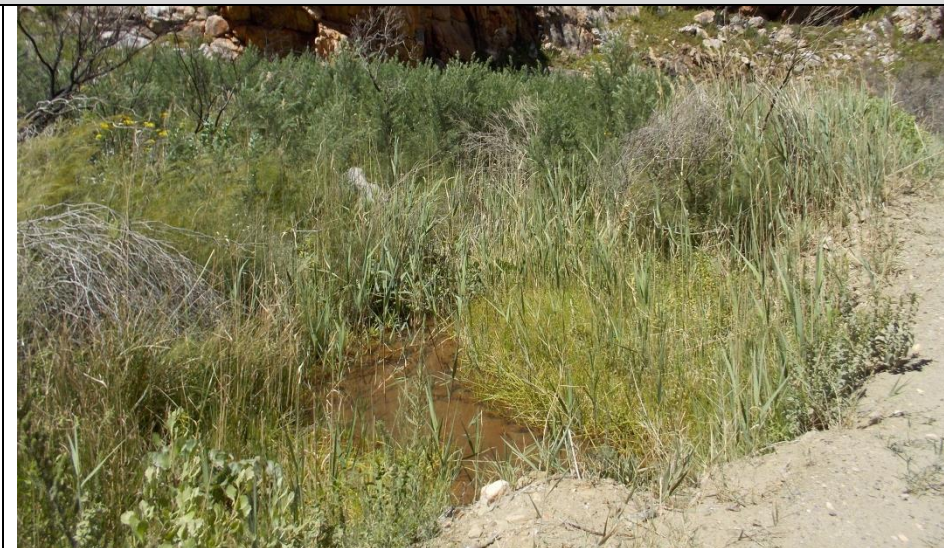
Km 45.05

Proposed Activity: The existing causeway structure consists of 2x600mm encased pipes, grouted stone head walls that have been damaged and the structure has become partially silted up. The structure is to be replaced with a 4m wide causeway. The temporary bypass will be placed upstream of the structure.

Site description: The river channel upstream and downstream of the crossing comprises wetland area with a berm on the upstream side that is the result of past road maintenance activities that was intended to protect the crossing from stormwater runoff. Indigenous vegetation includes Cape willow (*Salix mucronata*), blinktaaibos (*Searsia lucida*), sand olive (*Dodonaea angustifolia*), creeping rush (*Juncus lomotophyllus*), *Isolepis polifera*, broom restio (*Calopsis paniculata*), common reeds (*Phragmites australis*) and the everlasting *Helichrysum cymosum*. Material from past road repair works has been deposited on the upstream bank.

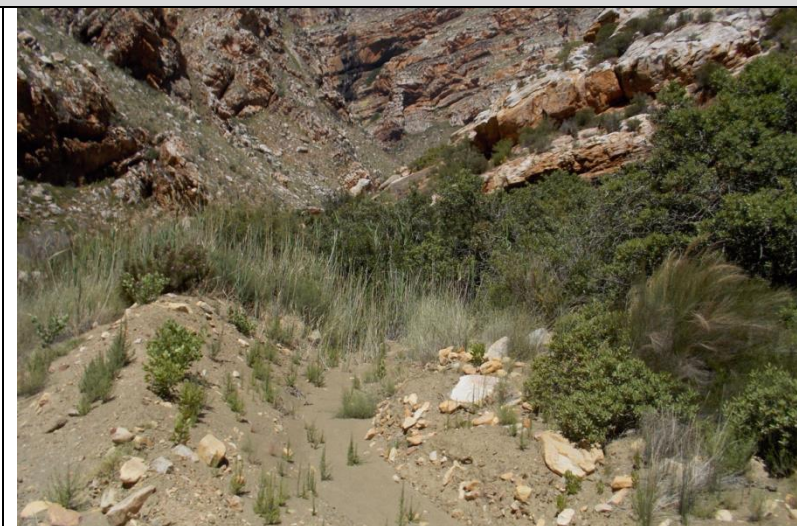
Km 45.1

Proposed Activity: The existing causeway structure consists of 2x600mm encased pipes with stone and concrete head walls upstream. The structure is to be replaced with a 4m wide causeway. The road will be realigned such that it crosses the river approximately 7m upstream of its current location and the temporary bypass will then be placed downstream of the new structure (largely in the location of the current structure).

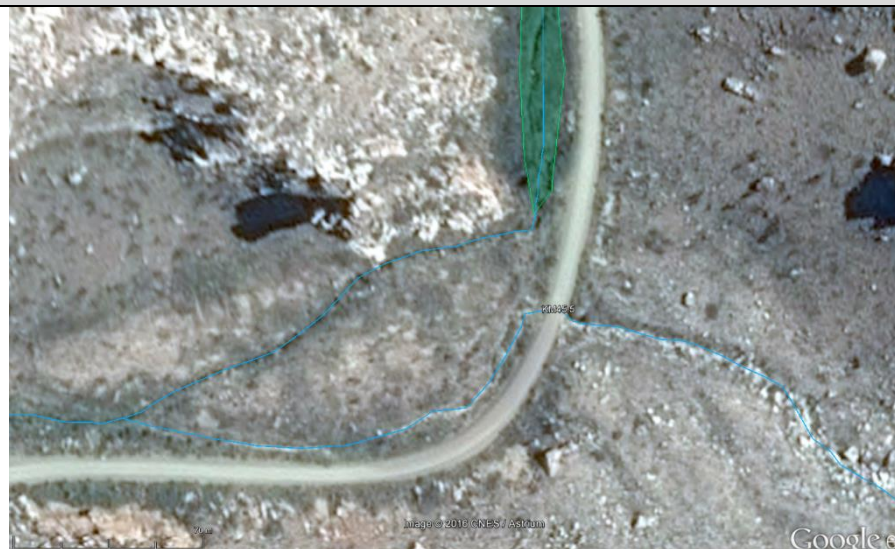
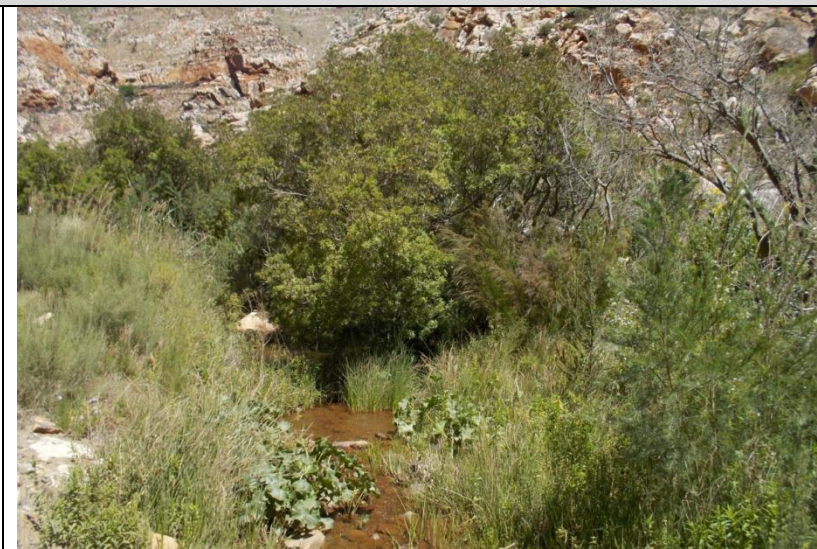
Km 45.5

Proposed Activity: The existing causeway structure consists of 1x600mm pipe. The structure is to be replaced with a 3m wide causeway. A temporary bypass will be placed downstream of the new structure.

Site description: The site consists of the crossing of a tributary of the river that flows down a steep catchment. The vegetation has been burnt and is currently dominated by weedy shrubs the larger riparian shrubs and trees such as the waterwitels (*Brachylaena neriifolia*), blinktaibos (*Searsia lucida*) and Bitou bush (*Chrysanthemoides monilifera* subsp. *rotundata*) are starting to resprout.

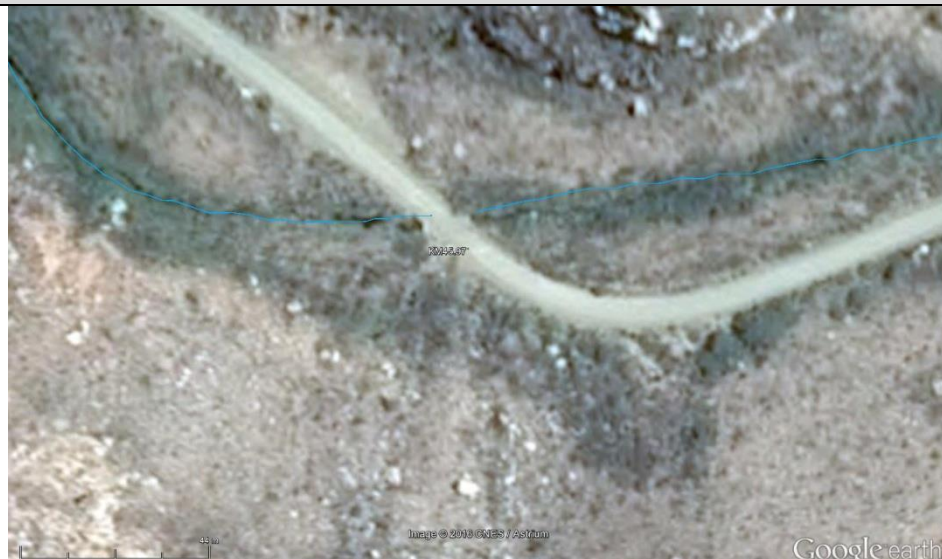
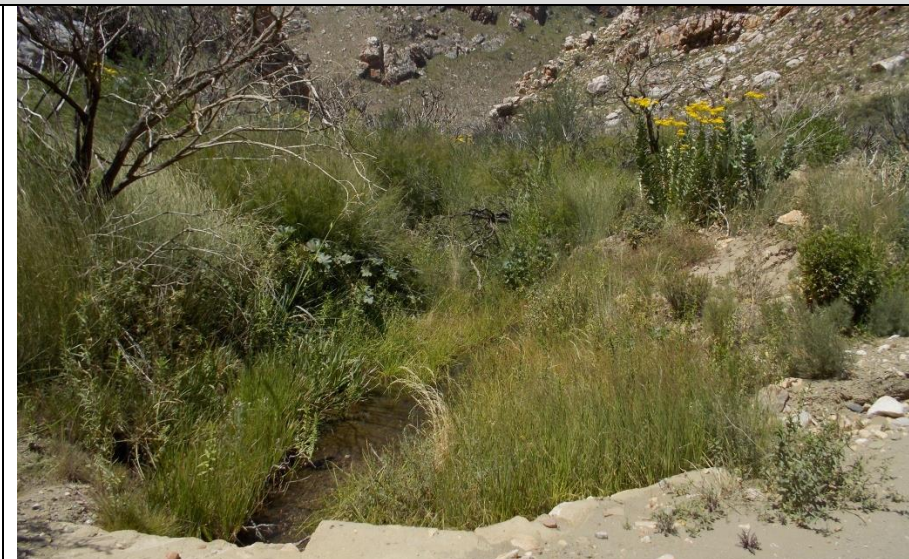
Km 45.97

Proposed Activity: The existing causeway structure consists of 2x600mm encased pipes with stone and concrete head walls at inlet and outlet. The structure is almost completely buried as a result of heavy siltation. The structure is to be replaced with a 4m wide causeway. The temporary bypass will be placed downstream of the structure. The current structure will be shifted slightly upstream.

Site description: The site shows evidence of disturbance and contains weedy shrubs and a berm of material from past road works. Indigenous vegetation includes Cape willow (*Salix mucronata*), bitter aloe (*Aloe ferox*), the sedge *Ficinia nigrescence*, creeping rush (*Juncus lomotophyllus*), broom restio (*Calopsis paniculata*), fountain bush (*Psoralea affinis*), river pumpkin (*Gunnera perpensa*) and wittamarak (*Albuca Canadensis*). Redfin minnow fry and tadpoles were also observed at the site.

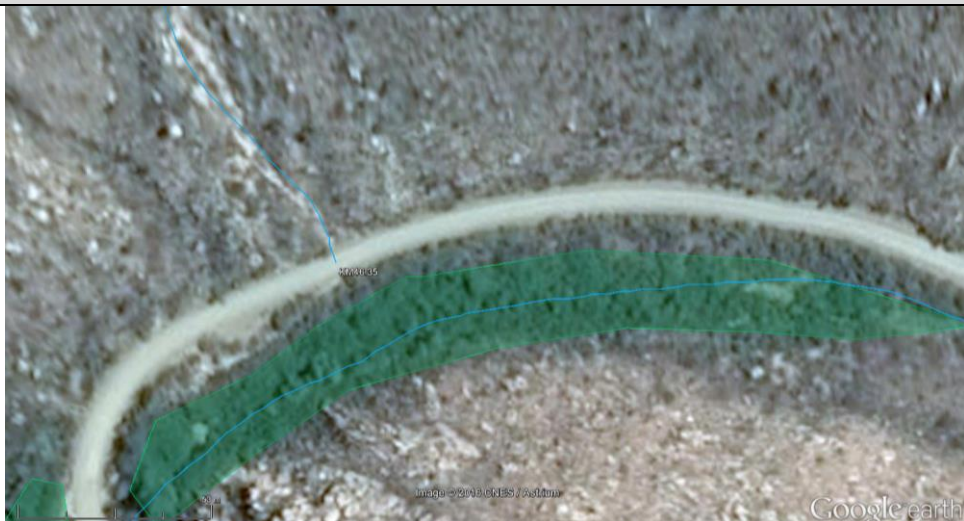
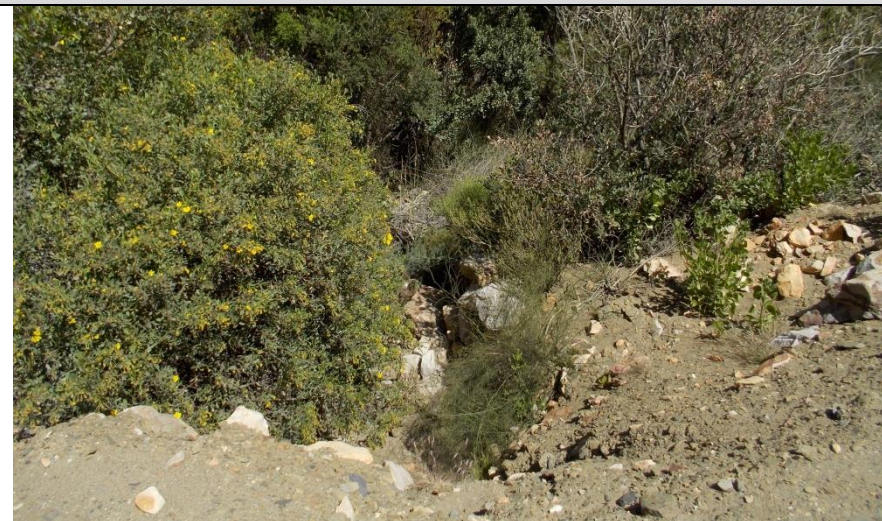
Km 46.35

Proposed Activity: The existing causeway structure consists of 1x600mm encased pipes with a stone head wall upstream. The new proposed structure will consist of a 2m wide causeway with 2x900mm pipe culverts with additional strengthening. The structure will also be stepped to accommodate the drop at the site. The works at the road will be undertaken in half roadwidths as there is no space for a temporary bypass road.

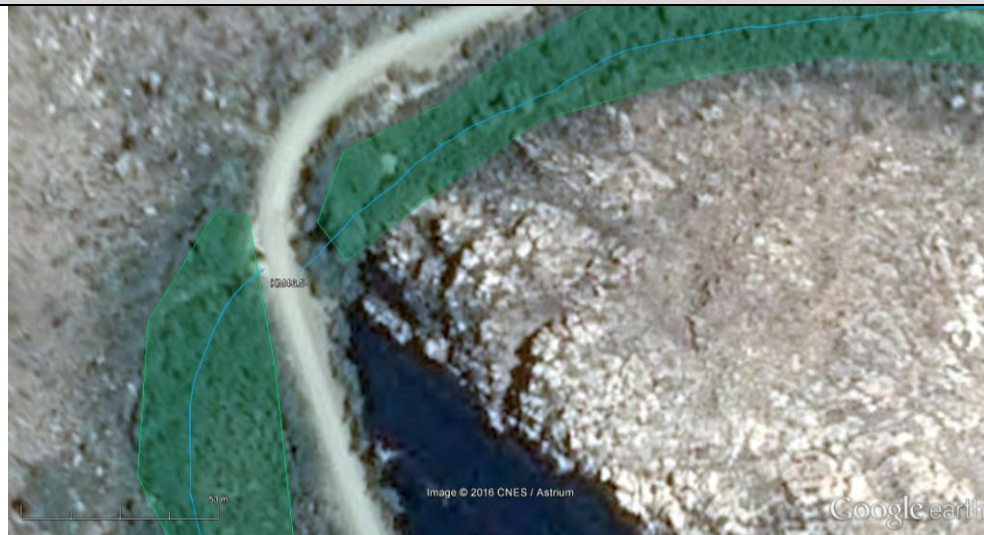
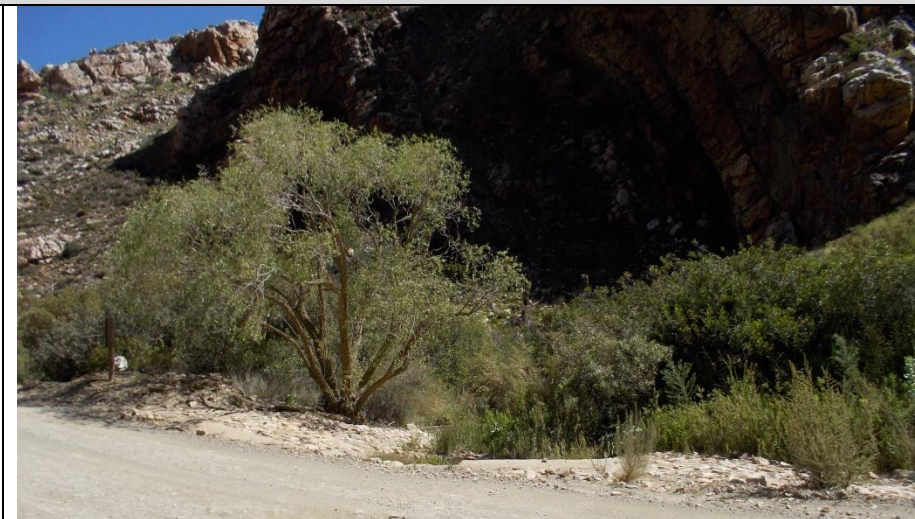
Km 46.5

Proposed Activity: The existing causeway structure consists of 2x600mm encased pipes, with concrete and stone head walls at inlet and outlet and stone pitching aprons. As a result of siltation, the structure is completely buried. The structure is to be replaced with a 6m wide causeway. The road will be shifted slightly downstream and some bedrock will need to be removed. The temporary bypass will be placed upstream of the structure.

Site description: The river channel upstream and downstream of the crossing is somewhat disturbed as a result of past road maintenance activities. Indigenous vegetation includes Cape willow (*Salix mucronata*), blinktaibos (*Searsia lucida*), the sedges, *Mariscus thunbergii* and *Ficinia nigrescence*, creeping rush (*Juncus lomotophyllus*), broom restio (*Calopsis paniculata*), fountain bush (*Psoralea affinis*), taaiblaarmalva (*Pelargonium glutinosum*), river pumpkin (*Gunnera perpensa*) and Bitou bush (*Chrysanthemoides monilifera* subsp. *rotundata*). Material from past road repair works has been deposited on the upstream bank.

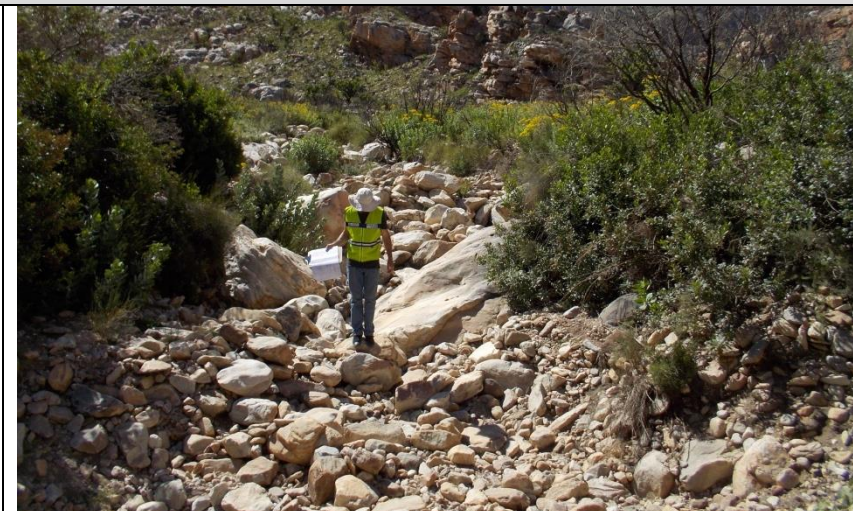
Km 48.00

Proposed Activity: The existing causeway structure consists of 1x900mm pipe with stone head and wing walls and damaged apron slabs both sides. The structure is to be replaced with a 6m wide causeway. The temporary bypass will be placed upstream of the structure.

Site description: The site consists of the crossing of a tributary of the river that flows down a steep catchment and drops steeply at the crossing. The vegetation is minimal with a stream channel dominated by larger boulders. Material from past road repair works has been deposited on both the upstream and the downstream stream banks. The road is located at the point at which the hillslope flattens out.

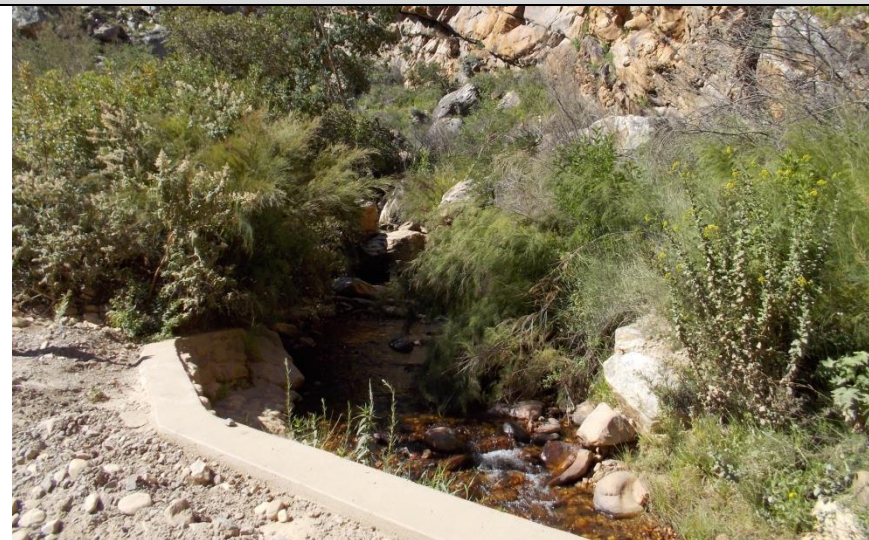
Km 50.1

Proposed Activity: The existing causeway structure consists of 3x600mm encased pipes, with stone head walls at inlet and outlet and stone pitching aprons that are severely damaged. The structure is to be replaced with an 8m wide causeway. Some of the existing structure will remain. The new structure will be constructed as far upstream and possible and the temporary bypass placed downstream of the structure.

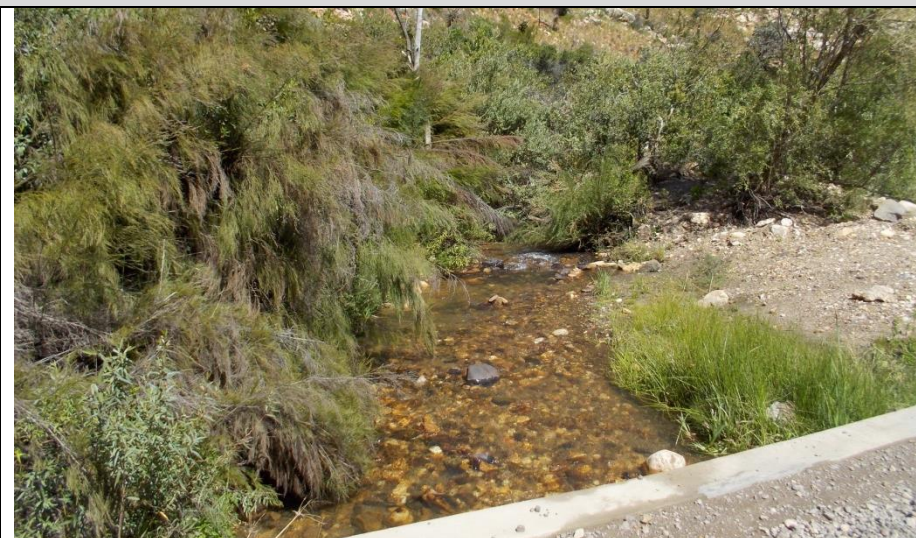
Km 50.3

Proposed Activity: The existing causeway structure consists of 2x900mm encased pipes, with stone head and return walls downstream that have been severely damaged and area silted up. The structure is to be replaced with a 5m wide causeway. The road will be realigned slightly downstream by 2m and the temporary bypass will be placed upstream of the structure.

Site description: The river channel upstream and downstream of the crossing is somewhat disturbed as result of past road maintenance activities. Indigenous vegetation includes the sedge *Ficinia nigrescence*, creeping rush (*Juncus lomotophyllus*), bostolbos (*Diospyros dichrophylla*), keurbroom (*Virgilia divaricata*), broom restio (*Calopsis paniculata*) and sagewood (*Buddleja salviifolia*). Material from past road repair works has been heaped within the site.

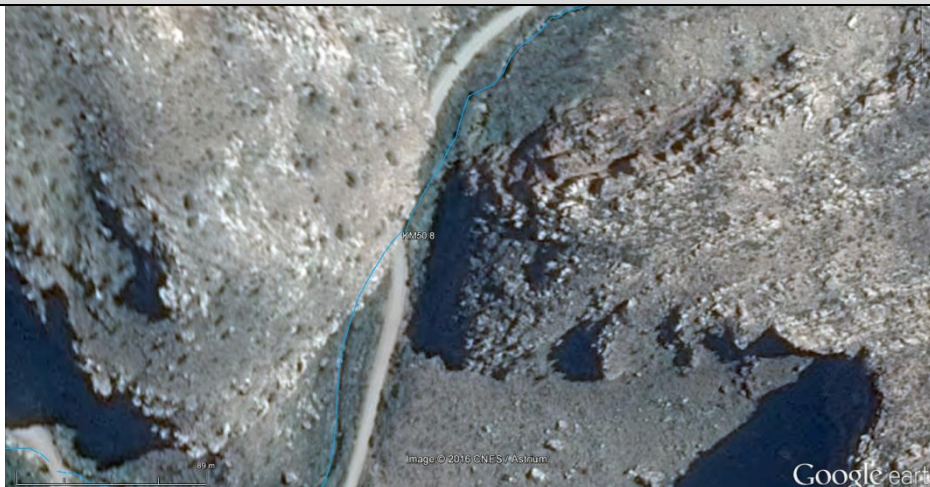
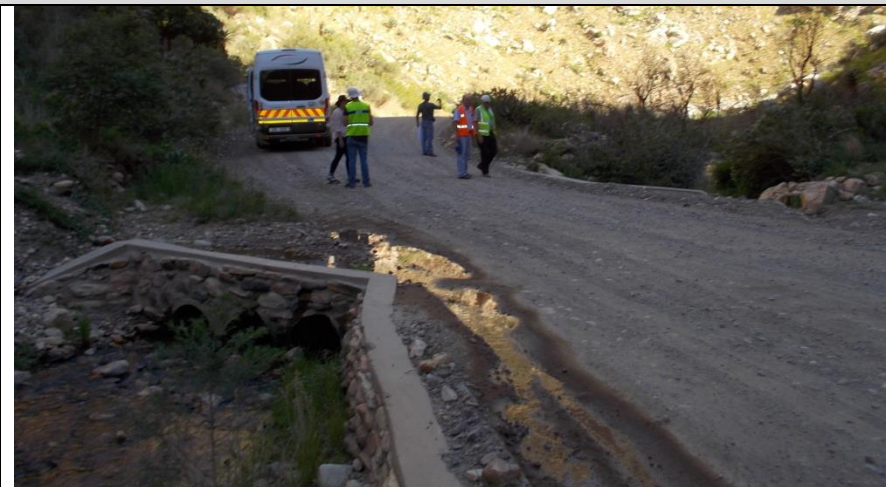
Km 50.8

Proposed Activity: The existing causeway structure consists of 3x600mm encased pipes, with stone head and return walls at inlet and outlet that have been severely damaged and are silted up. The structure is to be replaced with a 6m wide causeway. The road will be realigned slightly upstream and the temporary bypass will be placed downstream of the structure. It is also proposed to straighten the crossing slightly.

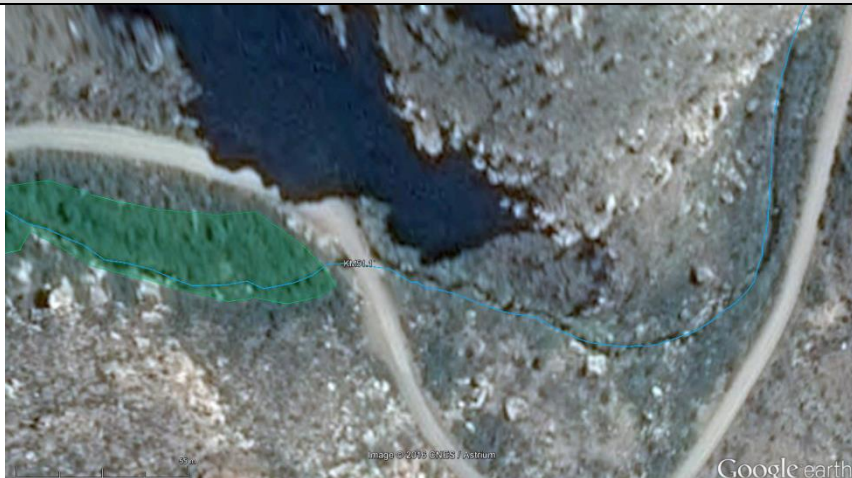
Km 51.1

Proposed Activity: The existing causeway structure consists of 2x900mm encased pipes, with stone head walls at inlet and outlet that are severely damaged by the large boulders that are abundant in the river. The structure is to be replaced with a 6m wide causeway. The structure will be realigned slightly upstream and the temporary bypass will be placed downstream of the structure.

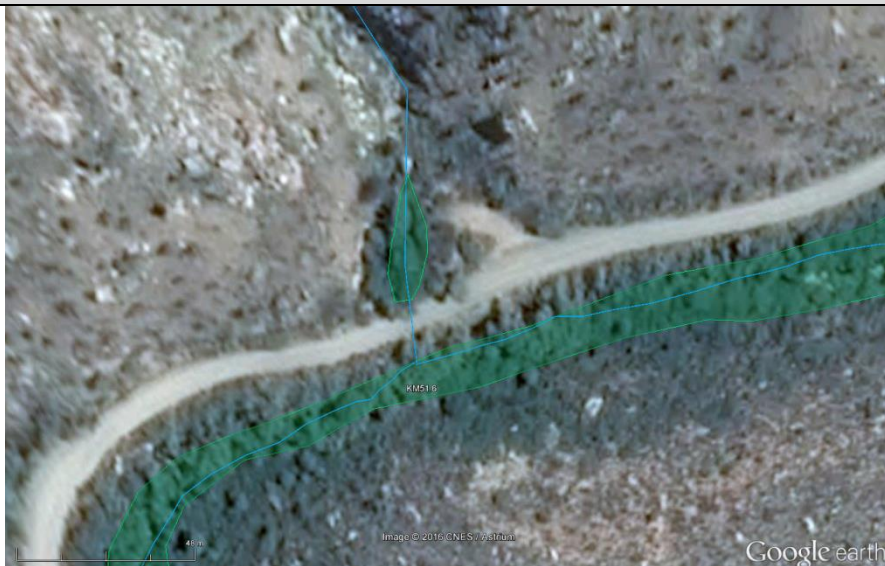
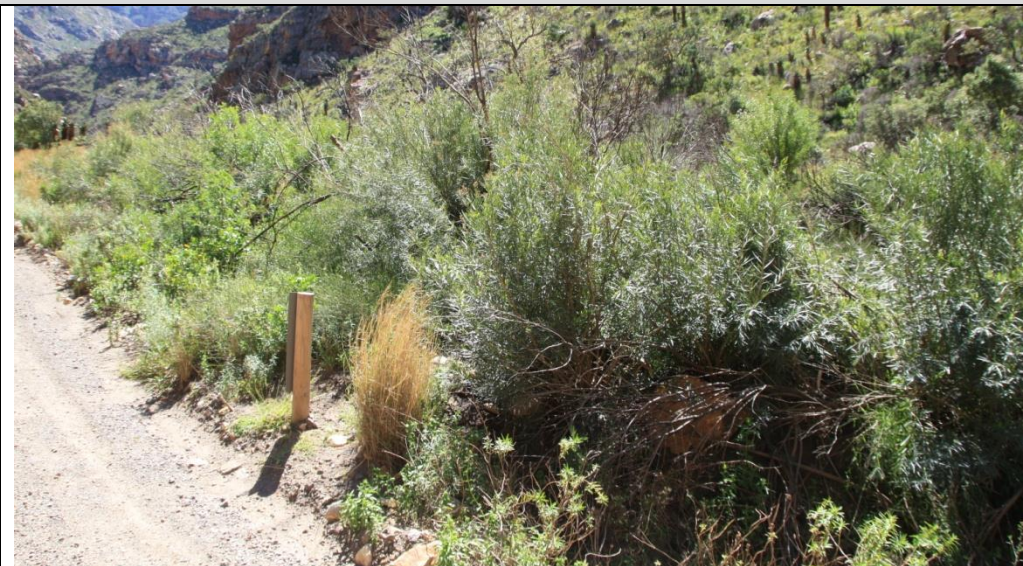
Km 51.6

Proposed Activity: The river is blocked by a fallen tree that has resulted in an eroded bank and under-scouring of the road. A 30m concrete or gabion wall is proposed. The wall will be placed at the edge of the road reserve.

Site description: The river is located alongside the road in a relatively narrow part of the valley. The riparian zone of the river consists of large riparian trees. Indigenous vegetation includes Cape willow (*Salix mucronata*), honey bells (*Freylinia lanceolata*), keurboom (*Virgilia divaricata*), kiepersol (*Cussonia spicata*) and broom restio (*Calopsis paniculata*).

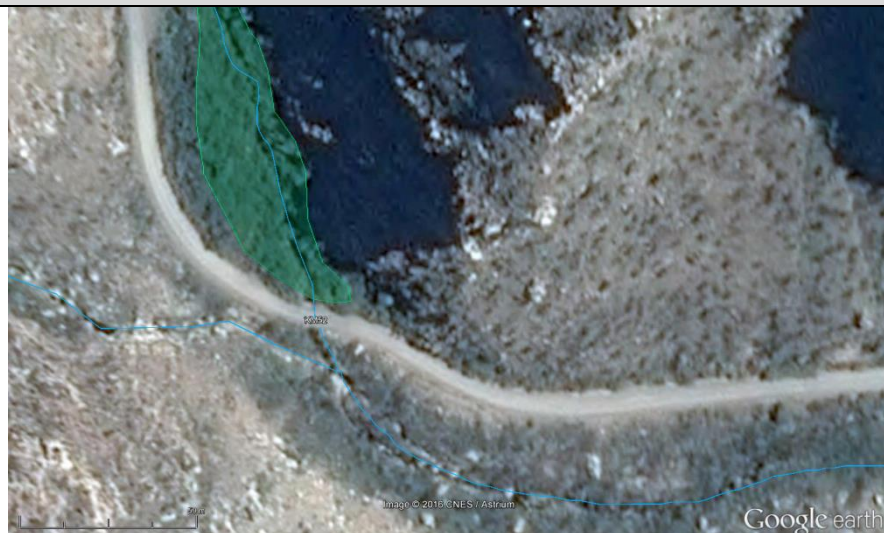
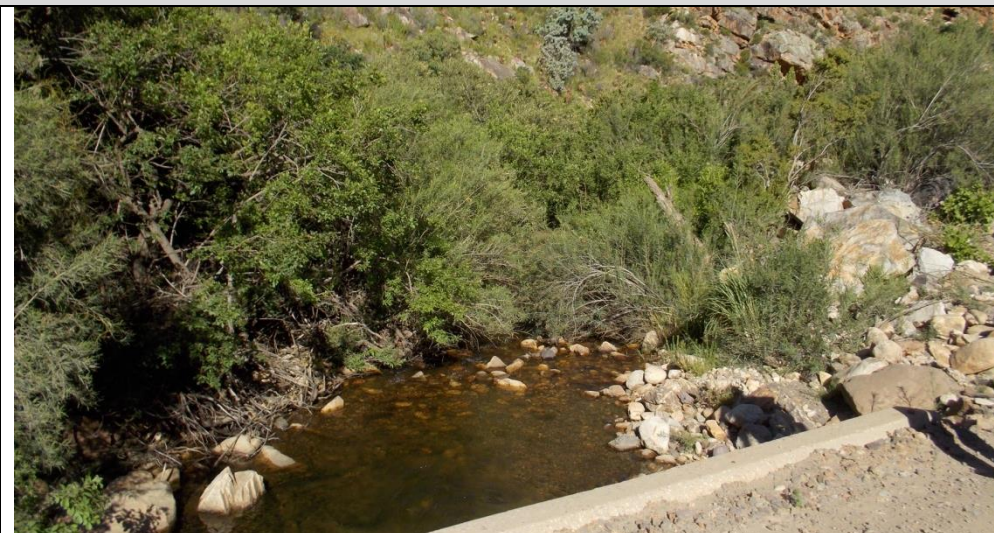
Km 52.0

Proposed Activity: The existing causeway structure consists of 2x900mm encased pipes, with stone head walls at inlet and outlet that are severely damaged by the large boulders that are abundant in the river. The structure is to be replaced with a 6m wide causeway. The temporary bypass will be placed downstream of the structure.

Site description: The river channel upstream and downstream of the crossing is somewhat disturbed as result of past road maintenance activities. Indigenous vegetation includes Cape willow (*Salix mucronata*), keurboom (*Virgilia divaricata*), kiepersol (*Cussonia spicata*), blinktaibos (*Searsia lucida*), broom restio (*Calopsis paniculata*), fountain bush (*Psoralea affinis*), common reeds (*Phragmites australis*) and sagewood (*Buddleja salviifolia*). Material from past road repair works has been deposited on the upstream bank.

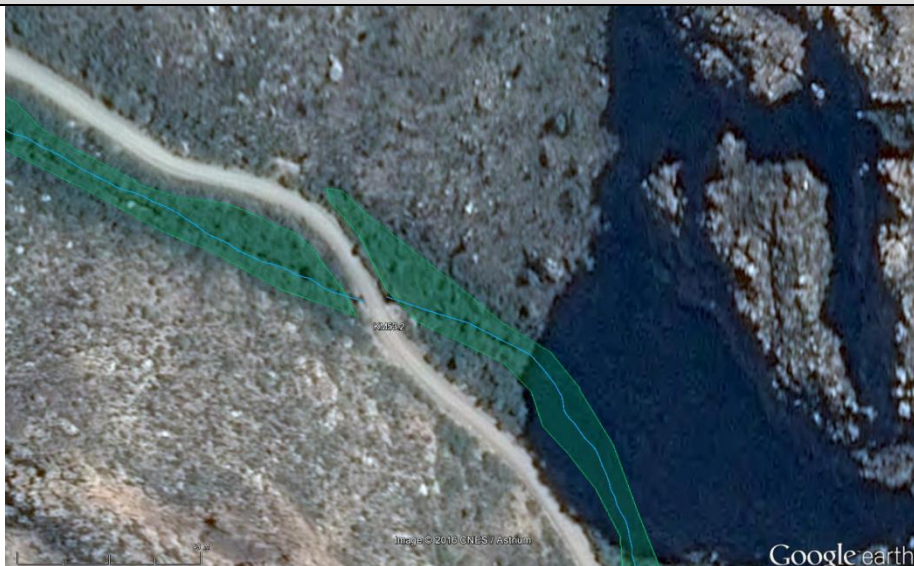
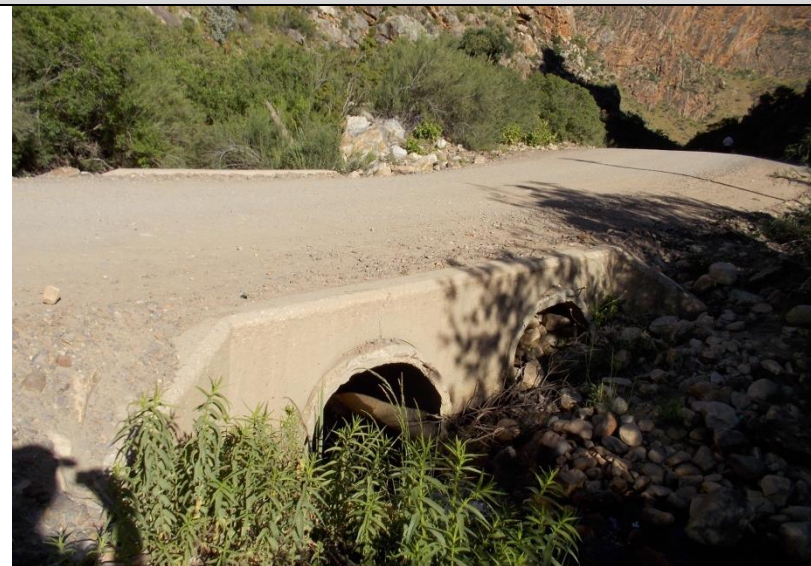
Km 53.2

Proposed Activity: The existing causeway structure consists of 2x900mm encased pipes, with upstream and downstream protection works. Scouring of the structure has taken place. The structure is to be replaced with a 6m wide causeway. The structure will be moved slightly upstream and the temporary bypass placed upstream of the structure.

Site description: The river channel upstream and downstream of the crossing is somewhat disturbed as result of past road maintenance activities. Indigenous vegetation includes honey bells (*Freylinia lanceolata*), keurboom (*Virgilia divaricata*), Cape Holly (*Ilex mitis*), taaibos (*Searsia laevigata*), wildedagga (*Leontotis loenurus*), *Isolepis prolifera* and palmiet (*Prionium serratum*).
