FRESHWATER ASSESSMENT FOR THE PROPOSED FLOOD DAMAGE REPAIRS TO STRUCTURES ON MR309 IN SEWEWEEKSPOORT PASS

DECEMBER 2016

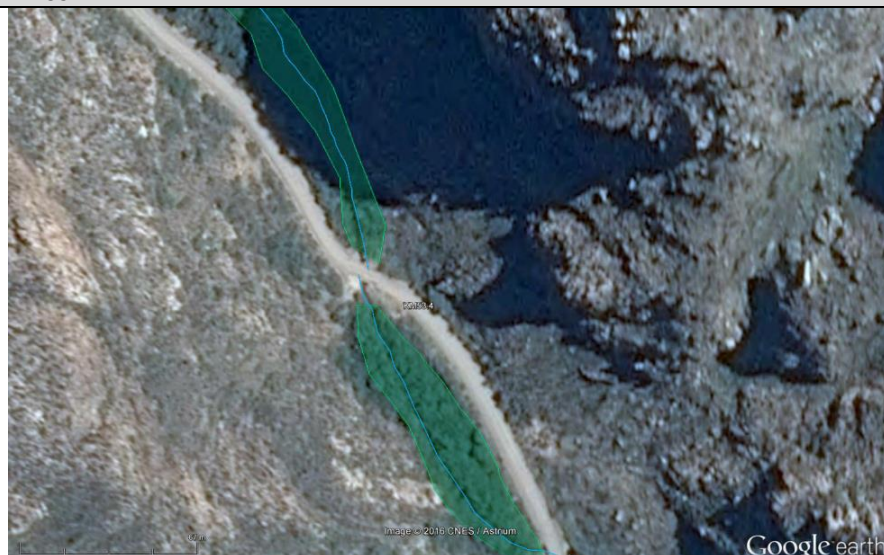
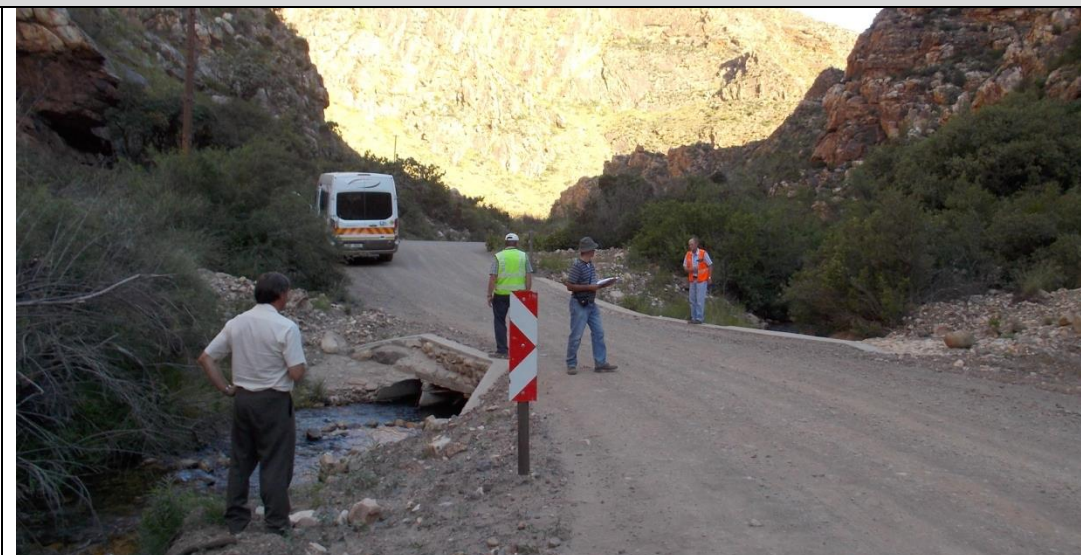
Km 53.4

Proposed Activity: The existing causeway structure consists of 2x600mm encased pipes, with head walls at the outlet that are mostly buried and have been almost completely destroyed. As a result of siltation, the structure is completely buried. The structure is to be replaced with a 6m wide causeway. The road will be shifted slightly upstream and the temporary bypass will be placed downstream of the structure.

Site description: The river channel upstream and downstream of the crossing is somewhat disturbed and cleared as result of past road maintenance activities. Indigenous vegetation includes keurboom (*Virgilia divaricata*), Cape honey bells (*Freylinia lanceolata*), taaibos (*Searsia laevigata*), the sedge *Isolepis prolifera*, creeping rush (*Juncus lomotophyllus*), broom restio (*Calopsis paniculata*), fountain bush (*Psoralea affinis*) and bostolbos (*Diospyros dichrophylla*). Material from past road repair works has been deposited on the river banks.

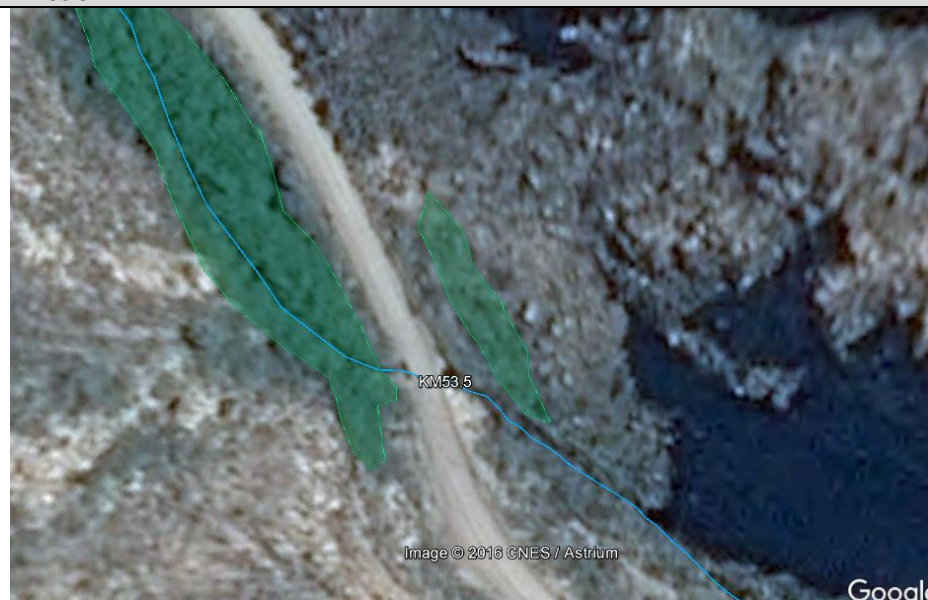
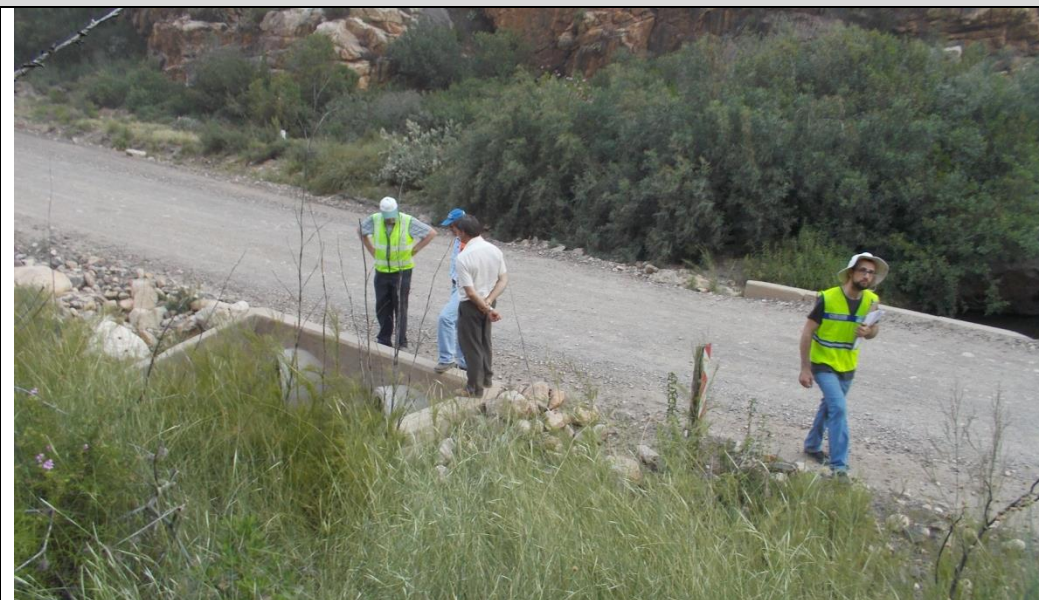
Km 53.5

Proposed Activity: The existing causeway structure consists of 2x900mm encased pipes, with concrete protection works at inlet and outlet. Severe scouring has taken place at the structure. The structure is to be replaced with a 6m wide causeway. The road will be shifted slightly upstream and some of the downstream bank will need to be removed. The temporary bypass will be placed downstream of the structure.

Site description: The river channel upstream and downstream of the crossing has been disturbed as result of past road maintenance activities. Indigenous vegetation includes keurboom (*Virgilia divaricata*), Cape honey bells (*Freylinia lanceolata*), taaibos (*Searsia laevigata*), broom restio (*Calopsis paniculata*), fountain bush (*Psoralea affinis*) and bostolbos (*Diospyros dichrophylla*). Material from past road repair works has been deposited on the upstream bank.

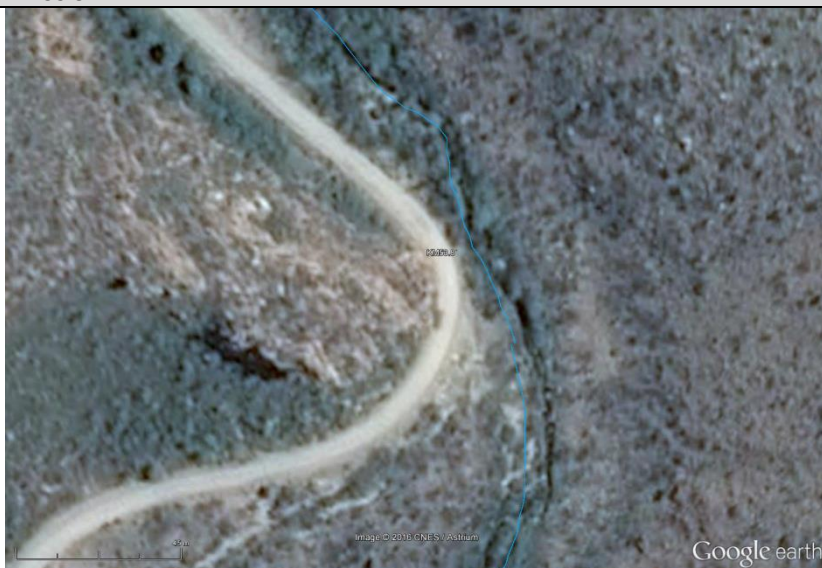
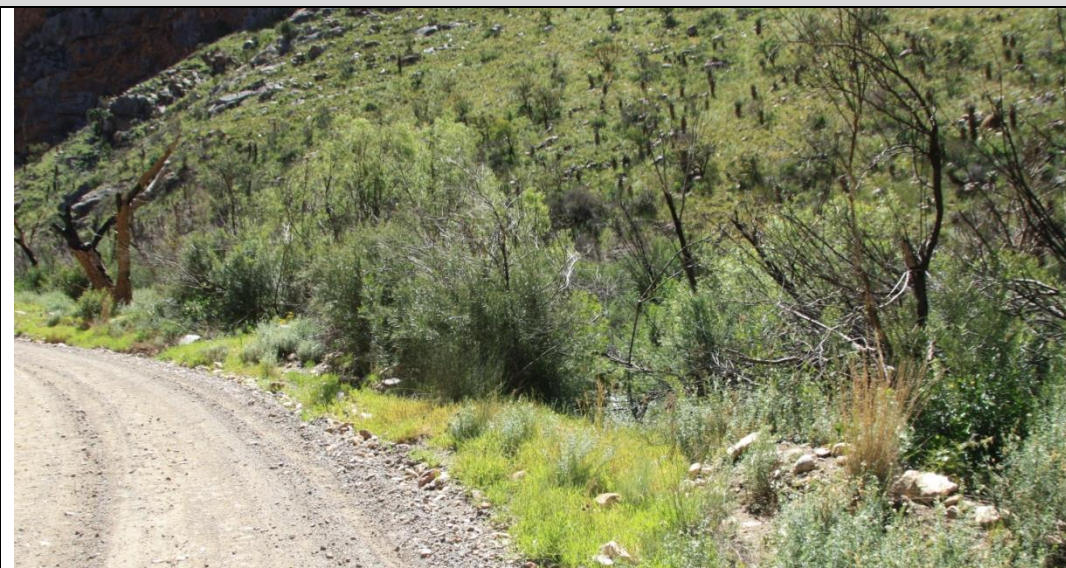
Km 53.8

Proposed Activity: The road way gets flooded by the river that washes the road material away completely during floods. It is proposed to construct a 100m long concrete retaining wall.

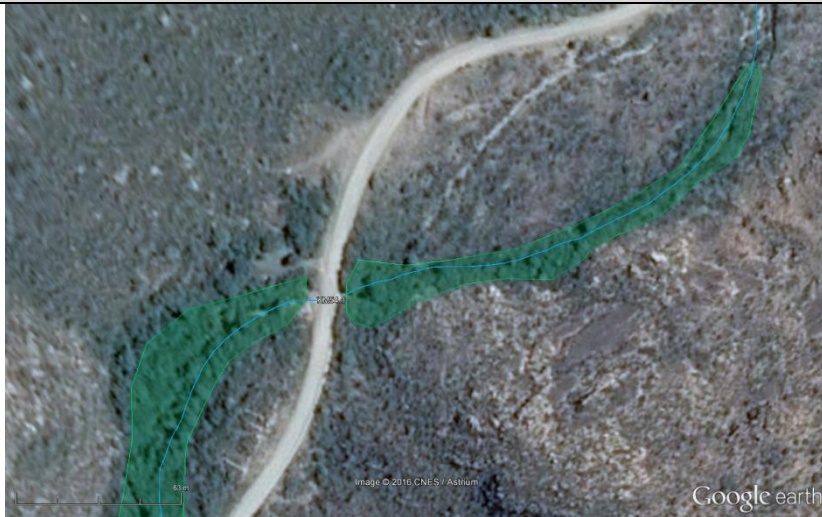
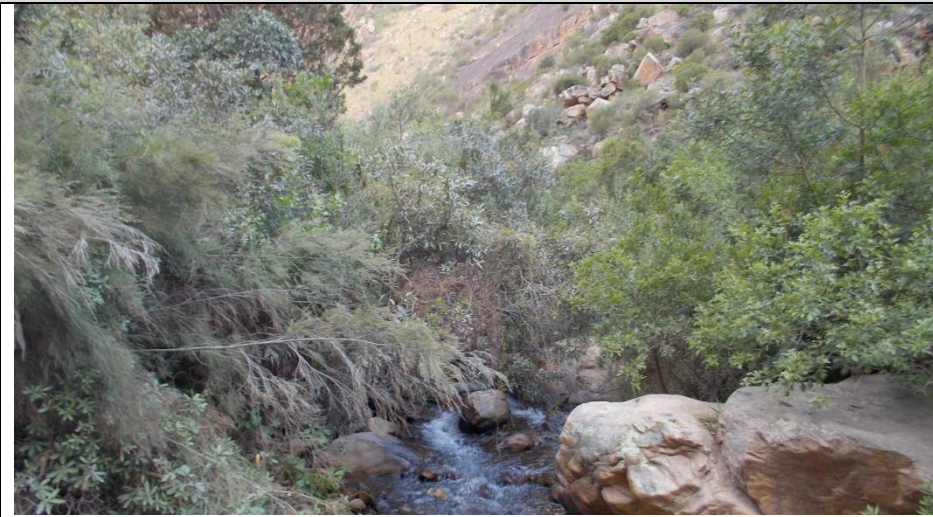
Km 54.1

Proposed Activity: The existing causeway structure consists of 2x900mm encased pipes, with stone head walls at inlet and outlet that have been damaged by boulders that are abundant in the river. The structure is to be replaced with a 6m wide causeway. The temporary bypass will be placed downstream of the structure.

Site description: The river channel upstream and downstream of the crossing has been disturbed as result of past road maintenance activities. Indigenous vegetation includes Cape honey bells (*Freylinia lanceolata*), silky bark (*Maytenus acuminata*), keurboom (*Virgilia divaricata*), wild olive (*Olea europaea* subsp. *africana*), sand olive (*Dodonaea angustifolia*), taabos (*Searsia laevigata*), the sedge, *Mariscus thunbergii* and broom restio (*Calopsis paniculata*).

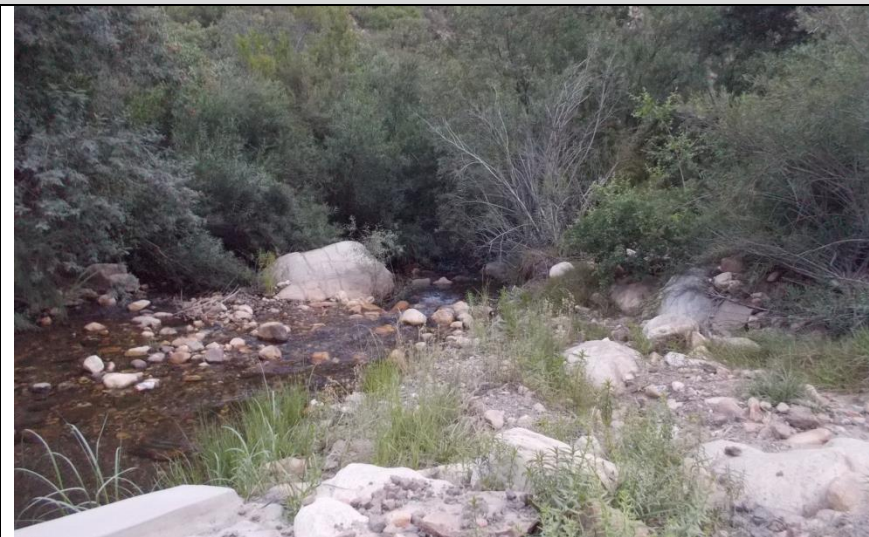
Km 54.3 and 54.4

Proposed Activity: The existing causeway structure consists of 2x900mm encased pipes, with stone head walls at inlet and outlet that have been damaged by boulders that are abundant in the river. The road way gets flooded by the river that washes the road material away completely during floods. It is proposed to construct a 350m long concrete retaining wall and a 6m wide causeway. The new structure will be placed slightly upstream of the existing structure and the temporary bypass will be placed downstream of the structure.

Routine monitoring of the structure should be undertaken to ensure that it does not become blocked with larger boulders. Ongoing monitoring and clearing of any invasive alien plants within the disturbed areas should also take place.

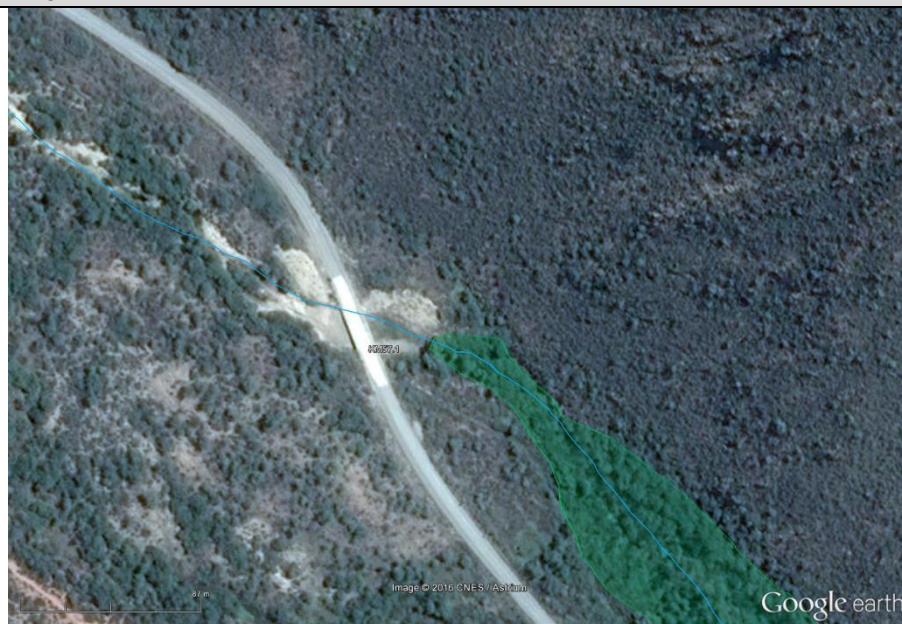
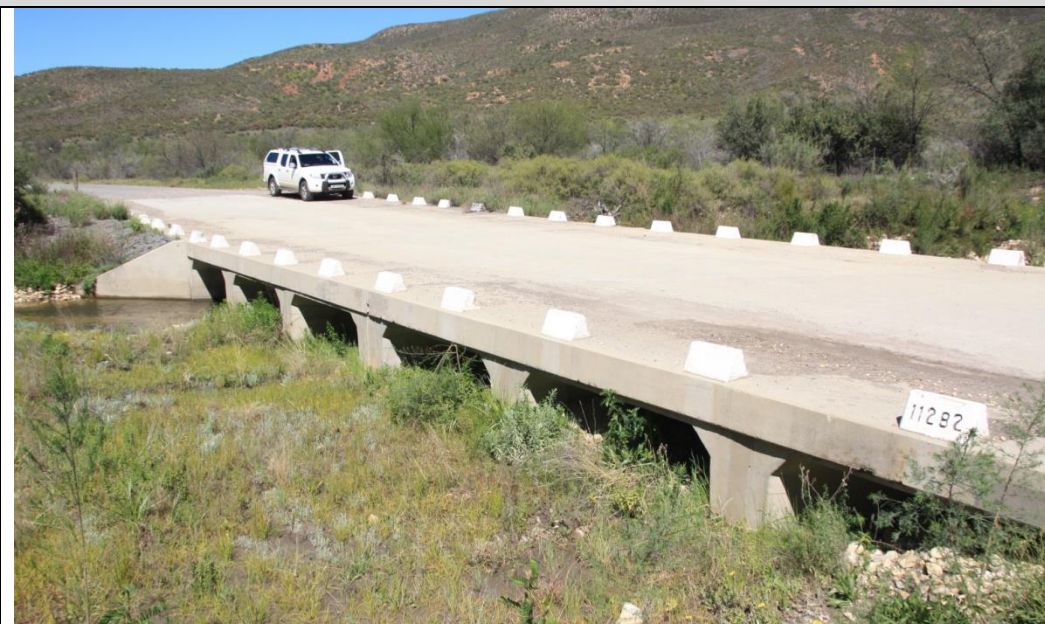
Km 57.1

Proposed Activity: The existing causeway structure consists of 57m long causeway with 6x2.4m openings with a 500mm thick slab, aprons and wing walls. Four openings area completely blocked with rocks and only 2 openings area clear. It is proposed to drop the inlet and realign the river. The temporary bypass will be placed upstream of the structure.

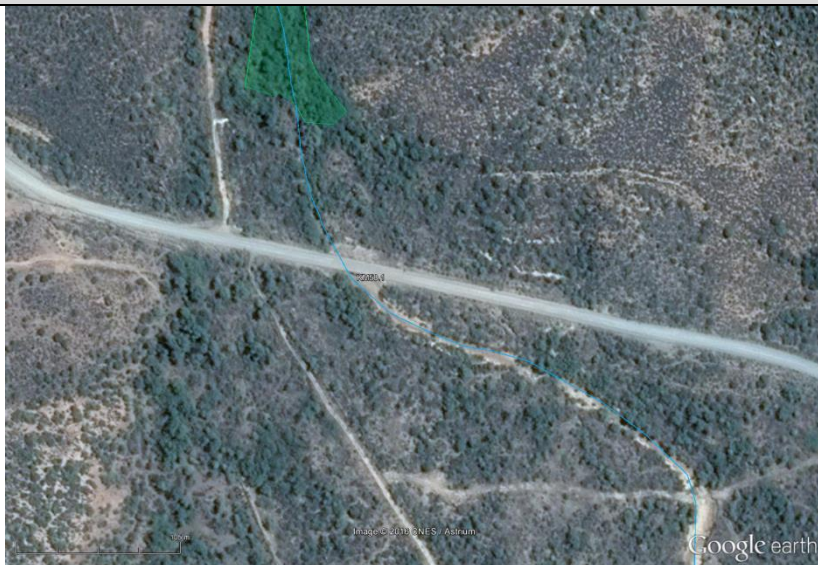
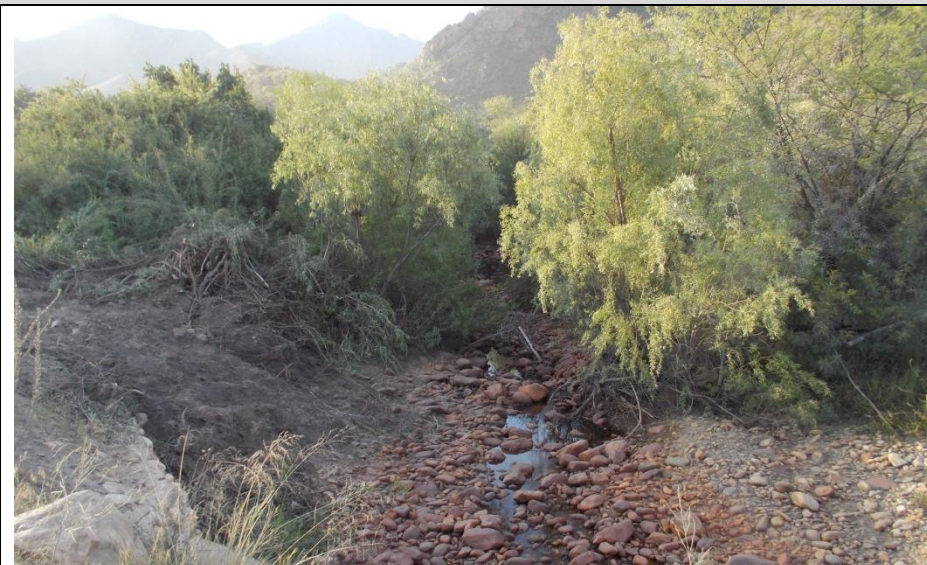
Km 58.1

Proposed Activity: The existing causeway structure consists of 1x1.9m W causeway with 750mm pipe down steam, broken apron slabs and downstream return walls. The structure is to be replaced with a 6m wide causeway. The temporary bypass will be placed upstream of the structure.

Site description: The river channel upstream and downstream of the crossing has been significantly disturbed and cleared of vegetation as result of recent road maintenance activities. Indigenous vegetation includes Cape willow (*Salix mucronata*), keurboom (*Virgilia divaricata*), sweet thorn (*Acacia karoo*), taibos (*Searsia laevigata*) and and bostolbos (*Diospyros dichrophylla*). There is a high flow bypass channel that has been constructed on the eastern bank of the river.
