SUPPLEMENTARY WATER USE INFORMATION

Section 21(c) and (i) Water Uses

1.1 Locality *1.1.1. Description of the location of the watercourse:*
The main freshwater features in the study area consist of the Seweweekspoort River, its tributaries within the pass and its associated valley bottom wetland area. The Seweweekspoort River is a tributary of the Kobus River, as tributary of the Gamka River in the Gouritz River System. The Seweweekspoort River is largely contained within the Klein Swartberg Mountains and is still in a largely natural ecological state. Only once the river exits the pass does it become modified by the surrounding agricultural activities. The Seweweekspoort pass was used by earlier farmers to access the Great Karoo from the south. It is approximately 17km long and in many places is only broad enough for the stream to pass through. In 1859 it was decided that a pass should be built through the poort. The early part of the work was done by 108 convicts, without the presence of a road engineer. In 1860 A G de Smidt, brother-in-law of Thomas Bain, continued and 11 of the 17km was completed. The road was finally completed in November 1962. The road crosses the river 23 t

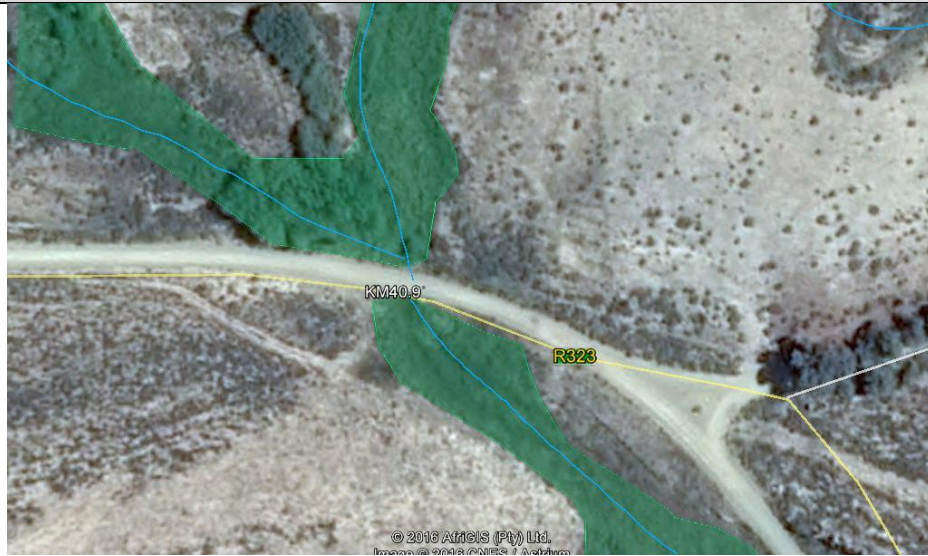
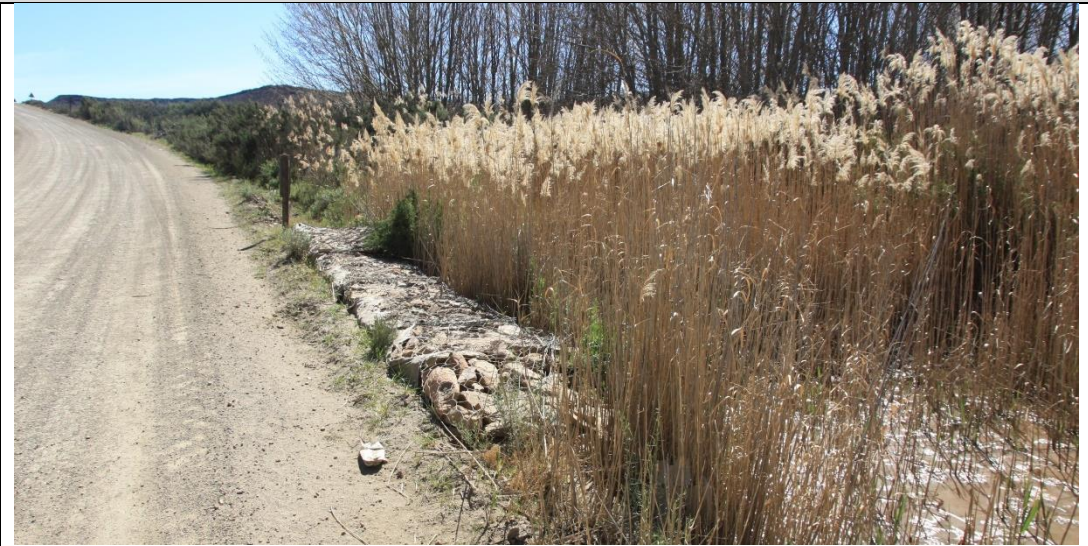
Km 40.9

Proposed Activity: The existing culvert structure consists of 3x600mm pipes with gabions upstream. Ponding occurs at the inlet and outlet to the structure. It is proposed to replace the structure with a 8m wide causeway of 2 x 4m Wide Cells. A 3.5m wide by-pass will be constructed downstream of the structure for the construction phase

Site description: The river at the road crossing flows through a relatively flat landscape. Upstream of the crossing the riparian zone is invaded with invasive alien trees such as poplars and black wattle trees that surround a *Phragmites* reedbed. Downstream of the river channel is consists of a large *Phragmites* reedbed. The upstream inlet has been stabilised by a low gabion wall.

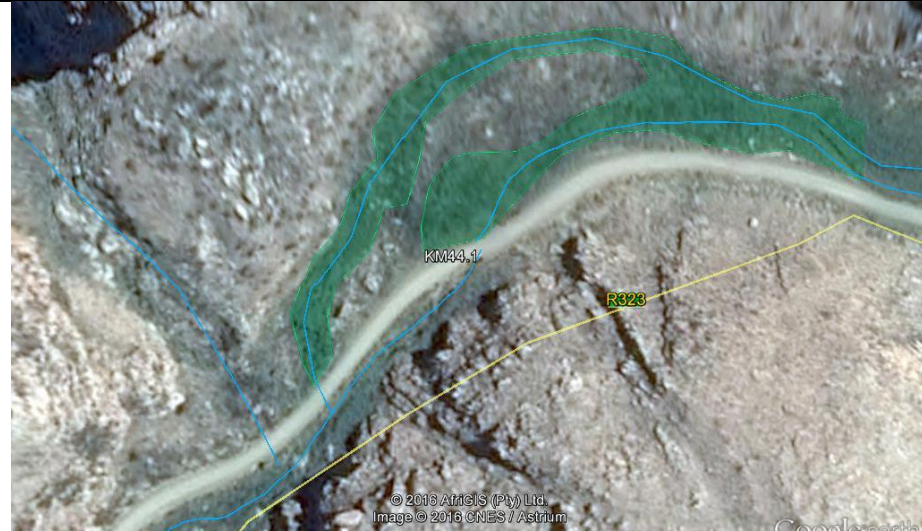
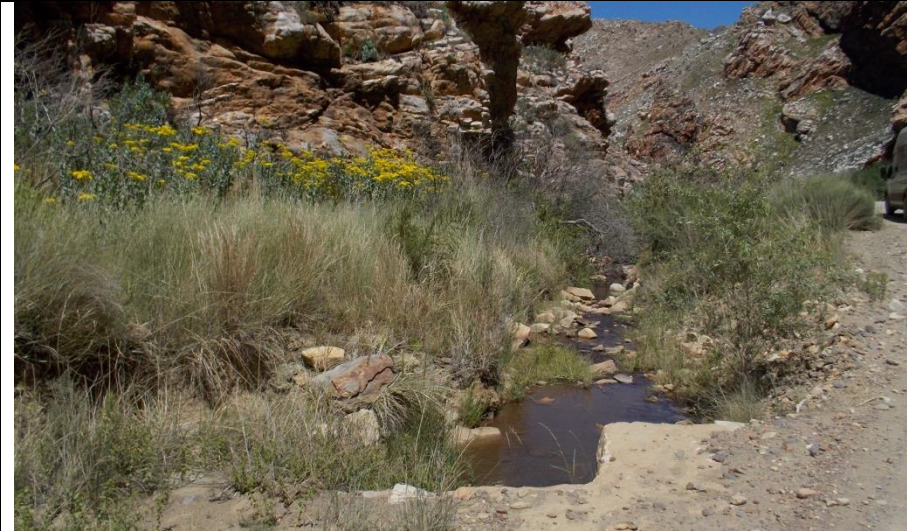
Km 44.1

Proposed Activity: The existing culvert structure consists of 2x600mm encased pipes that are orientated at an acute angle to the road. It is proposed to straighten the crossing by 7m and to replace the culvert structure with a 4m wide causeway. The upstream and downstream wingwalls will need to be extended to protect the banks from erosion. The temporary bypass will be placed downstream of the crossing.

Site description: Upstream of the road crossing the channel is located along the road and consists of wetland vegetation such as broom restio (*Calopsis paniculata*), river pumpkin (*Gunnera perpensa*) and arum lilies (*Zantheschia aethiopica*) together with Cape willows (*Salix mucronata*). Downstream of the crossing the river is contained within a narrow channel with grassed banks. This upper section of the river channel within the pass has recently burnt, with most of the larger riparian trees being significantly burnt.

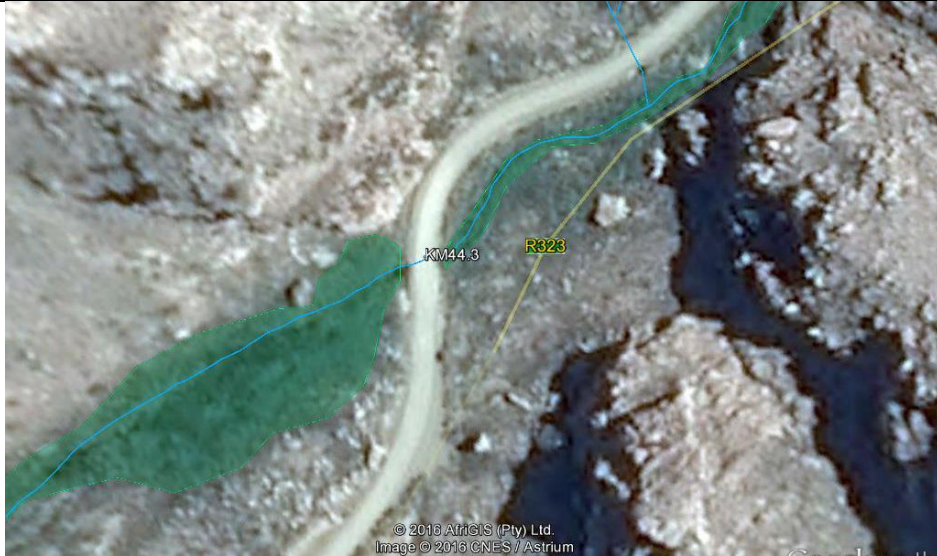
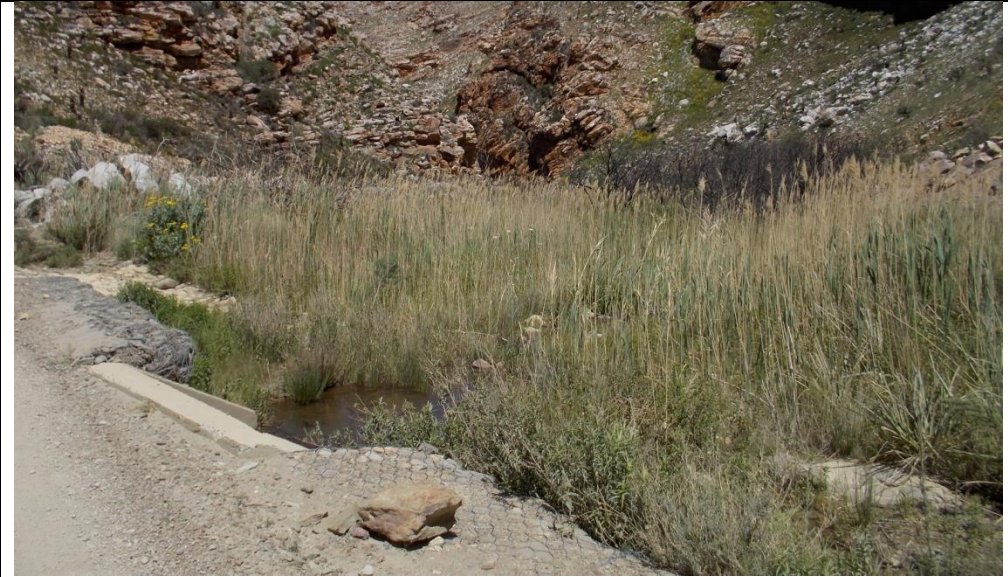
Km 44.3

Proposed Activity: The existing culvert structure consists of 2x600mm encased pipes, with wing walls and apron slabs. The gabions downstream have been damaged. It is proposed to replace the structure with a 6m wide causeway and to remove the gabions. The new structure will be aligned slightly upstream of its current location. A temporary bypass will be placed downstream of the crossing.

The material from the removed gabion structures and any rock that needs to be broken should be removed from the river channel and utilised for reshaping of the river banks or elsewhere in the construction works. The baselevel of the river channel should not be significantly altered.

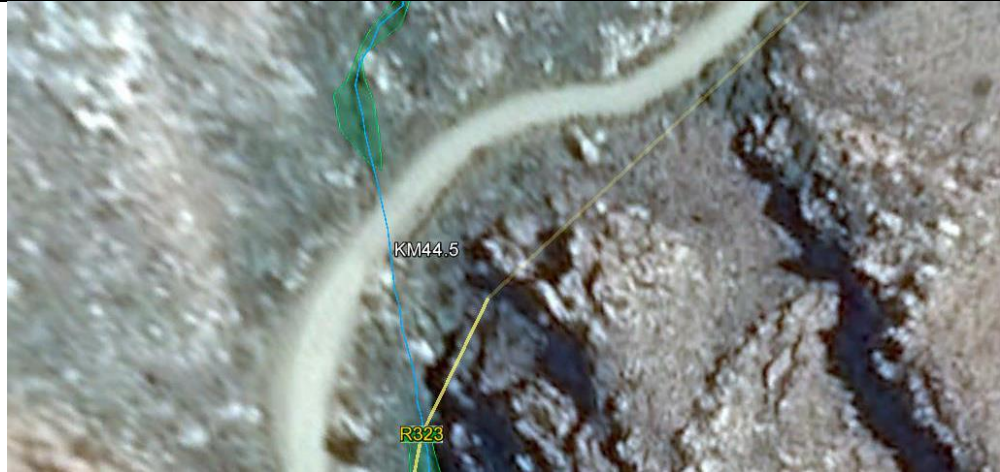
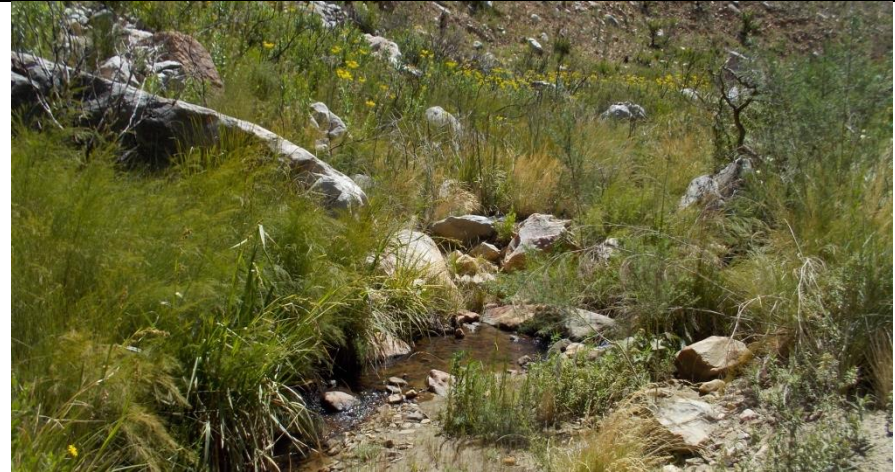
Km 44.5

Proposed Activity: The existing causeway structure consists of 2x600mm encased pipes, grouted stone head walls, The base of the structure is scoured and water is running under the structure. It is proposed to replace the structure with a 4m wide causeway. The temporary bypass will be placed downstream of the structure.

Site description: The stream is largely confined to a narrow channel at the crossing, consisting mostly of boulders. Indigenous vegetation includes Cape willow (*Salix mucronata*), blinktaibos (*Searsia lucida*), sand olive (*Dodonaea angustifolia*), fountain grass (*Pennisetum setaceum*), broom restio (*Calopsis paniculata*). Material from past road repair works has been deposited on the upstream bank.

The dumped material from previous road repair works should be utilised as far as possible for the construction of the new crossing and the banks shaped to resemble that of the surrounding unimpacted banks.

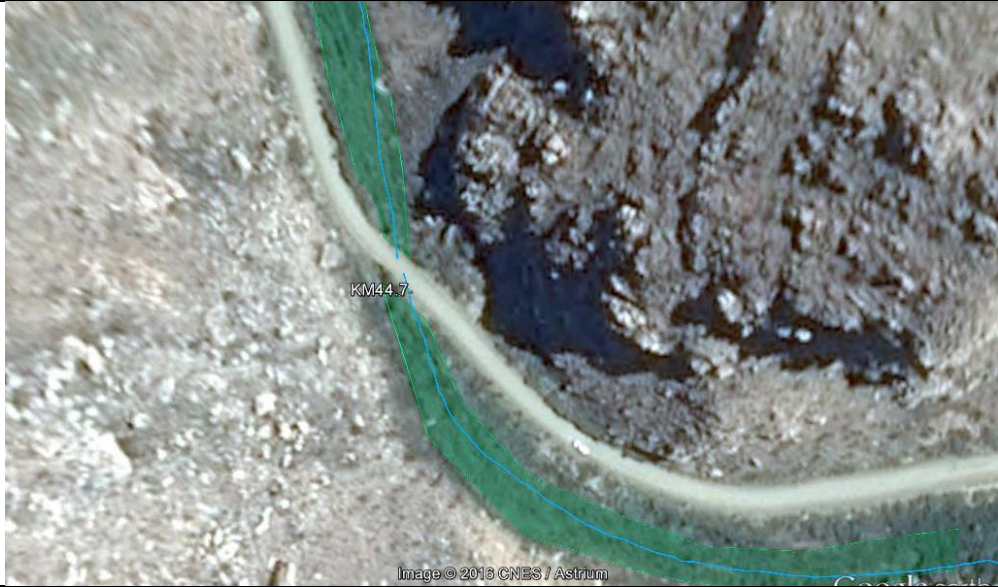
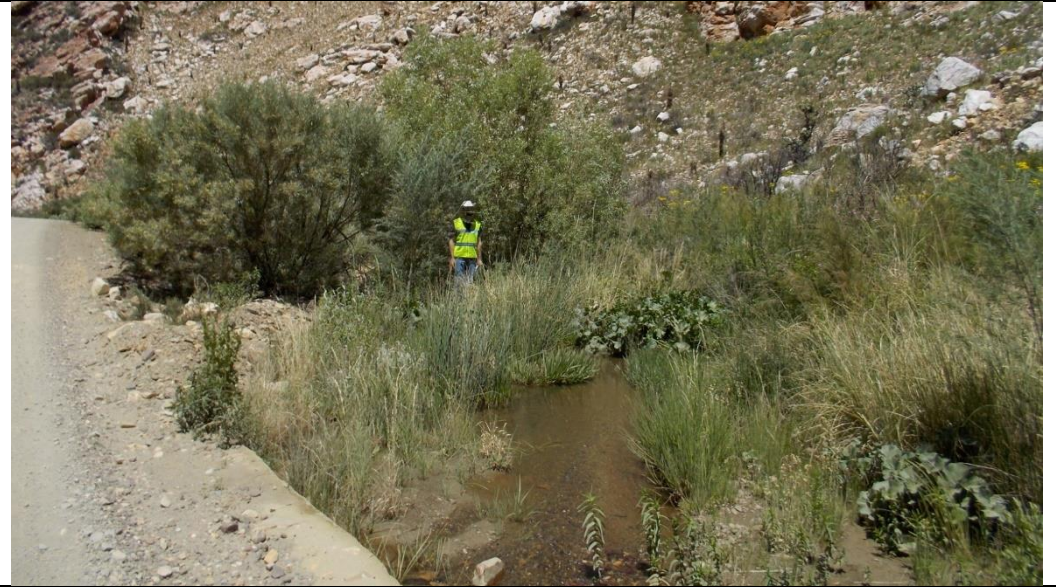
Km 44.7

Proposed Activity: The existing culvert structure consists of 2x600mm encased pipes that have been placed at a low level and been subjected to heavy siltation. The structure has also been placed at a low level. It is to be replaced with a 6m wide causeway. The temporary bypass is to be located on the downstream side of the crossing.

Site description: The river is largely confined to a relatively narrow channel at the crossing. Indigenous vegetation includes Cape willow (*Salix mucronata*), vleibos (*Cliffortia strobilifera*), sand olive (*Dodonaea angustifolia*), blinktaabos (*Searsia lucida*), fountain grass (*Pennisetum setaceum*) and broom restio (*Calopsis paniculata*). Material from past road repair works has been deposited on the downstream bank.

Temporary bypass to be moved to downstream site as the side with the least potential impact

The dumped material from previous road repair works should be utilised as far as possible for the construction of the new crossing and the banks shaped to resemble that of the surrounding unimpacted banks. The mature Cape willow trees adjacent to the crossing should be avoided. Ongoing monitoring and clearing of any invasive alien plants within the disturbed areas should take place.

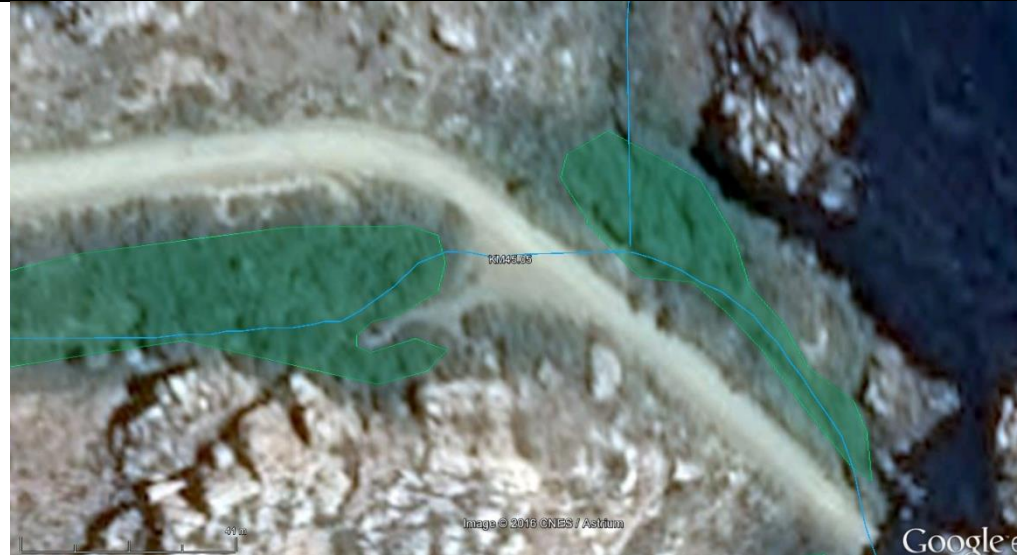
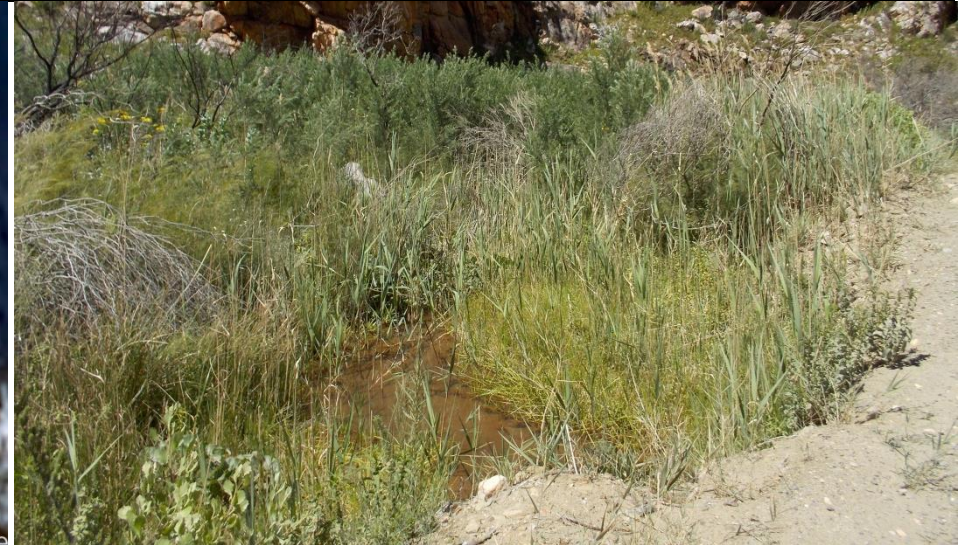
Proposed Activity: The existing causeway structure consists of 2x600mm encased pipes, grouted stone head walls that have been damaged and the structure has become partially silted up. The structure is to be replaced with a 4m wide causeway. The temporary bypass will be placed upstream of the structure.

Site description: The river channel upstream and downstream of the crossing comprises wetland area with a berm on the upstream side that is the result of past road maintenance activities that was intended to protect the crossing from stormwater runoff. Indigenous vegetation includes Cape willow (*Salix mucronata*), blinktaibos (*Searsia lucida*), sand olive (*Dodonaea angustifolia*), creeping rush (*Juncus lomotophyllus*), *Isolepis polifera*, broom restio (*Calopsis paniculata*), common reeds (*Phragmites australis*) and the everlasting *Helichrysum cymosum*. Material from past road repair works has been deposited on the upstream bank.

The dumped material berm should be removed and utilised as far as possible for the construction of the new crossing and the banks shaped to resemble that of the surrounding unimpacted banks.

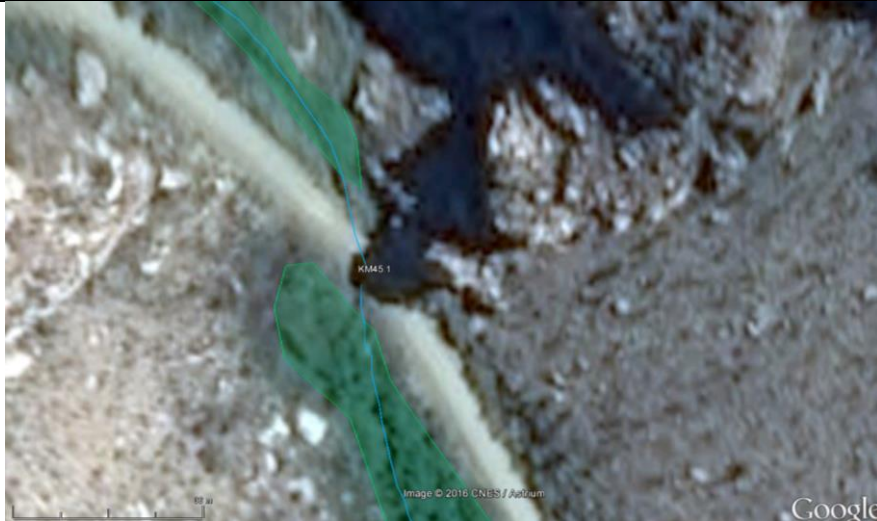
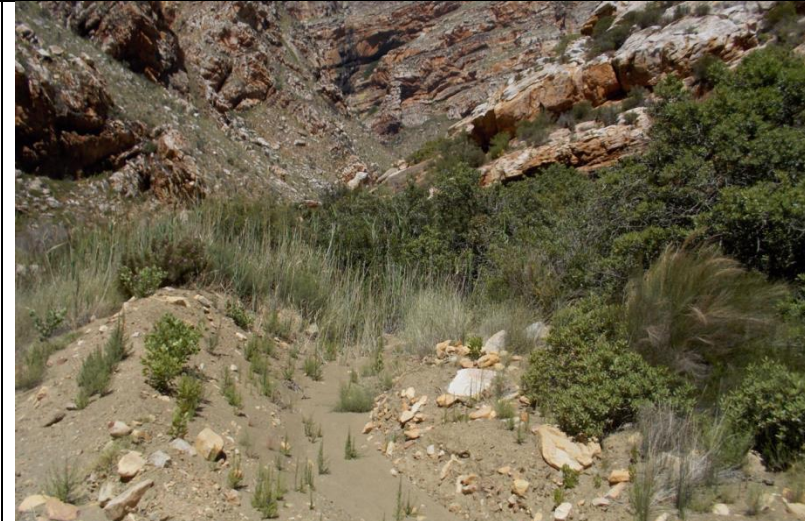
Proposed Activity: The existing causeway structure consists of 2x600mm encased pipes with stone and concrete head walls upstream. The structure is to be replaced with a 4m wide causeway. The road will be realigned such that it crosses the river approximately 7m upstream of its current location and the temporary bypass will then be placed downstream of the new structure (largely in the location of the current structure).

Site description: The river channel contains many large riparian trees as well as some wetland vegetation. A sand and stone berm is located on the upstream side that is the result of past road maintenance activities. Indigenous vegetation includes honey bells (*Freylinia lanceolata*), blinktaabos (*Searsia lucida*), broom restio (*Calopsis paniculata*), fountain bush (*Psoralea affinis*) and river pumpkin (*Gunnera perpensa*). Material from past road repair works has been deposited on the upstream bank.

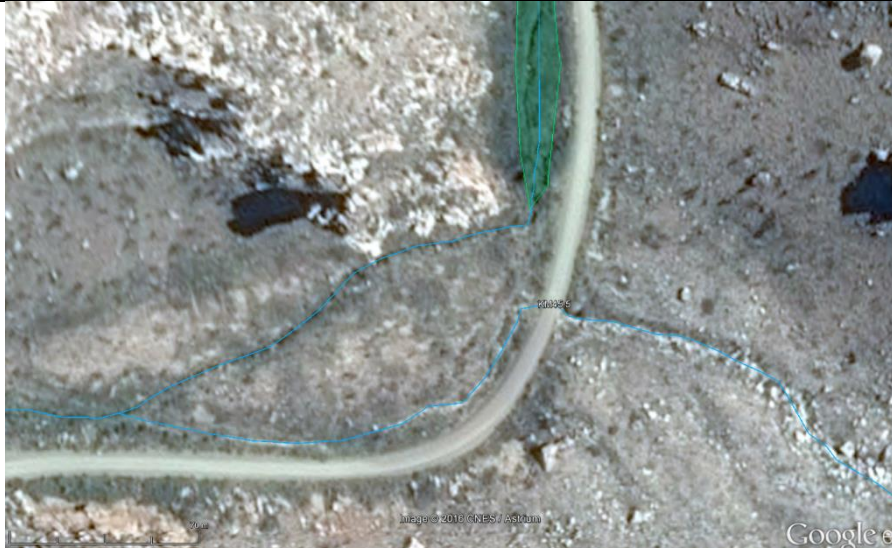
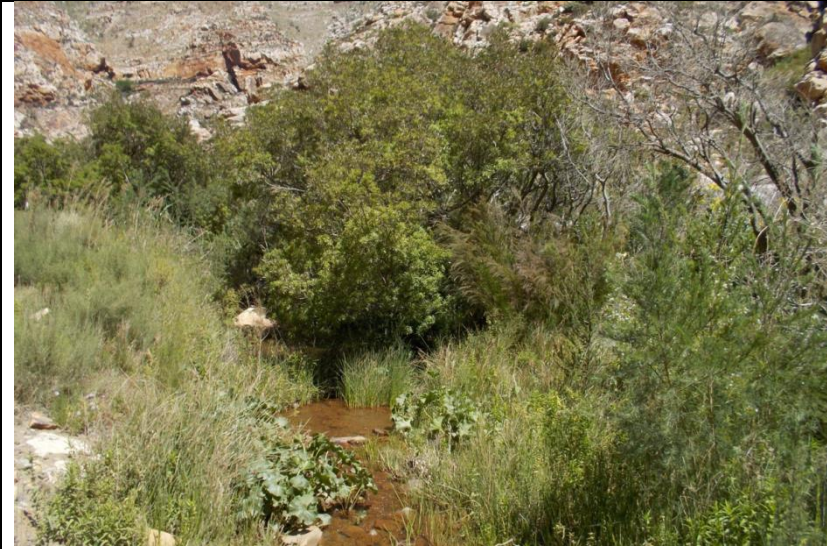
Km 45.5

Proposed Activity: The existing causeway structure consists of 1x600mm pipe. The structure is to be replaced with a 3m wide causeway. A temporary bypass will be placed downstream of the new structure.

Site description: The site consists of the crossing of a tributary of the river that flows down a steep catchment. The vegetation has been burnt and is currently dominated by weedy shrubs the larger riparian shrubs and trees such as the waterwitels (*Brachylaena neriifolia*), blinktaabos (*Searsia lucida*) and Bitou bush (*Chrysanthemoides monilifera* subsp. *rotundata*) are starting to resprout.

As this area is relatively disturbed as a result of the recent fire, it will need to be monitored and managed for invasive alien plant growth and has the potential for increased sedimentation downstream. Although the large riparian shrubs have been burnt they are resprouting and should be avoided as far as possible when establishing the bypass road. The shrubs that cannot be avoided should be cut back that they can resprout after the construction activities are complete.

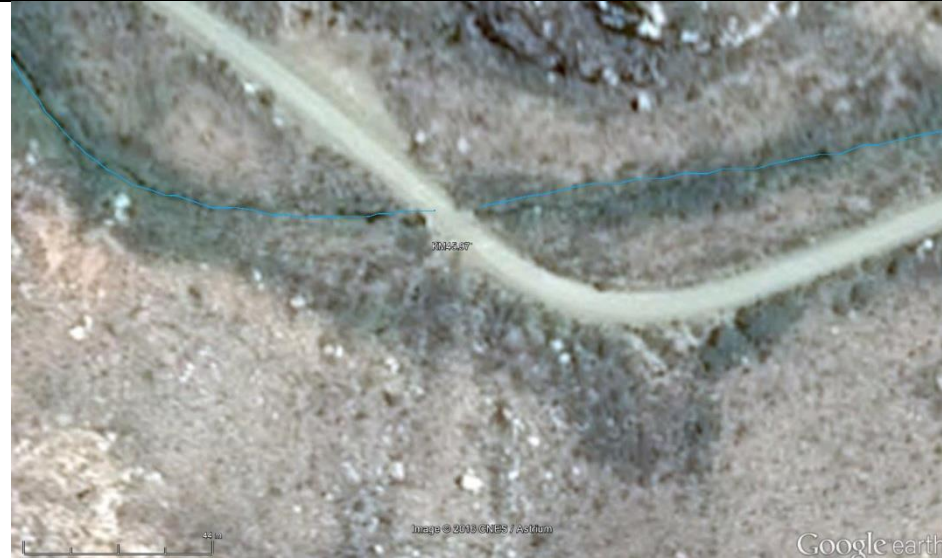
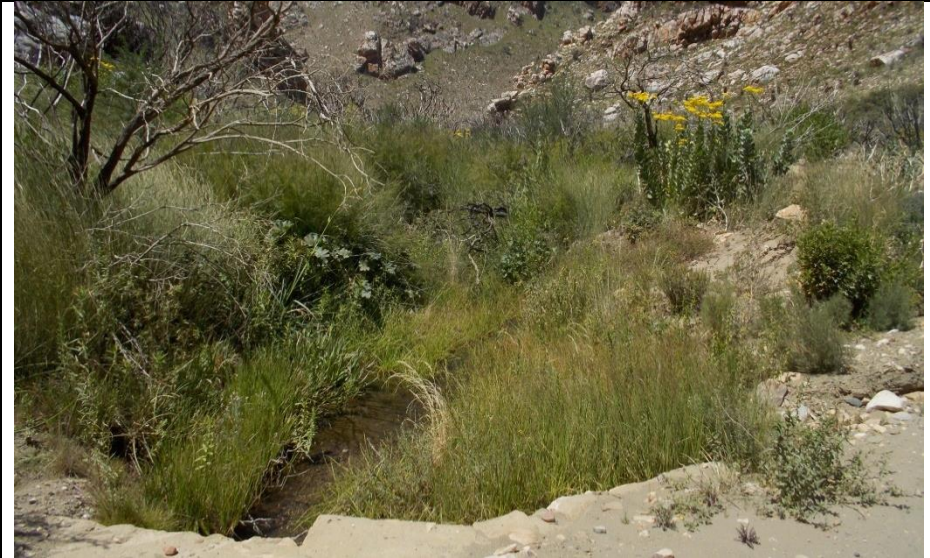
Km 45.97

Proposed Activity: The existing causeway structure consists of 2x600mm encased pipes with stone and concrete head walls at inlet and outlet. The structure is almost completely buried as a result of heavy siltation. The structure is to be replaced with a 4m wide causeway. The temporary bypass will be placed downstream of the structure. The current structure will be shifted slightly upstream.

Site description: The site shows evidence of disturbance and contains weedy shrubs and a berm of material from past road works. Indigenous vegetation includes Cape willow (*Salix mucronata*), bitter aloe (*Aloe ferox*), the sedge *Ficinia nigrescence*, creeping rush (*Juncus lomotophyllus*), broom restio (*Calopsis paniculata*), fountain bush (*Psoralea affinis*), river pumpkin (*Gunnera perpensa*) and wittamarak (*Albuca Canadensis*). Redfin minnow fry and tadpoles were also observed at the site.

Although the large riparian shrubs have been burnt they are resprouting and should be avoided as far as possible when establishing the bypass road. The shrubs that cannot be avoided should be cut back that they can resprout after the construction activities are complete.

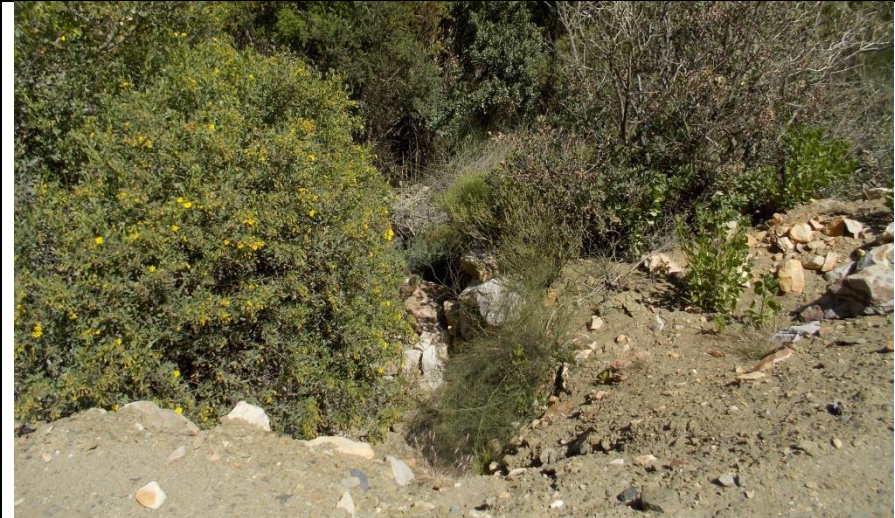
Km 46.35

Proposed Activity: The existing causeway structure consists of 1x600mm encased pipes with a stone head wall upstream. The new proposed structure will consist of a 2m wide causeway with 2x900mm pipe culverts with additional strengthening. The structure will also be stepped to accommodate the drop at the site. The works at the road will be undertaken in half roadwidths as there is no space for a temporary bypass road.

Site description: The site consists of the crossing of a tributary of the river that flows down a steep catchment and drops steeply at the crossing. The vegetation is minimal with a stream channel dominated by larger boulders.

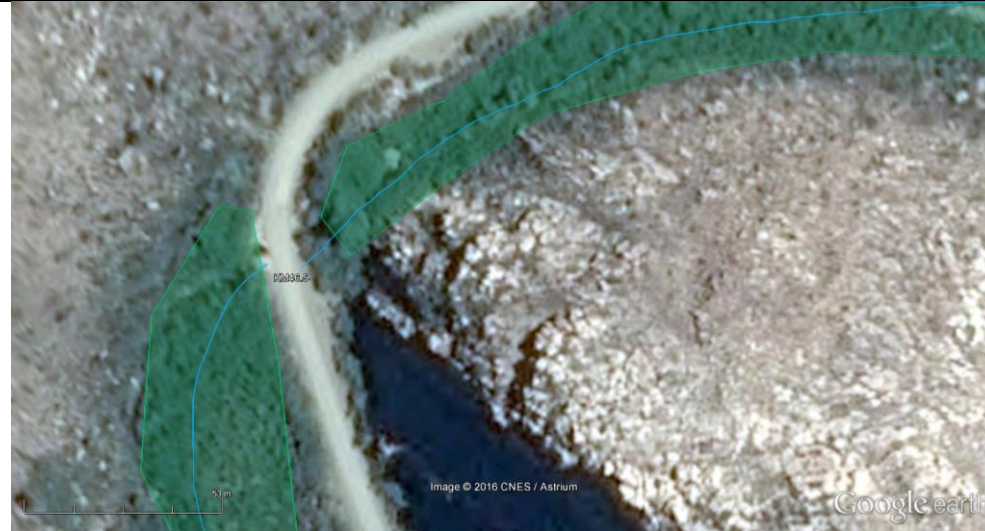
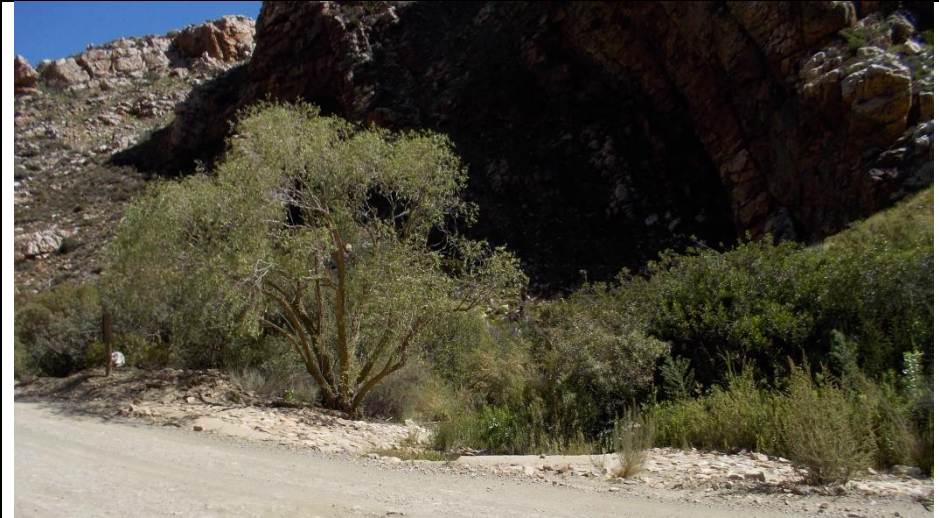
Km 46.5

Proposed Activity: The existing causeway structure consists of 2x600mm encased pipes, with concrete and stone head walls at inlet and outlet and stone pitching aprons. As a result of siltation, the structure is completely buried. The structure is to be replaced with a 6m wide causeway. The road will be shifted slightly downstream and some bedrock will need to be removed. The temporary bypass will be placed upstream of the structure.

Site description: The river channel upstream and downstream of the crossing is somewhat disturbed as result of past road maintenance activities. Indigenous vegetation includes Cape willow (*Salix mucronata*), blinktaibos (*Searsia lucida*), the sedges, *Mariscus thunbergii* and *Ficinia nigrescence*, creeping rush (*Juncus lomotophyllus*), broom restio (*Calopsis paniculata*), fountain bush (*Psoralea affinis*), taaiblaarmalva (*Pelargonium glutinosum*), river pumpkin (*Gunnera perpensa*) and Bitou bush (*Chrysanthemoides monilifera* subsp. *rotundata*). Material from past road repair works has been deposited on the upstream bank.

The dumped material from previous road repair works should be utilised as far as possible for the construction of the new crossing and the banks shaped to resemble that of the surrounding unimpacted banks.

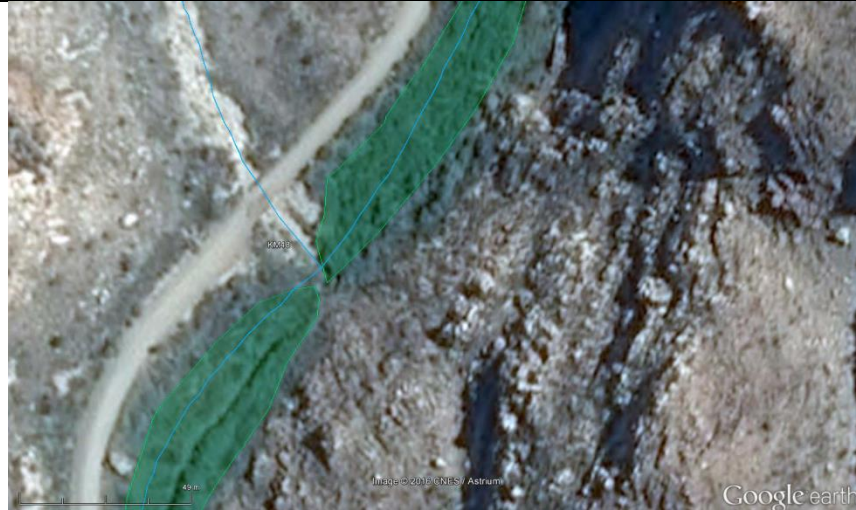
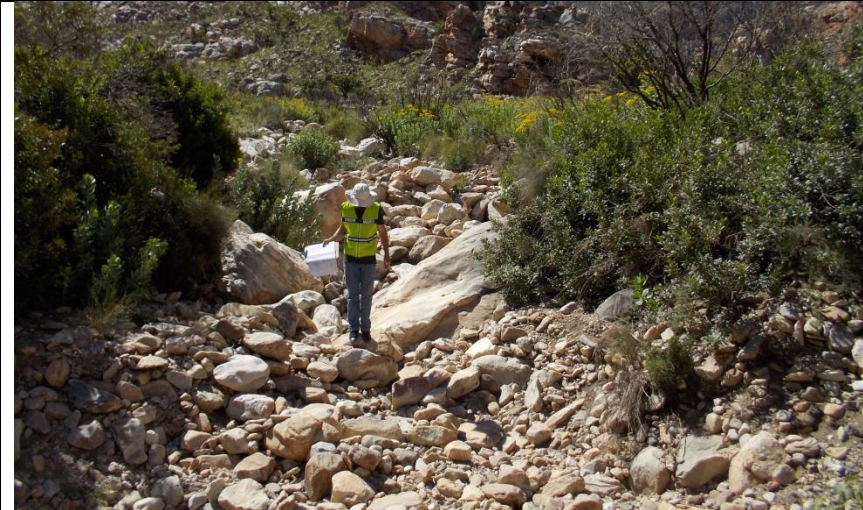
Km 48.00

Proposed Activity: The existing causeway structure consists of 1x900mm pipe with stone head and wing walls and damaged apron slabs both sides. The structure is to be replaced with a 6m wide causeway. The temporary bypass will be placed upstream of the structure.

Site description: The site consists of the crossing of a tributary of the river that flows down a steep catchment and drops steeply at the crossing. The vegetation is minimal with a stream channel dominated by larger boulders. Material from past road repair works has been deposited on both the upstream and the downstream stream banks. The road is located at the point at which the hillslope flattens out.

The dumped material from previous road repair works should be utilised as far as possible for the construction of the new crossing and the banks shaped to resemble that of the surrounding unimpacted banks.

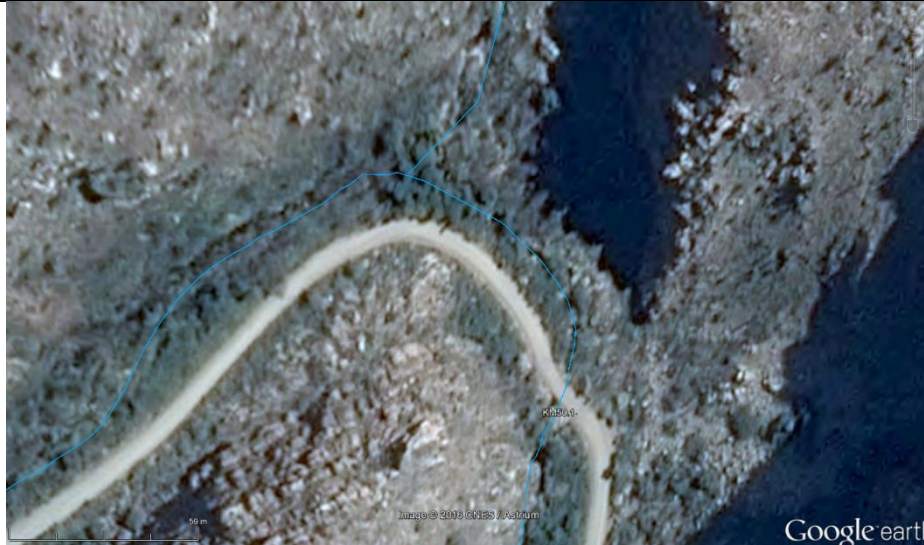
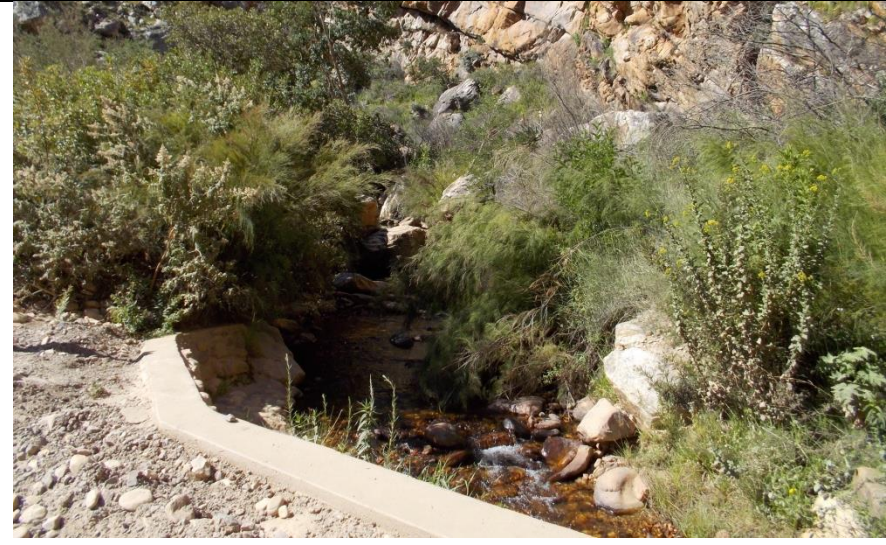
Km 50.1

Proposed Activity: The existing causeway structure consists of 3x600mm encased pipes, with stone head walls at inlet and outlet and stone pitching aprons that are severely damaged. The structure is to be replaced with an 8m wide causeway. Some of the existing structure will remain. The new structure will be constructed as far upstream and possible and the temporary bypass placed downstream of the structure.

Site description: The river channel upstream and downstream of the crossing is somewhat disturbed as result of past road maintenance activities. Indigenous vegetation includes Cape willow (*Salix mucronata*), blinktaibos (*Searsia lucida*), bostolbos (*Diospyros dichrophylla*), keurboom (*Virgilia divaricata*), kiepersol (*Cussonia spicata*), sand olive (*Dodonaea angustifolia*), broom restio (*Calopsis paniculata*) and sagewood (*Buddleja salviifolia*).

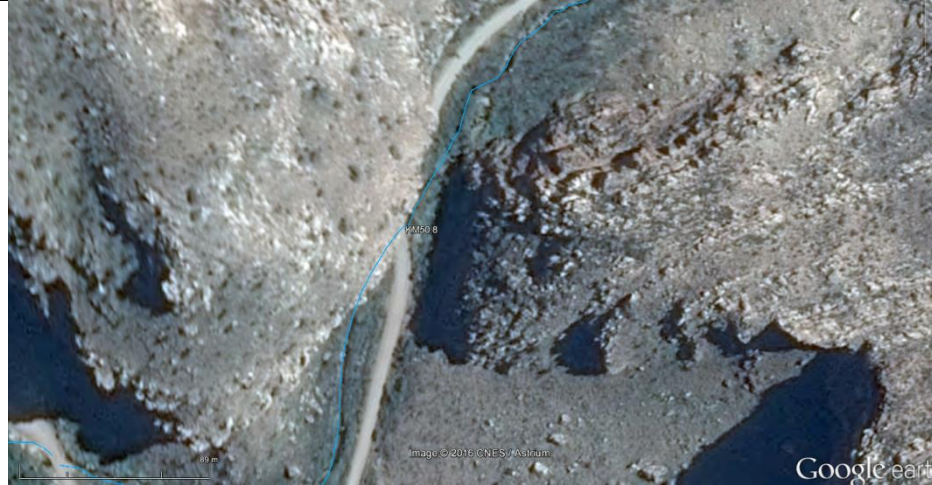
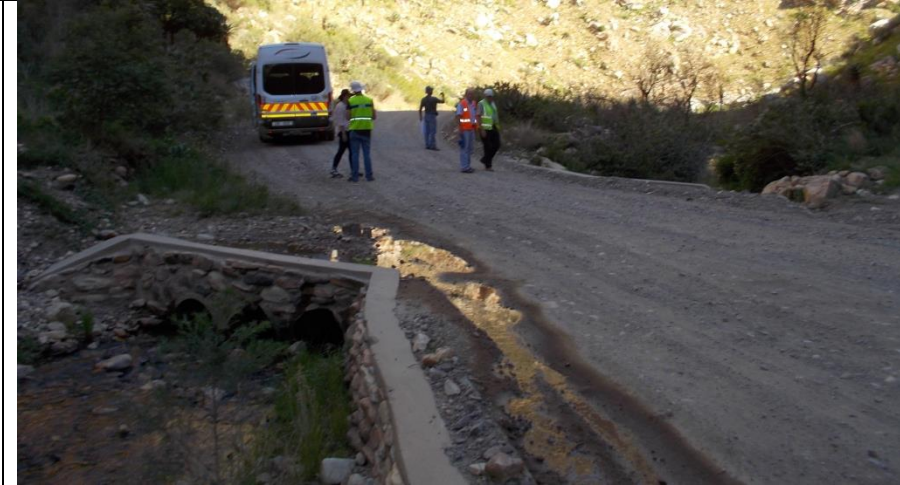
Km 50.8

Proposed Activity: The existing causeway structure consists of 3x600mm encased pipes, with stone head and return walls at inlet and outlet that have been severely damaged and are silted up. The structure is to be replaced with a 6m wide causeway. The road will be realigned slightly upstream and the temporary bypass will be placed downstream of the structure. It is also proposed to straighten the crossing slightly.

Site description: The river channel upstream and downstream of the crossing is somewhat disturbed as result of past road maintenance activities. Indigenous vegetation includes keurboom (*Virgilia divaricata*), broom restio (*Calopsis paniculata*) and sagewood (*Buddleja salviifolia*).

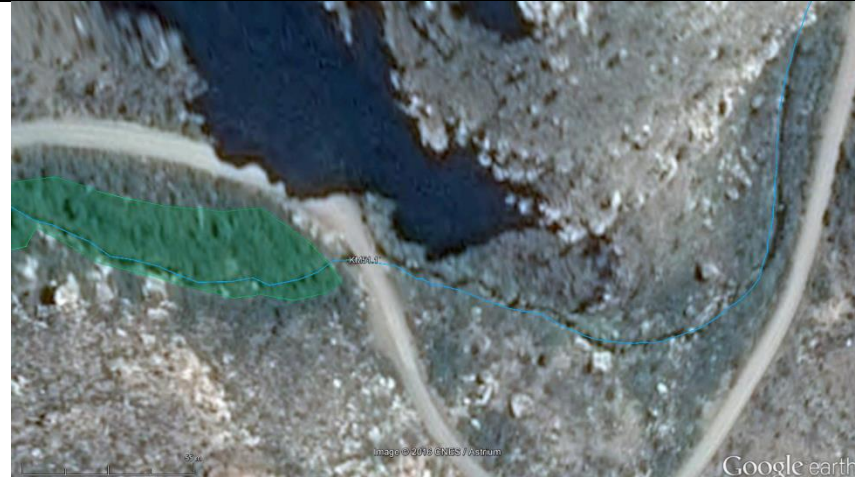
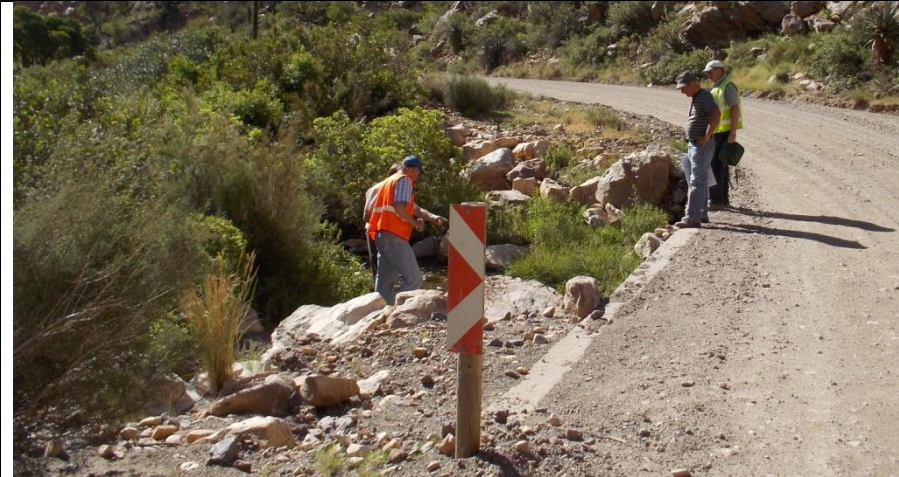
Km 51.1

Proposed Activity: The existing causeway structure consists of 2x900mm encased pipes, with stone head walls at inlet and outlet that are severely damaged by the large boulders that are abundant in the river. The structure is to be replaced with a 6m wide causeway. The structure will be realigned slightly upstream and the temporary bypass will be placed downstream of the structure.

Site description: The river channel upstream and downstream of the crossing is somewhat disturbed as result of past road maintenance activities. Indigenous vegetation includes keurboom (*Virgilia divaricata*), blinktaaibos (*Searsia lucida*), the sedges, *Mariscus thunbergii* and *Isolepis prolifera*, broom restio (*Calopsis paniculata*), fountain bush (*Psoralea affinis*) and katoenbos (*Gomphocarpus fruticosus*).

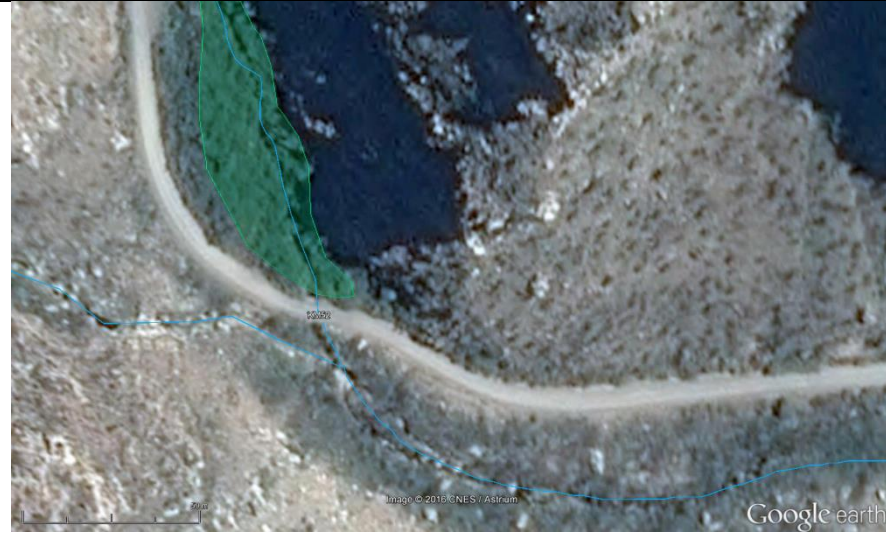
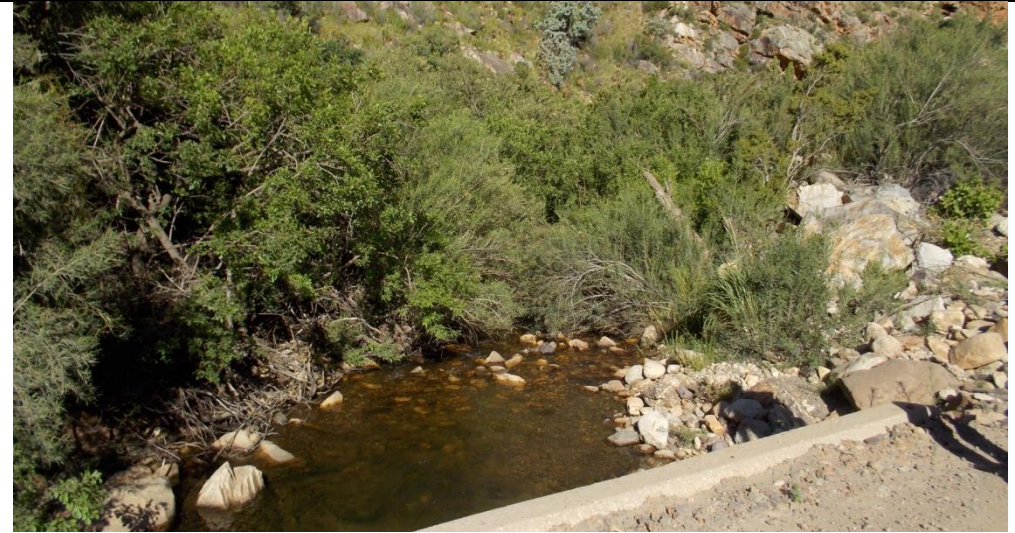
Km 52.0

Proposed Activity: The existing causeway structure consists of 2x900mm encased pipes, with stone head walls at inlet and outlet that are severely damaged by the large boulders that are abundant in the river. The structure is to be replaced with a 6m wide causeway. The temporary bypass will be placed downstream of the structure.

Site description: The river channel upstream and downstream of the crossing is somewhat disturbed as result of past road maintenance activities. Indigenous vegetation includes Cape willow (*Salix mucronata*), keurboom (*Virgilia divaricata*), kiepersol (*Cussonia spicata*), blinktaibos (*Searsia lucida*), broom restio (*Calopsis paniculata*), fountain bush (*Psoralea affinis*), common reeds (*Phragmites australis*) and sagewood (*Buddleja salviifolia*). Material from past road repair works has been deposited on the upstream bank.

The dumped material from previous road repair works should be utilised as far as possible for the construction of the new crossing and the banks shaped to resemble that of the surrounding unimpacted banks. The bed and banks of the river upstream and downstream of the road reserve should be disturbed as little as possible. Routine monitoring of the structure should be undertaken to ensure that it does not become blocked with larger boulders. Ongoing monitoring and clearing of any invasive alien plants within the disturbed areas should also take place.

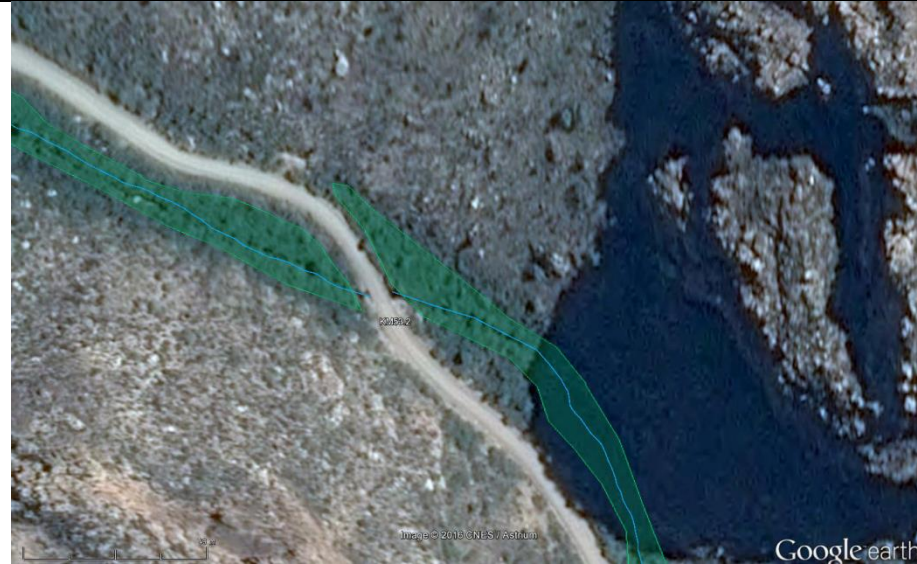
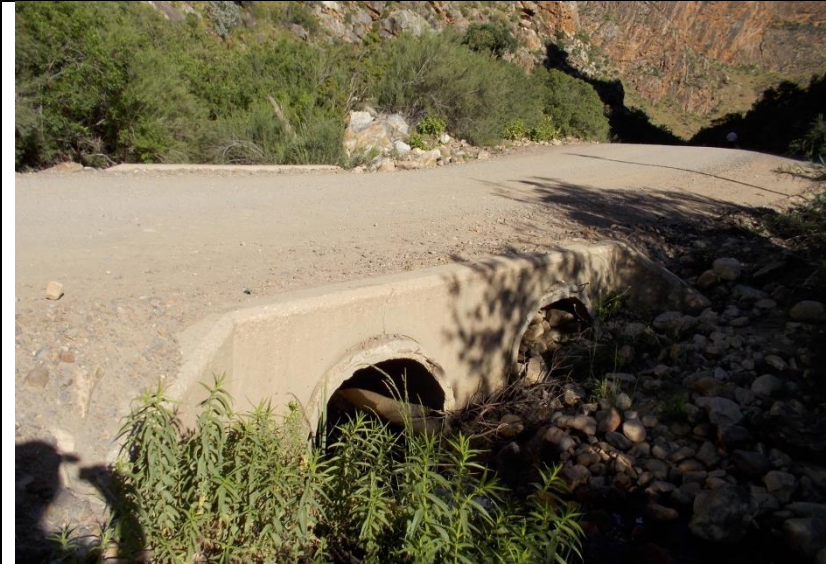
Km 53.2

Proposed Activity: The existing causeway structure consists of 2x900mm encased pipes, with upstream and downstream protection works. Scouring of the structure has taken place. The structure is to be replaced with a 6m wide causeway. The structure will be moved slightly upstream and the temporary bypass placed upstream of the structure.

Site description: The river channel upstream and downstream of the crossing is somewhat disturbed as result of past road maintenance activities. Indigenous vegetation includes honey bells (*Freylinia lanceolata*), keurboom (*Virgilia divaricata*), Cape Holly (*Ilex mitis*), taabos (*Searsia laevigata*), wildedagga (*Leonotis loenurus*), *Isolepis prolifera* and palmiet (*Prionium serratum*).

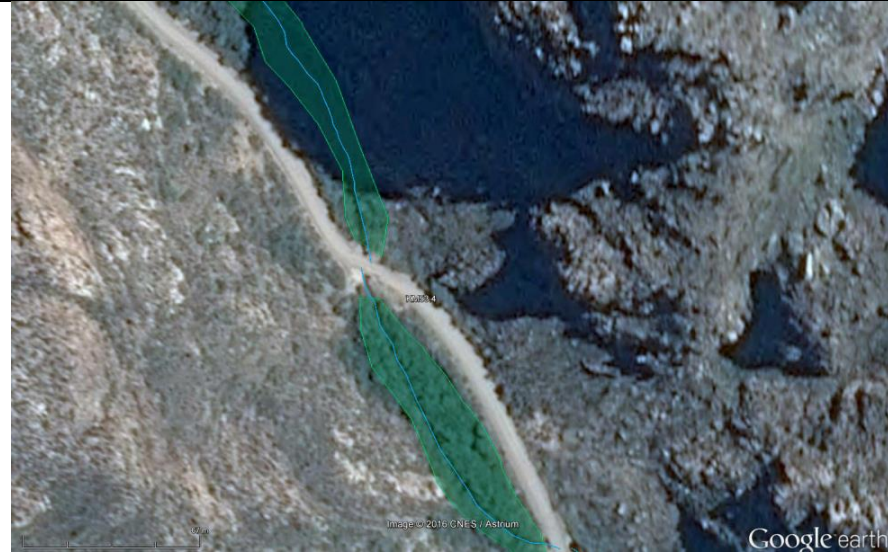
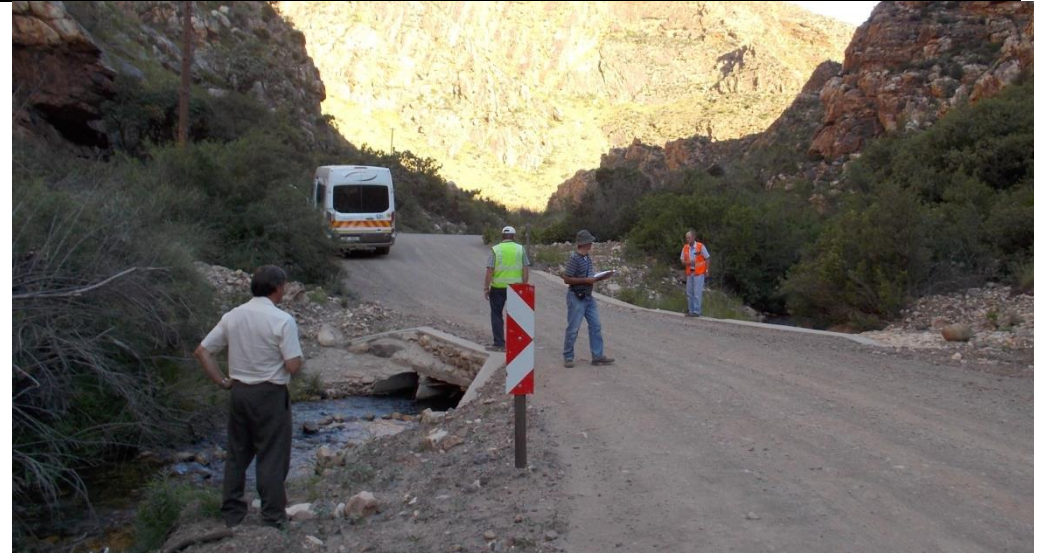
Km 53.4

Proposed Activity: The existing causeway structure consists of 2x600mm encased pipes, with head walls at the outlet that are mostly buried and have been almost completely destroyed. As a result of siltation, the structure is completely buried. The structure is to be replaced with a 6m wide causeway. The road will be shifted slightly upstream and the temporary bypass will be placed downstream of the structure.

Site description: The river channel upstream and downstream of the crossing is somewhat disturbed and cleared as result of past road maintenance activities. Indigenous vegetation includes keurboom (*Virgilia divaricata*), Cape honey bells (*Freylinia lanceolata*), taaibos (*Searsia laevigata*), the sedge *Isolepis prolifera*, creeping rush (*Juncus lomotophyllus*), broom restio (*Calopsis paniculata*), fountain bush (*Psoralea affinis*) and bostolbos (*Diospyros dichrophylla*). Material from past road repair works has been deposited on the river banks.

The dumped material from previous road repair works should be utilised as far as possible for the construction of the new crossing and the banks shaped to resemble that of the surrounding unimpacted banks.
