SUPPLEMENTARY WATER USE INFORMATION

Section 21(c) and (i) Water Uses

1.1 Locality *1.1.1. Description of the location of the watercourse:*
The main freshwater features in the study area consist of the Seweweekspoort River, its tributaries within the pass and its associated valley bottom wetland area. The Seweweekspoort River is a tributary of the Kobus River, as tributary of the Gamka River in the Gouritz River System. The Seweweekspoort River is largely contained within the Klein Swartberg Mountains and is still in a largely natural ecological state. Only once the river exits the pass does it become modified by the surrounding agricultural activities. The Seweweekspoort pass was used by earlier farmers to access the Great Karoo from the south. It is approximately 17km long and in many places is only broad enough for the stream to pass through. In 1859 it was decided that a pass should be built through the poort. The early part of the work was done by 108 convicts, without the presence of a road engineer. In 1860 A G de Smidt, brother-in-law of Thomas Bain, continued and 11 of the 17km was completed. The road was finally completed in November 1962. The road crosses the river 23 t

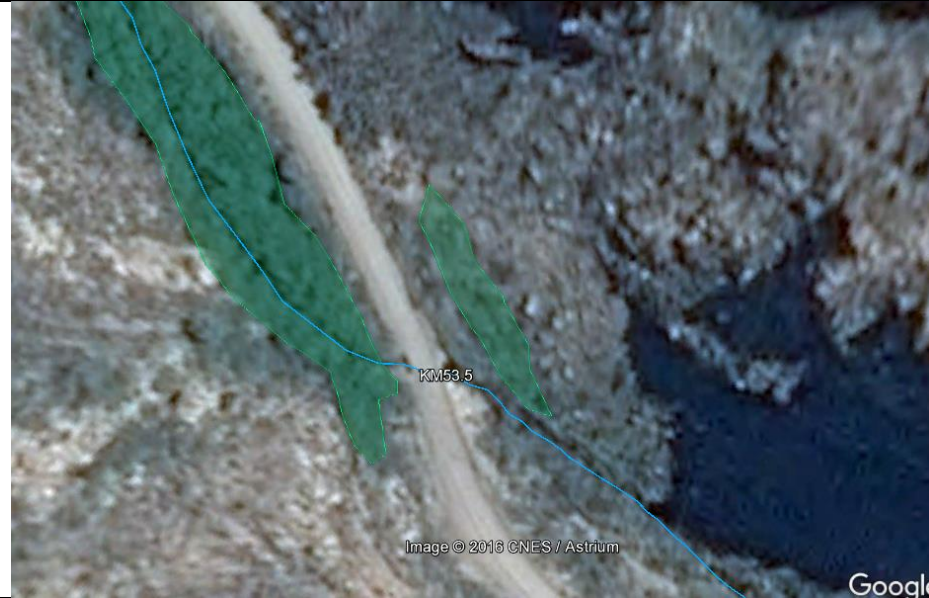
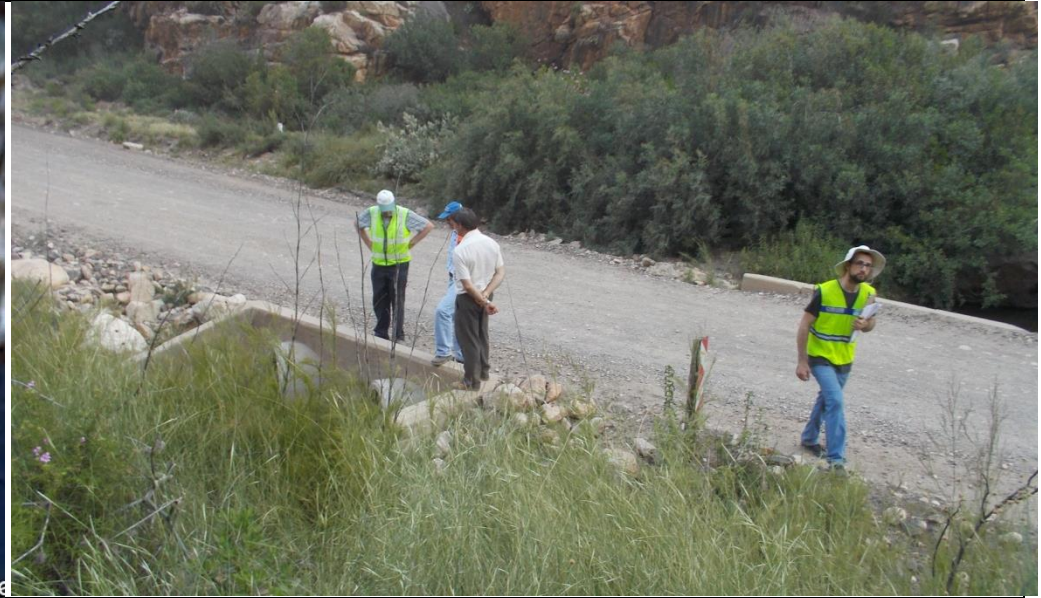
Km 53.5

Proposed Activity: The existing causeway structure consists of 2x900mm encased pipes, with concrete protection works at inlet and outlet. Severe scouring has taken place at the structure. The structure is to be replaced with a 6m wide causeway. The road will be shifted slightly upstream and some of the downstream bank will need to be removed. The temporary bypass will be placed downstream of the structure.

Site description: The river channel upstream and downstream of the crossing has been disturbed as result of past road maintenance activities. Indigenous vegetation includes keurboom (*Virgilia divaricata*), Cape honey bells (*Freylinia lanceolata*), taaibos (*Searsia laevigata*), broom restio (*Calopsis paniculata*), fountain bush (*Psoralea affinis*) and bostolbos (*Diospyras dichrophylla*). Material from past road repair works has been deposited on the upstream bank.

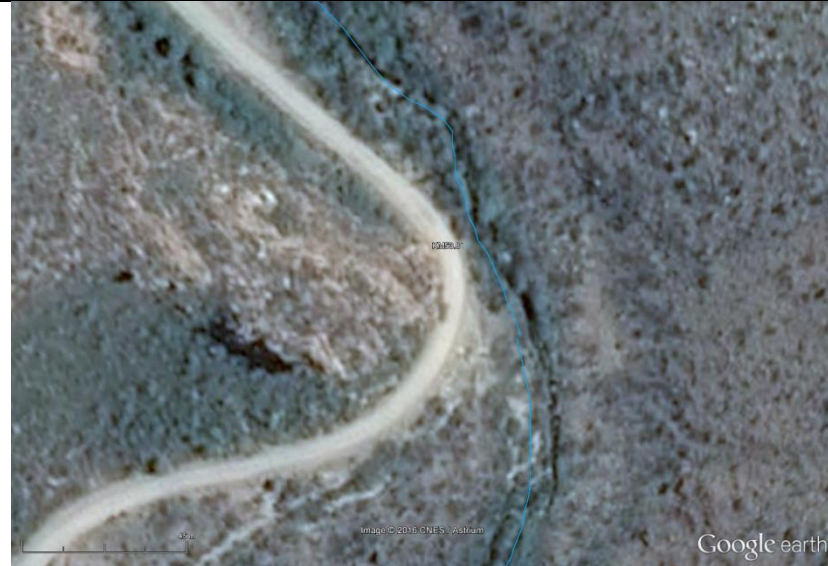
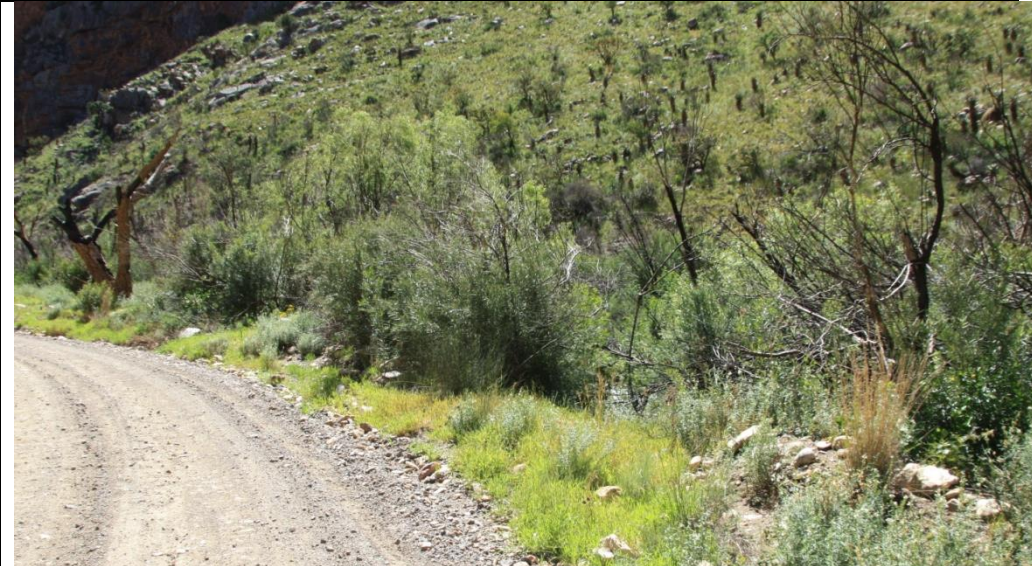
Km 53.8

Proposed Activity: The road way gets flooded by the river that washes the road material away completely during floods. It is proposed to construct a 100m long concrete retaining wall.

Site description: The river channel adjacent to the road has been disturbed as result of past road maintenance activities. Indigenous vegetation includes Cape honey bells (*Freylinia lanceolata*), keurboom (*Virgilia divaricata*), silky bark (*Maytenus acuminata*), wild olive (*Olea europaea* subsp. *africana*), sand olive (*Dodonaea angustifolia*), taaibos (*Searsia laevigata*), the sedge, *Mariscus thunbergii*), broom restio (*Calopsis paniculata*), taaiblaarmalva (*Pelargonium glutinosum*) and sagewood (*Buddleja salviifolia*). Some material from past road repair works has been deposited along the bank.

The wall should be constructed within the road reserve and should not encroach into the riparian zone of the river. It should also not significantly confine or intensify the flood flows of the river but should only protect the road from flood damage.

Any dumped material from previous road repair works should be utilised as far as possible for the construction works and the banks shaped to resemble that of the surrounding unimpacted banks. The mature trees adjacent to the crossing should be avoided and the bed and banks of the river upstream and downstream of the road reserve should be disturbed as little as possible.

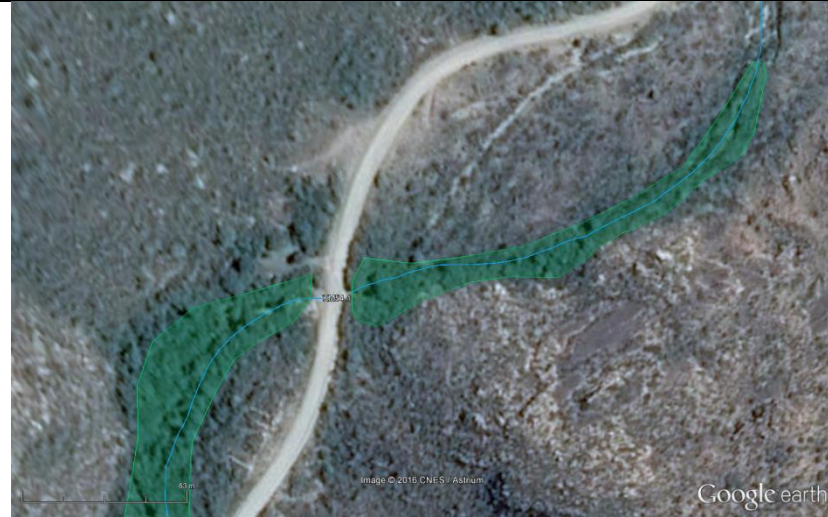
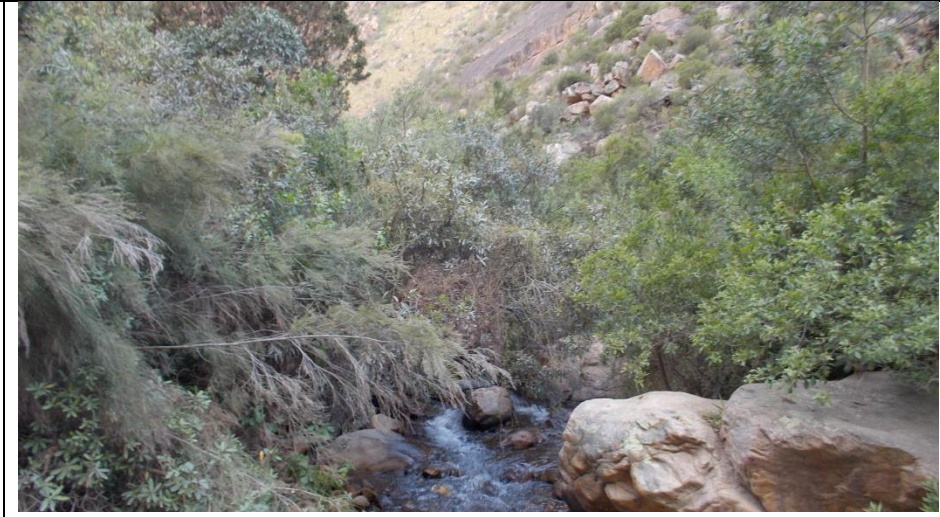
Km 54.1

Proposed Activity: The existing causeway structure consists of 2x900mm encased pipes, with stone head walls at inlet and outlet that have been damaged by boulders that are abundant in the river. The structure is to be replaced with a 6m wide causeway. The temporary bypass will be placed downstream of the structure.

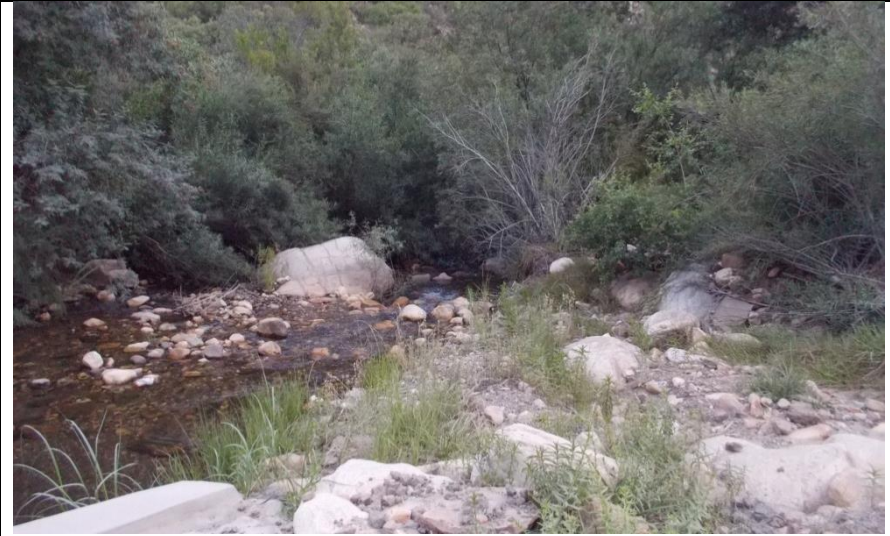
Km 54.3 and 54.4

Proposed Activity: The existing causeway structure consists of 2x900mm encased pipes, with stone head walls at inlet and outlet that have been damaged by boulders that are abundant in the river. The road way gets flooded by the river that washes the road material away completely during floods. It is proposed to construct a 350m long concrete retaining wall and a 6m wide causeway. The new structure will be placed slightly upstream of the existing structure and the temporary bypass will be placed downstream of the structure.

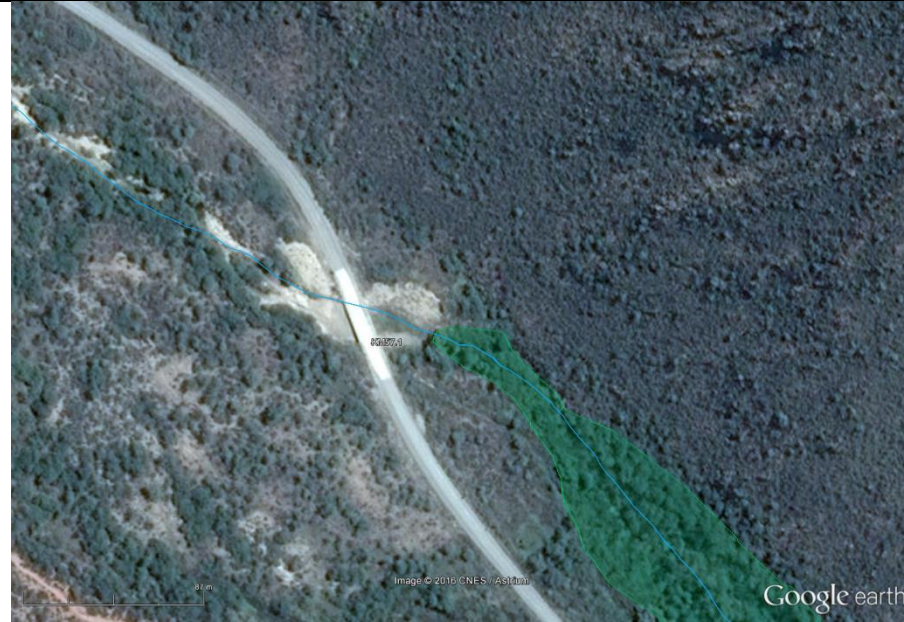
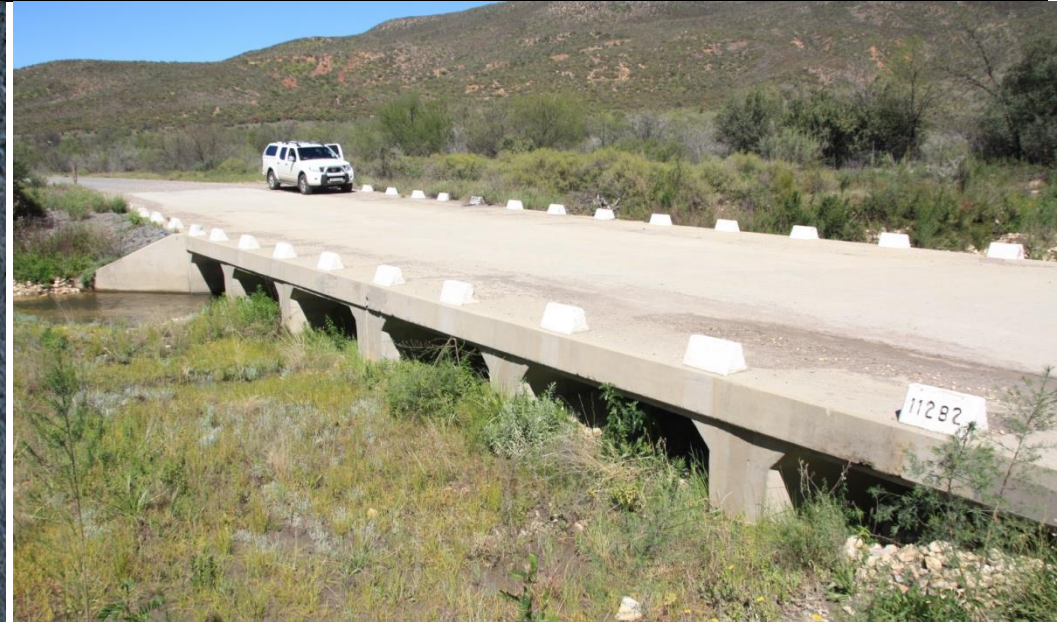
Km 57.1

Proposed Activity: The existing causeway structure consists of 57m long causeway with 6x2.4m openings with a 500mm thick slab, aprons and wing walls. Four openings area completely blocked with rocks and only 2 openings area clear. It is proposed to drop the inlet and realign the river. The temporary bypass will be placed upstream of the structure.

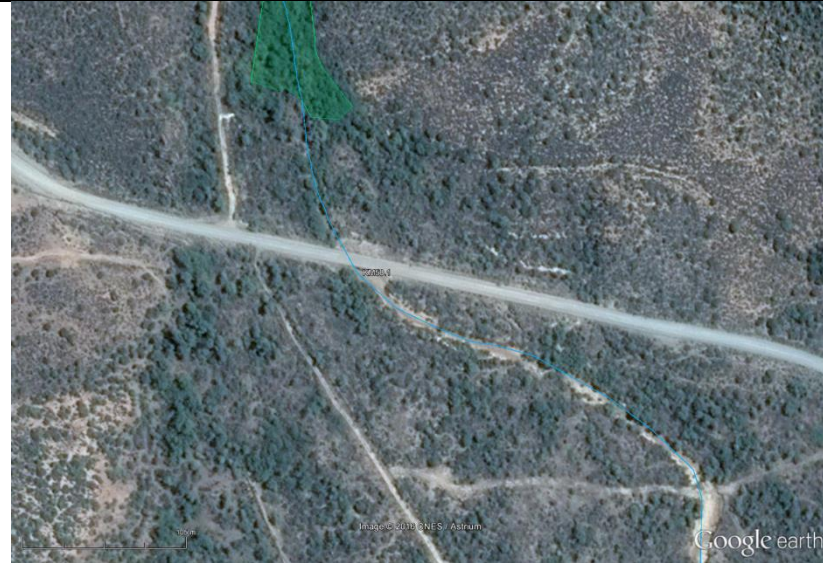
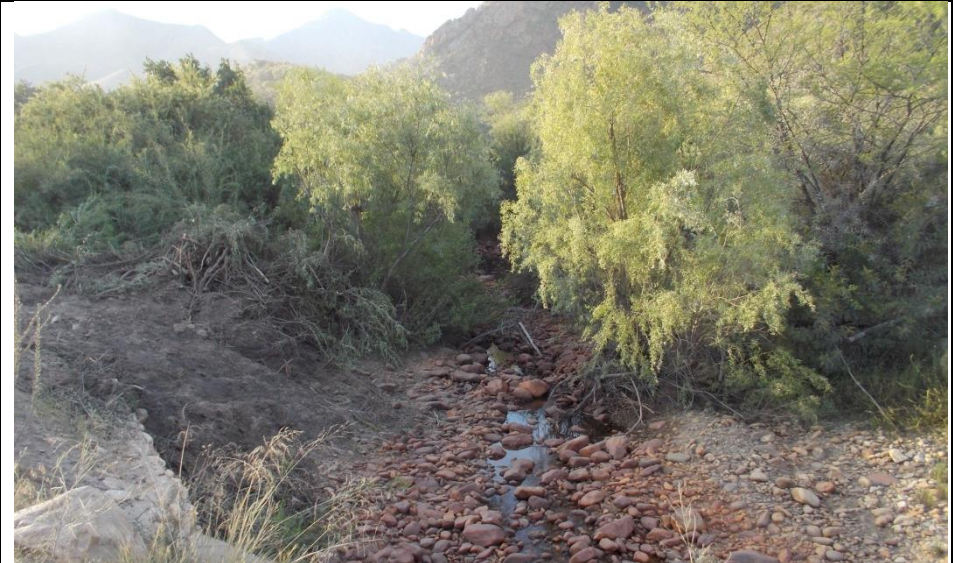
Km 58.1

Proposed Activity: The existing causeway structure consists of 1x1.9m W causeway with 750mm pipe down steam, broken apron slabs and downstream return walls. The structure is to be replaced with a 6m wide causeway. The temporary bypass will be placed upstream of the structure.

The dumped material from previous road repair works should be utilised as far as possible for the construction of the new crossing and the banks shaped to resemble that of the surrounding unimpacted banks.
