**NID supporting document:
Seweweekspoort Pass repairs/replacement of river culverts**

HERITAGE IMPACT ASSESSMENT FOR PROPOSED REMEDIAL WORKS TO THE SEWEWEEKSPOORT PASS, LAINGSBURG AND LADISMITH MAGISTERIAL DISTRICTS, WESTERN CAPE

Required under Section 38 (8) of the National Heritage Resources Act (No. 25 of 1999).

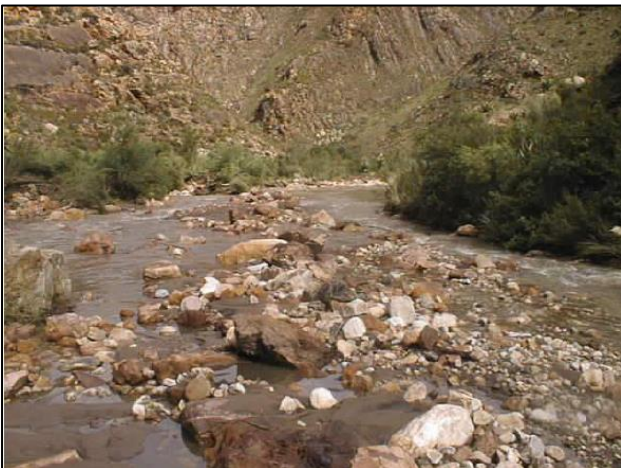
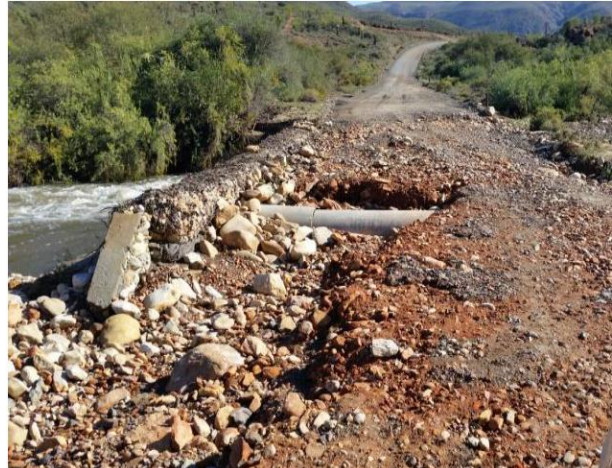
Two examples of damaged river crossings from recent floods illustrating the need for the proposed remedial work.

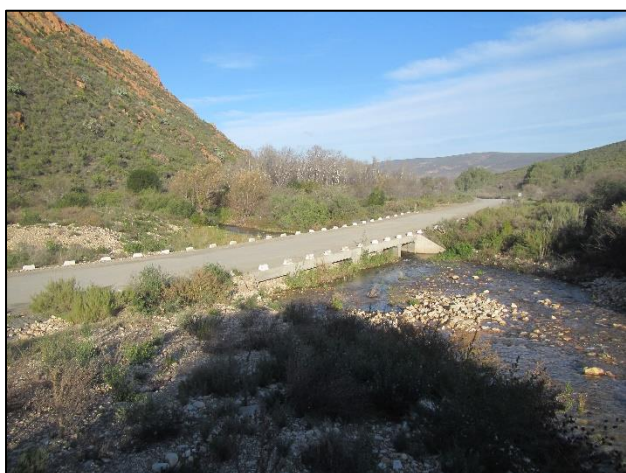
Current river crossing at km 57.1.

54.40	33°26'3.00"S 21°24'24.34"E	Road way gets flooded by river and washes material away completely during floods	350m long concrete retaining wall
57.10	33°27'14.40"S 21°25'15.08"E	57m long causeway with 6x2.4m openings, 500mm thk slab, aprons and wing walls, 4 openings completely blocked with rocks only 2 openings clear	Drop inlet and river realignment

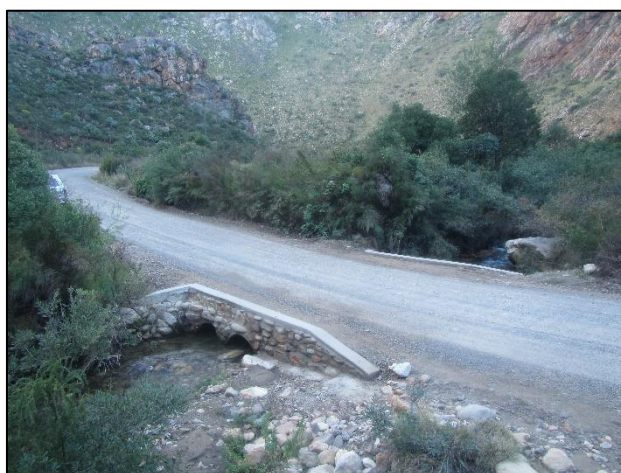
Current river crossing at km 54.1.

54.10	33°25'58.48"S 21°24'26.57"E	2x900mm pipes with stone head wall up and down stream, mostly damaged, large boulders abundant in river	6m wide causeway

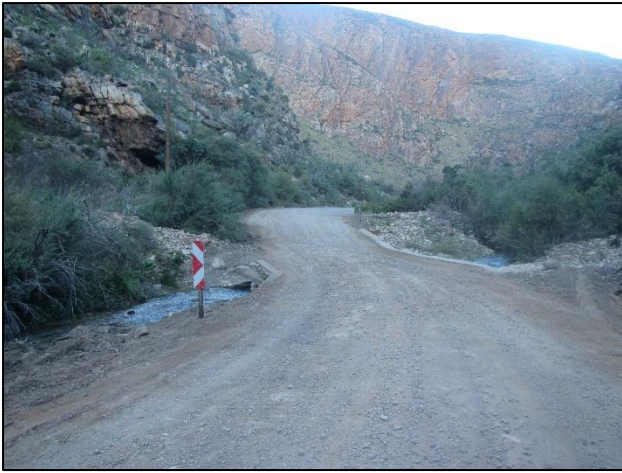
Current river crossing at km 53.4.

53.20	33°25'35.88"S 21°24'16.53"E	2x900mm pipes with concrete protection works up and down stream, scouring severe	6m wide causeway
53.40	33°25'39.94"S 21°24'20.83"E	2x800mm pipes with stone head walls at inlet and outlet, mostly buried, nearly completely destroyed	6m wide causeway

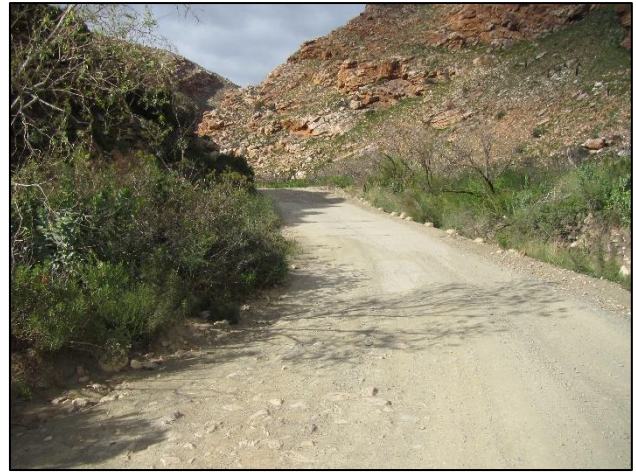
Current river crossing at km 47.2.

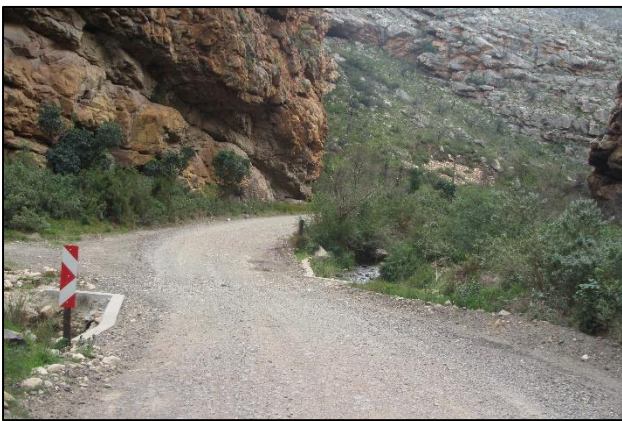
Current river crossing at km 50.8.

50.30	33°24'46.14"S 21°24'29.91"E	2x900mm pipes with stone head and return wall downstream, severely damaged and siltation issue	5m wide causeway
50.80	33°24'58.08"S 21°24'14.54"E	3x800mm pipes with stone head and return walls up and down stream, severely damaged and siltation prevalent	6m wide causeway

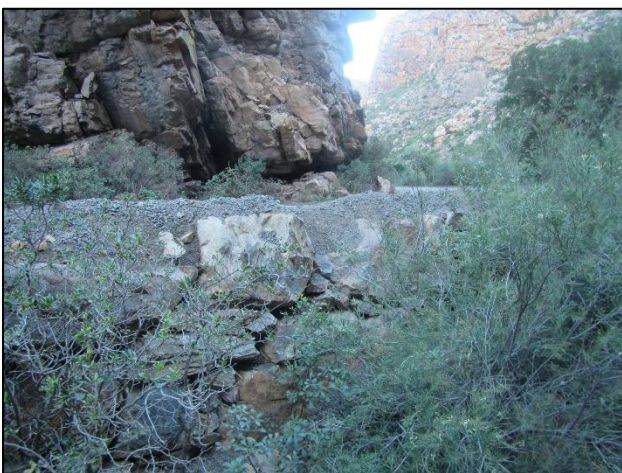
Drystone retaining wall with road above and river below (waypoint 217).

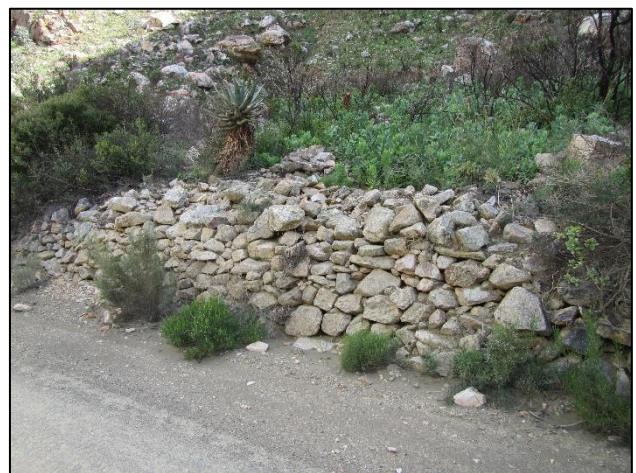
Drystone retaining wall with mountain slope above and road below (waypoint 250).

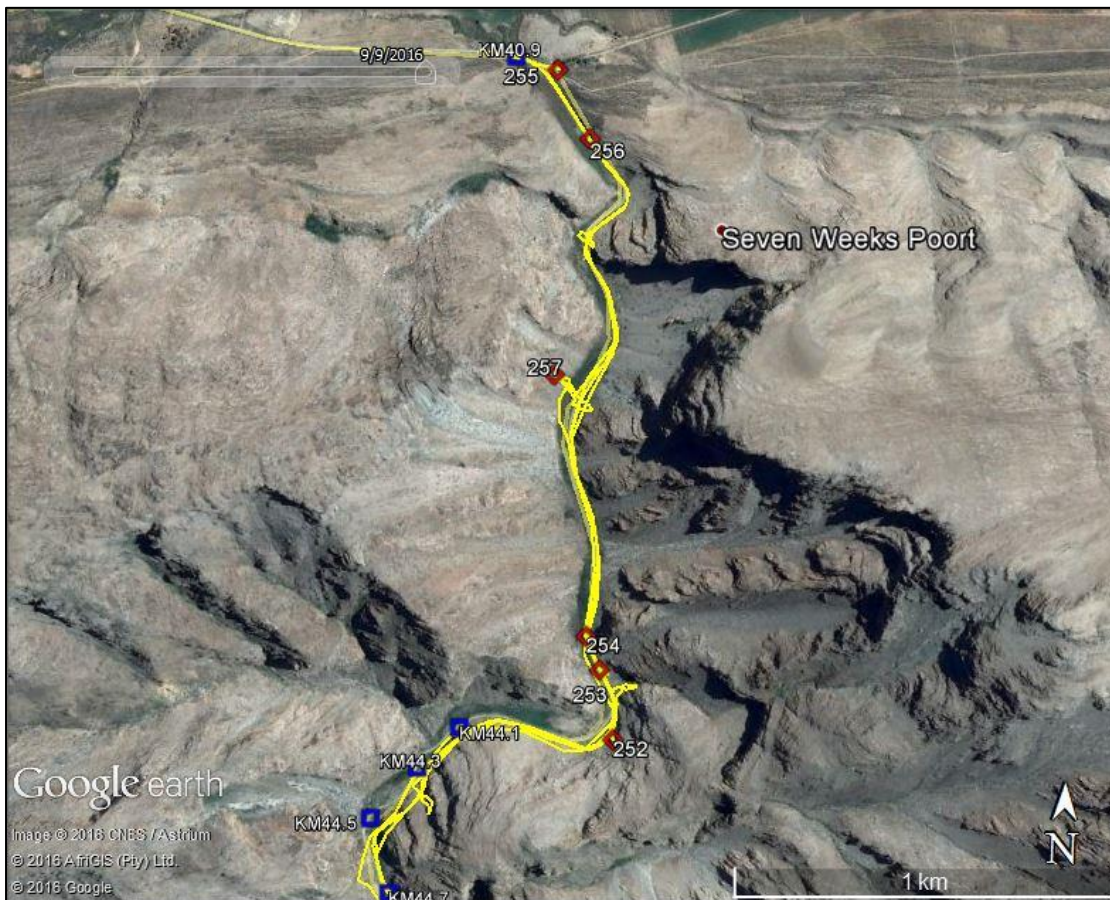
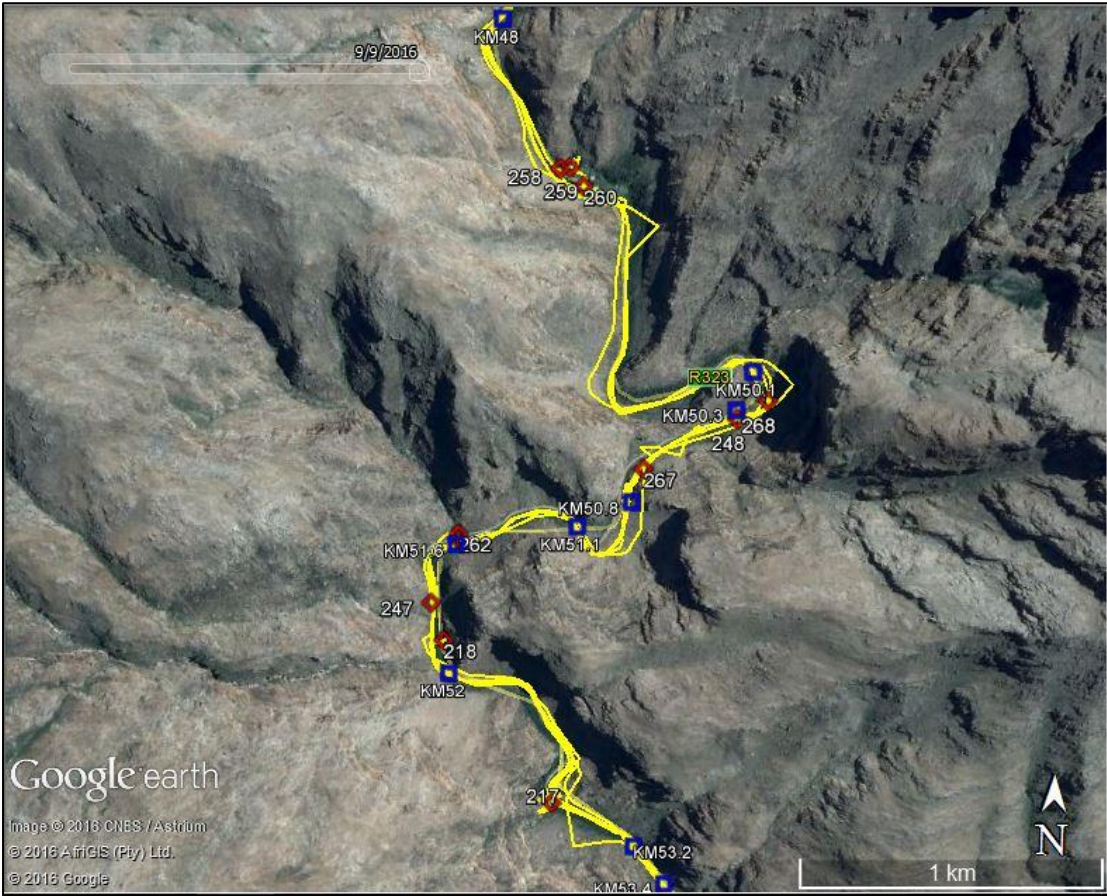
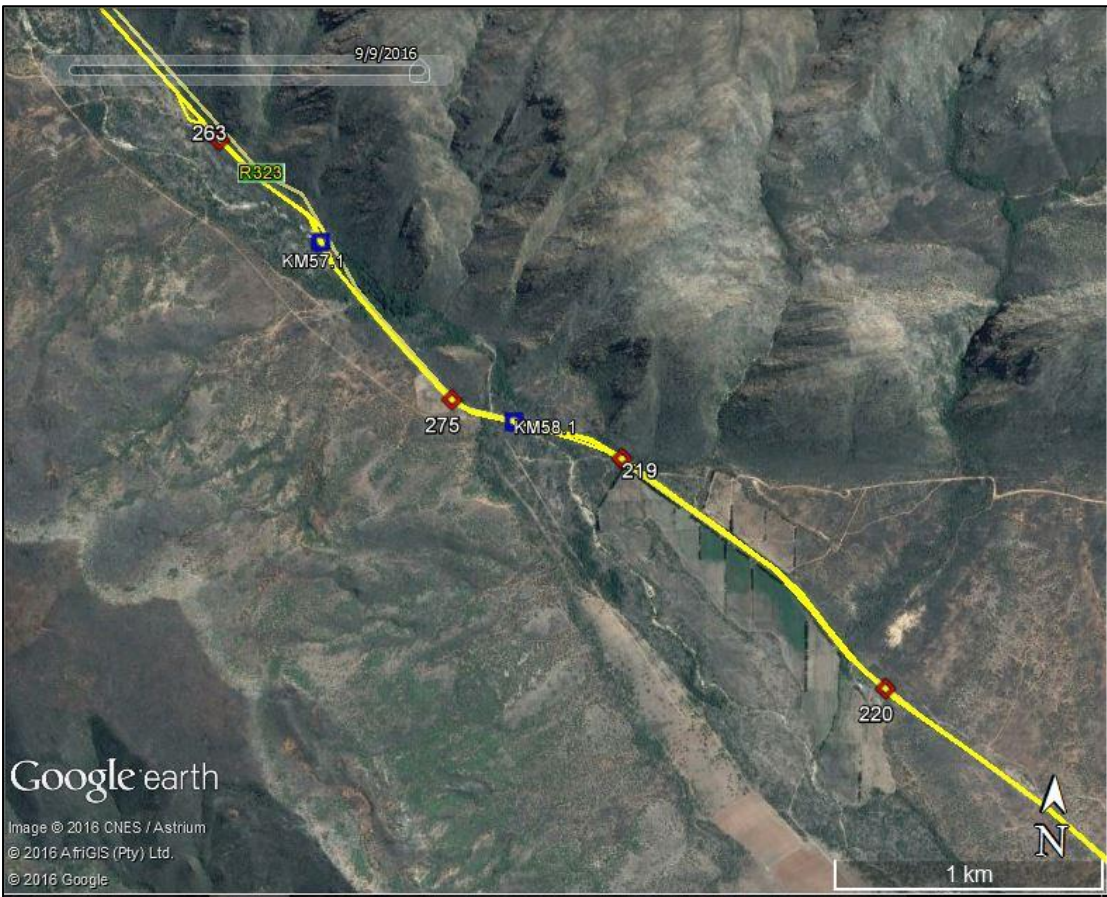
Mapping of sites requiring work (blue symbols numbered with their km marker) and heritage sites and places of local significance (numbered red symbols). The yellow lines represent the drive- and walk-paths recorded during the survey. The five maps below proceed from north to south.

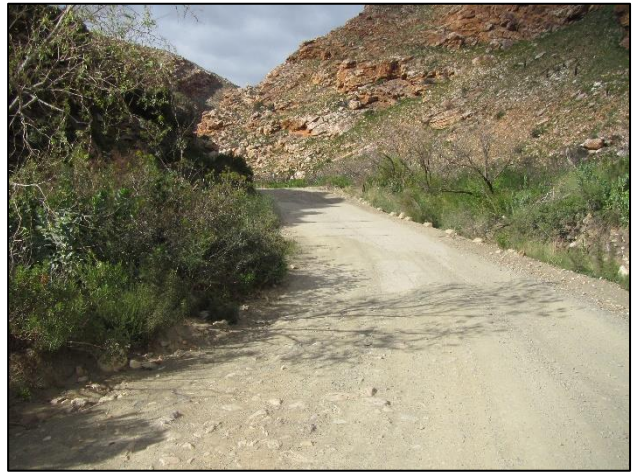
Figure 5: Current river crossing at km 47.2. Note eroded road surface in foreground.

It is thus proposed to construct new structures that will be large enough to allow 1:2 year floods to pass easily beneath them, bearing in mind vegetation and other debris that might be carried in the stream. The 1:5 year floods may need to pass above the structures but the design would allow for minimal damage to the roadway in such events. In three places the river runs alongside the road and undercuts it during flood events. In these locations a retaining wall would be constructed between road and river to protect the road. The full list of structures and locations requiring remedial work is provided in Table 1. Photographs of a selection of them are provided here (Figures 2 to 7), while a full photographic catalogue appears in Appendix 3.

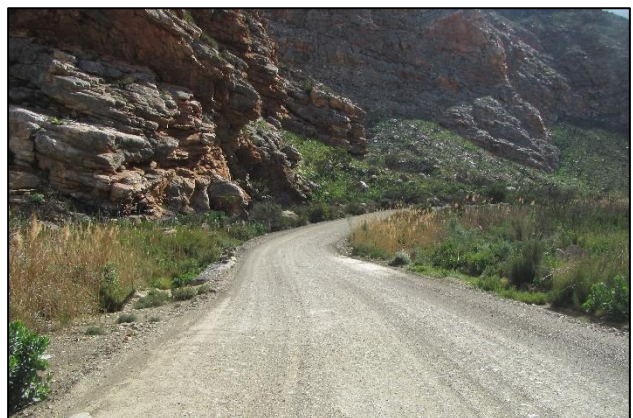
Figure 7: Current river crossing at km 44.3.

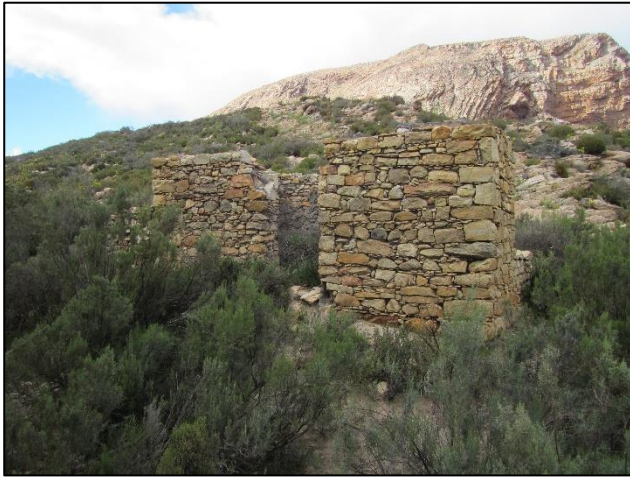
Figure 14: Ruined structure at waypoint 255.

Most of the ruined structures were built from stone and sections of walling often remain standing. At the northern end of the pass, immediately alongside a T-junction in the road, stands the ruin of what was once a toll house controlling access to the pass (Figure 14). It is a small stone structure built with mud mortar between the rocks and tiny stones inserted into gaps to stabilise successive courses of stones.

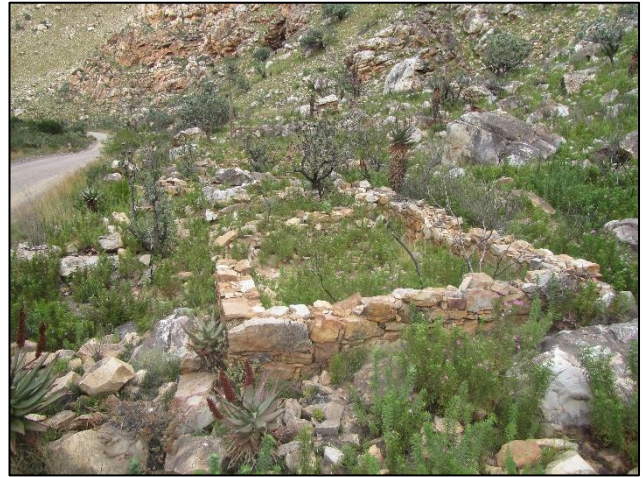
Figure 15: Ruined structure at waypoint 247.

The ruin at waypoint 247 exists only as a stone foundation marking out the position of the structure (Figure 15). Waypoint 253 marks another stone structure but this time with partially standing walls and some stone terracing (Figure 16). At waypoints 215-216 is a third structure, also with walls partially standing, but which has been disturbed through pushing of gravel against and over one of

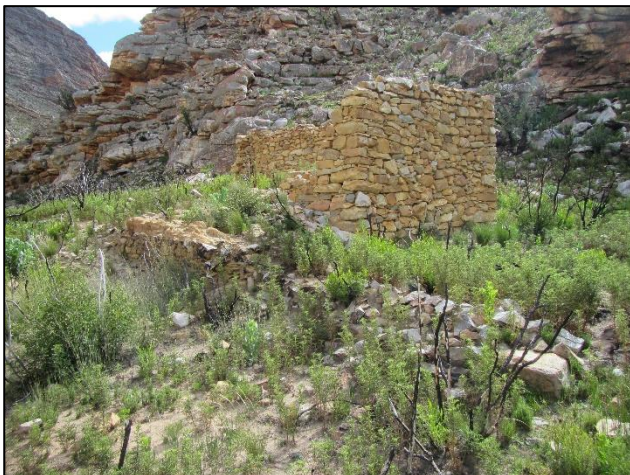
Figure 16: Ruined structure at waypoint 253 with stone terracing present on the slope below. The road is just to the left in this view.

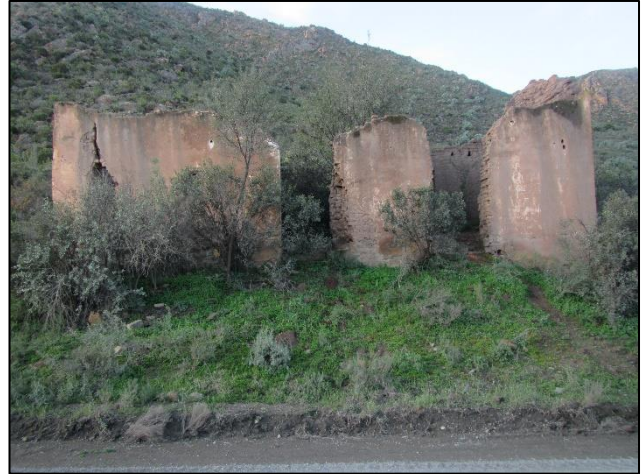
Figure 19: Ruined structure at waypoint 219. It is built of mud bricks.

There are also a few ruins to the south of the poort in the area where the valley opens out. One of these is located very close to the road and was a water mill (waypoint 219; Figure 19). The millrace is still evident on the north-western end of the building but the mill wheel – which apparently still exists somewhere – has long since been removed. Interestingly, this building is not located below a stream and a stone-lined canal (some parts seem to be excavated into the rock) runs towards the northwest. Unfortunately it was heavily silted up and disappeared into dense bush making it impossible to follow to its source.

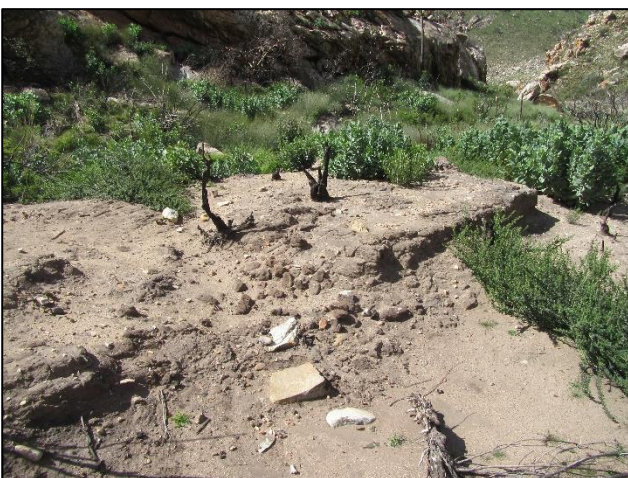
Figure 20: Collapsed mud brick structure at

waypoint 271.

Two small farms were found to have been located within the poort. One has now been turned into a guesthouse and, as noted above, will be addressed in Sections 6.3 and 6.4. The other is purely archaeological and was comprised of many features, some of which are described here. The main aspect was the house which had been constructed of stone and mud bricks (Figures 20 & 21). According to Mr Reizenberg, the family of Machiel Mitchell used to live in this house during the late 19th century. Its ruin lies at the eastern end of the *werf*, very close to one of the river crossings where work is required. A second, and far smaller, structure stood about 30 m to the northwest of the main house.

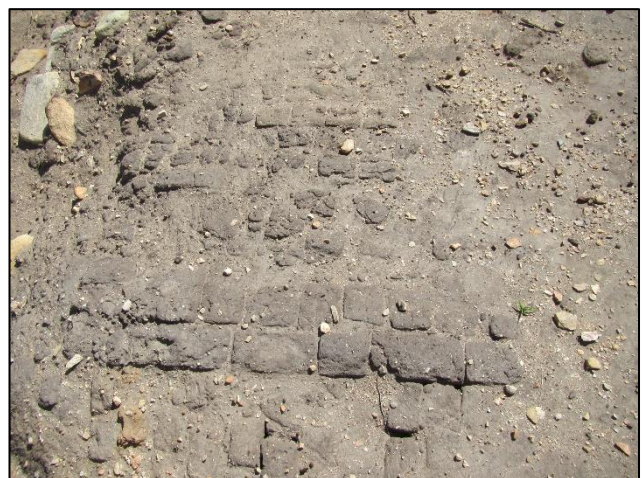
Figure 21: Detail of collapsed mud brick walling

at waypoint 271.

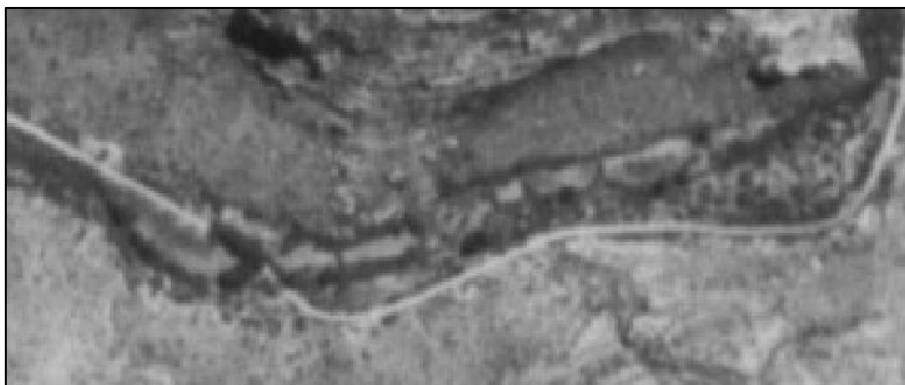
Figure 22: Aerial view of the farm werf at waypoint 271 (Job 53, strip 8, photograph 2743).

Some 250 m to the east there is the remains of another small structure, while there are a few low terraces to help level the land which otherwise slopes gently downhill towards the west. An aerial view of the area from 1944 shows what looks like a number of terraces across the site with bushes surrounding them (Figure 22). The aerial view shows that the land south of the river at the eastern end of the *werf* was not cultivated, while the land between the road and river in the east was cultivated.

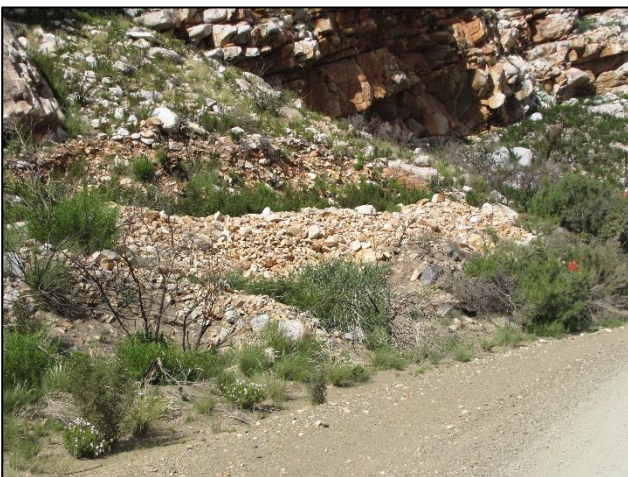
Figure 26: Example of one of the larger stone and gravel quarries scattered along the entire length of the pass.

The last archaeological features of note are the very large number of small excavations situated alongside the road throughout the length of the pass (Figures 26 & 27). These were material sources dating to the original construction of the road. They were excavated into the colluvial deposits at the foot of the slopes in order to obtain rocks and gravel. Comparison of a section of the pass on 1944 and modern aerial photographs shows these features clearly – they were less overgrown in 1944 (Figure 28).

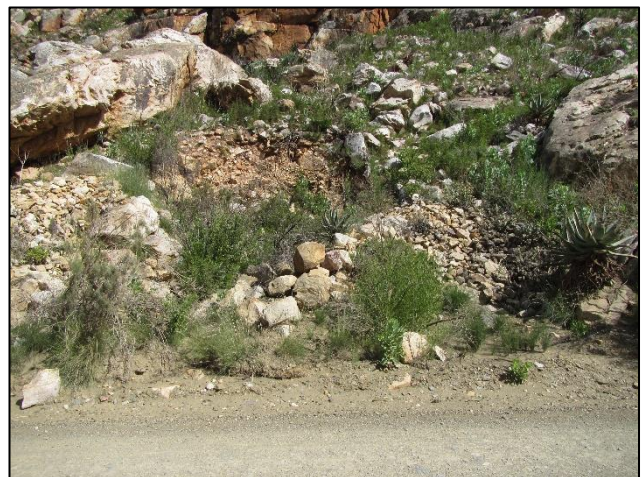
Figure 27: Example of one of the very small stone and gravel quarries found along the side of the road in the pass.

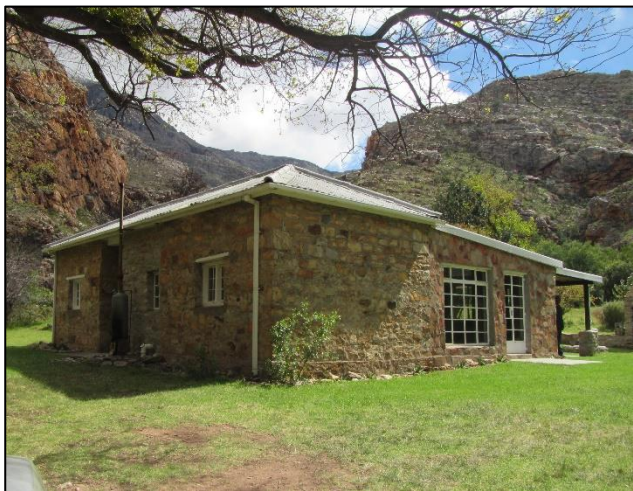
Figure 33: View of the historical stone cottage On the Aristata Farm at waypoint 260.

Heritage resources falling within the category of buildings occurred at one place only – the Aristata Farm. Here there are a few small stone structures that have been renovated to fulfil the function of guest accommodation. Figure 33 shows the best example which has had an addition to its rear and had its front porch divided in half, presumably to create a bathroom. It appears as though some original joinery occurs. The house looks to be early 20th century in age and does not match the location of any structure on the 1872 survey diagram. It seems likely that the original construction camp structures were demolished with the stones used to build new farm structures. It is possible that some structures are original and that the survey diagram is simply inaccurate. In any case, the structures on the farm are all on the opposite side of the river from the road and well away from any crossings.

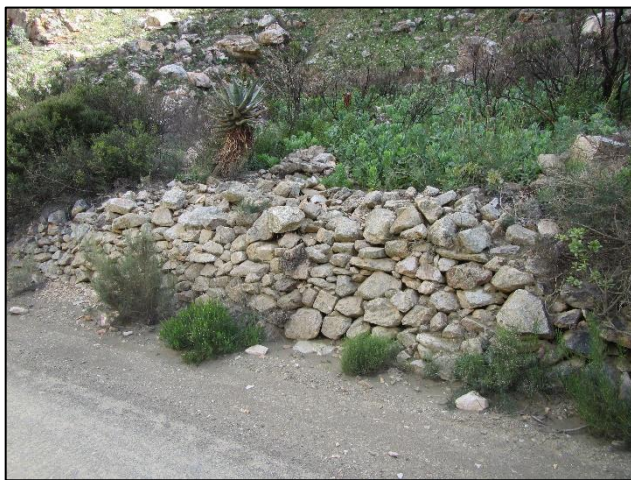
Figure 34: View of the stone retaining wall located along the road at waypoints 674-675.

Other heritage resources considered under built environment are sections of walling that were built as part of the road and retain their original functionality. Such retaining walls were observed in two locations, one above the road (waypoint 674-675; Figure 34) and one below the road where the latter passes very close to the river (waypoint 217). While no works are planned in the vicinity of

the second one, the first one does have a tributary stream crossing that requires attention immediately at its north-eastern end. This section on the end does look slightly different to the rest and may have been reconstructed after flood damage at some point in the past.

It is likely that damage to the retaining wall at waypoints 674-675 is going to be inevitable during upgrade of the structure at km 46.35. However, the section of concern may have been at least partially rebuilt during maintenance work subsequent to its original construction. Mitigation measures would involve minimising the damage to the drystone walling, integrating the new works with the base of the wall and rebuilding the wall where it was damaged. It would be important to use old, weathered and lichen-coated rocks so as to not create a high degree of contrast between old and new fabric.

- At Km 46.35 minimise damage to the drystone walling, integrate the new works with the base of the wall and rebuild the wall where it was damaged in such a way as to ensure minimal contrast between the old and new fabric;

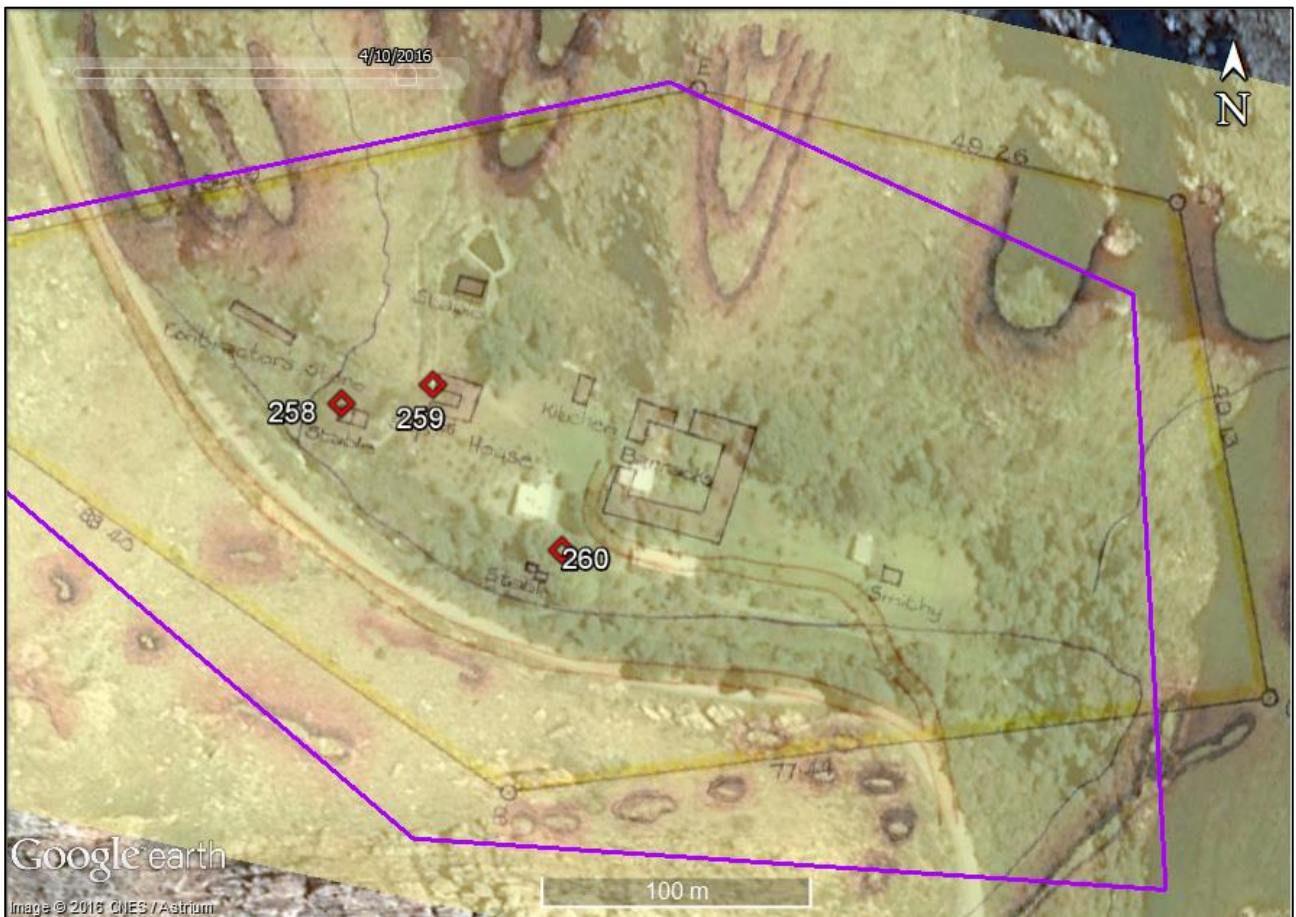
Figure 40: Composite image created by superimposing Survey Diagram 667/1872 onto the modern aerial view. The purple polygon is, according to Cape Farm Mapper, the correct farm boundary.

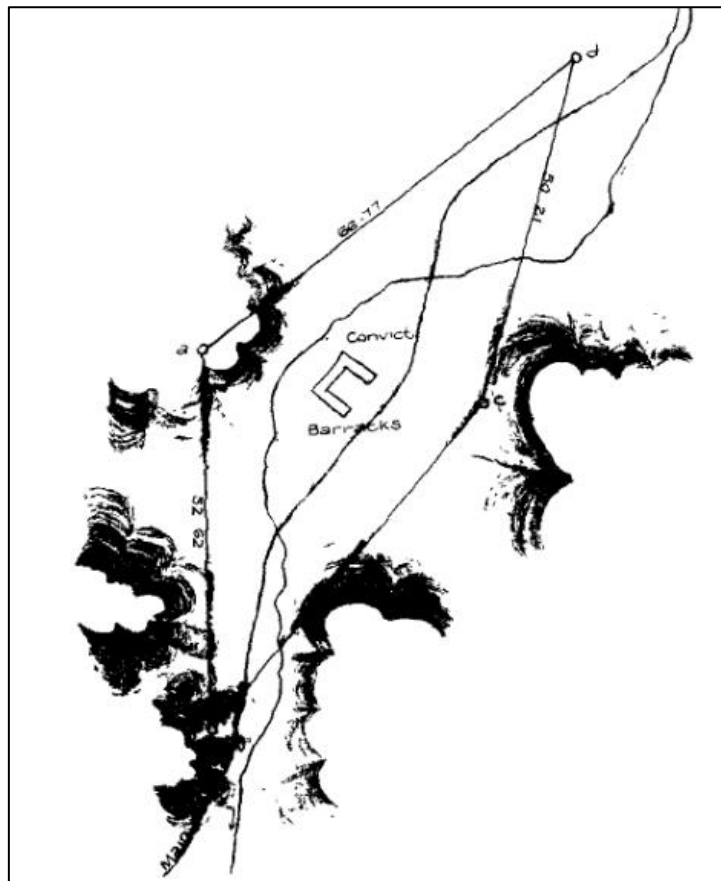
Figure 40: Extract from Survey Diagram 665/1872 showing the U-shaped ‘convict barracks’ with the river to its northwest and the road to its southeast.

Further south again, Survey Diagram 665/1872 is once more indicating a small farm. This one has a 'convict barracks' indicated on it and is the now-ruined structure located at Waypoints 215 and 216.

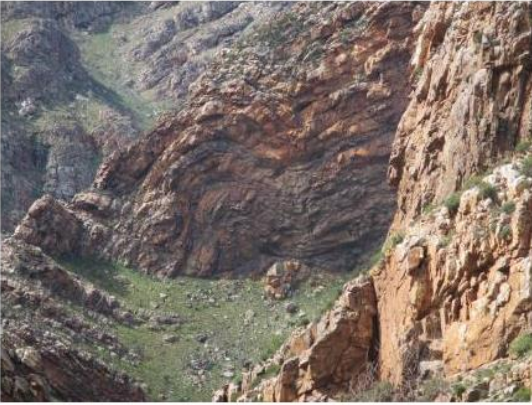
I also wanted to ask was about the folding. The poort is a great example of a section through the Cape Fold Belt so I think it is worth listing as a geological heritage site from that point of view. Do you agree? There is one especially spectacular view of folds as below.

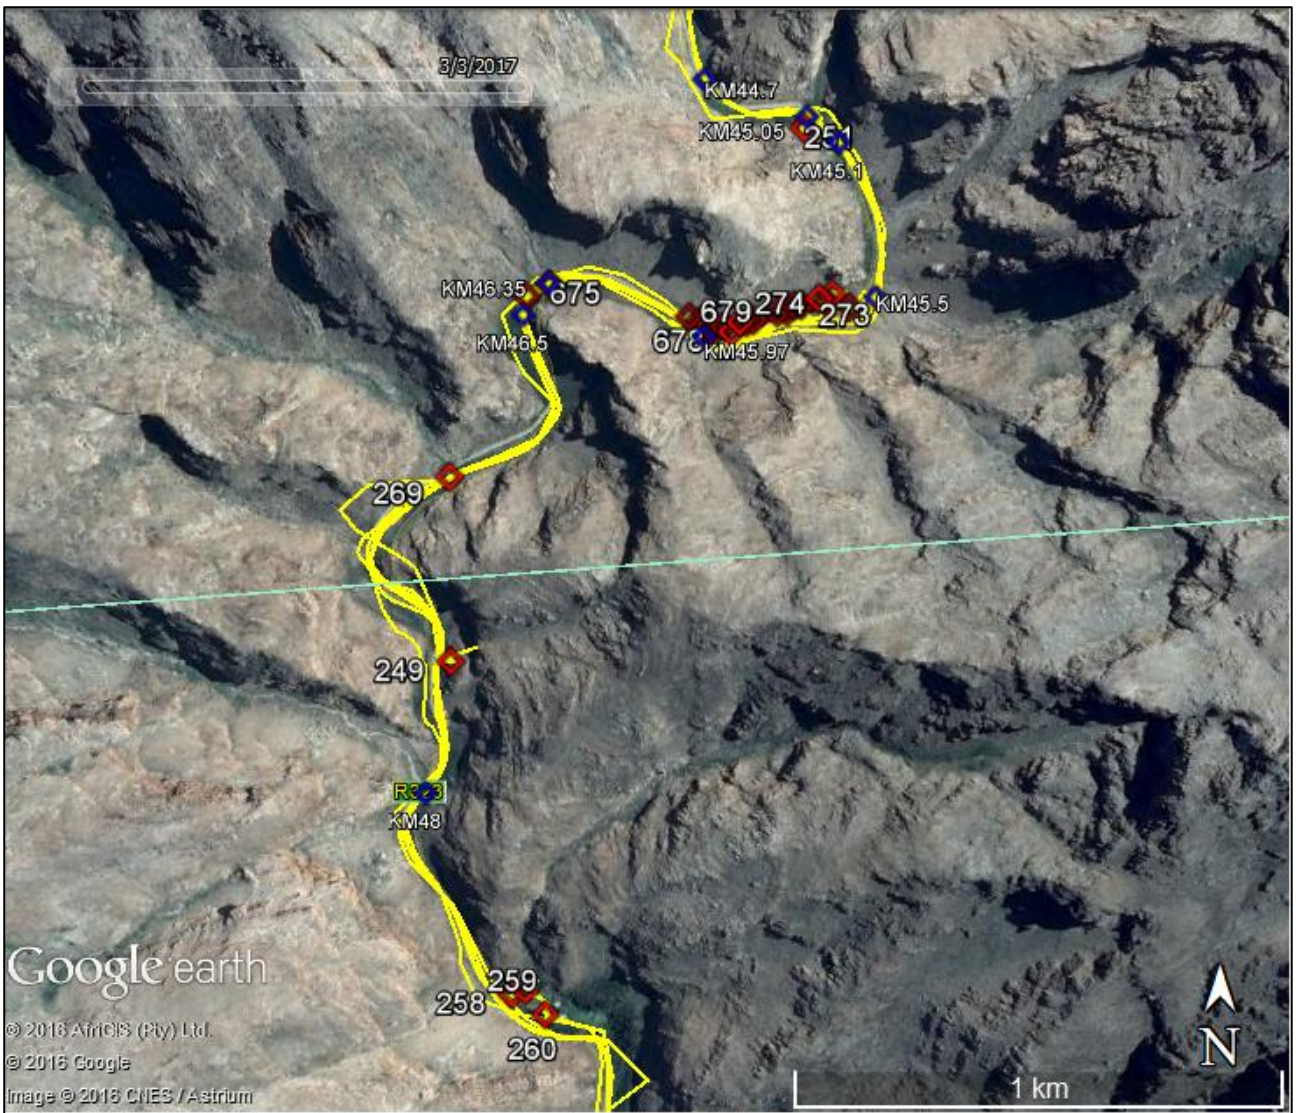
Figure A4.2: Map 2 (see Figure A4.1 caption).

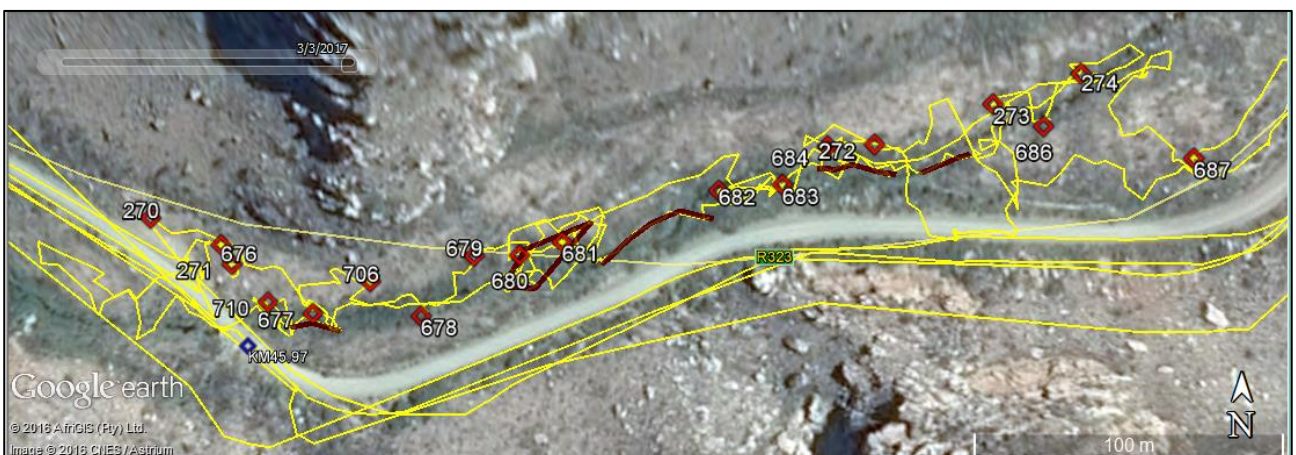
Figure A4.3: Map 2A (see Figure 13 caption). The dark red lines indicate piled stone berms.
